Navajo Abandoned Uranium Mine

Site Screen Report

Mine Name: A & B No. 7
Mine ID: 451

August 2011

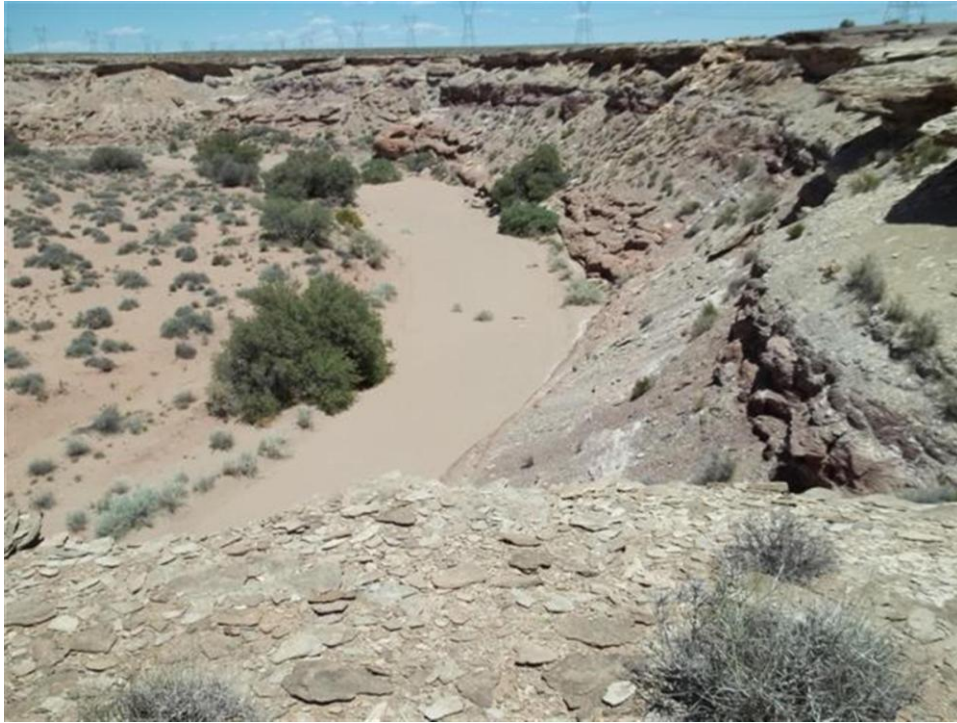
Photo 3: Mine Site #451; Dry river bed north of site

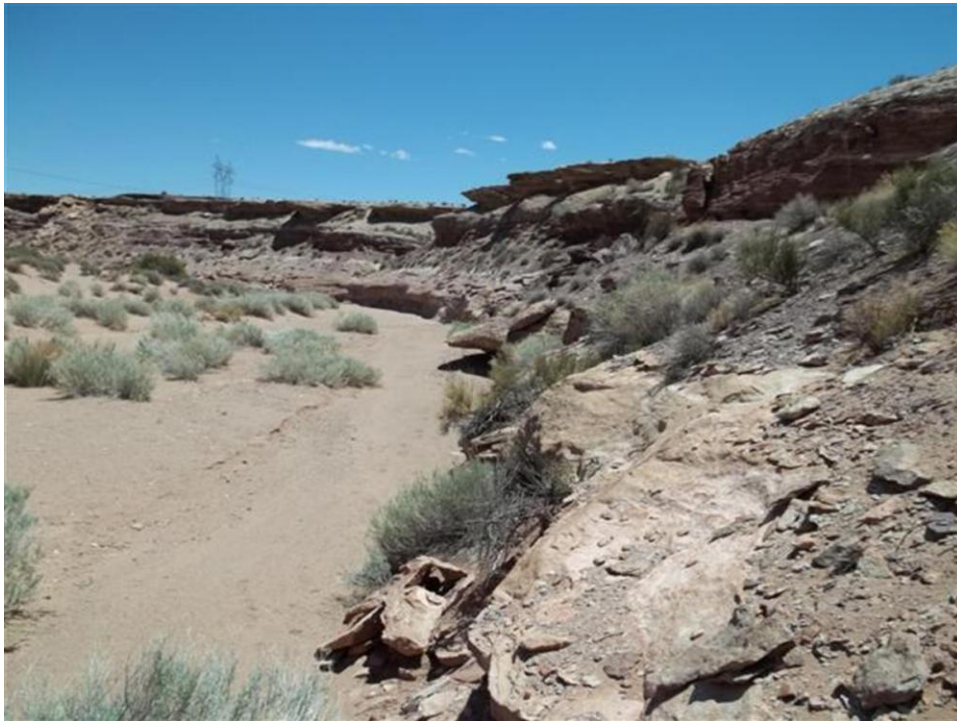
Photo 4: Mine Site #451; Dry river bed northwest of site

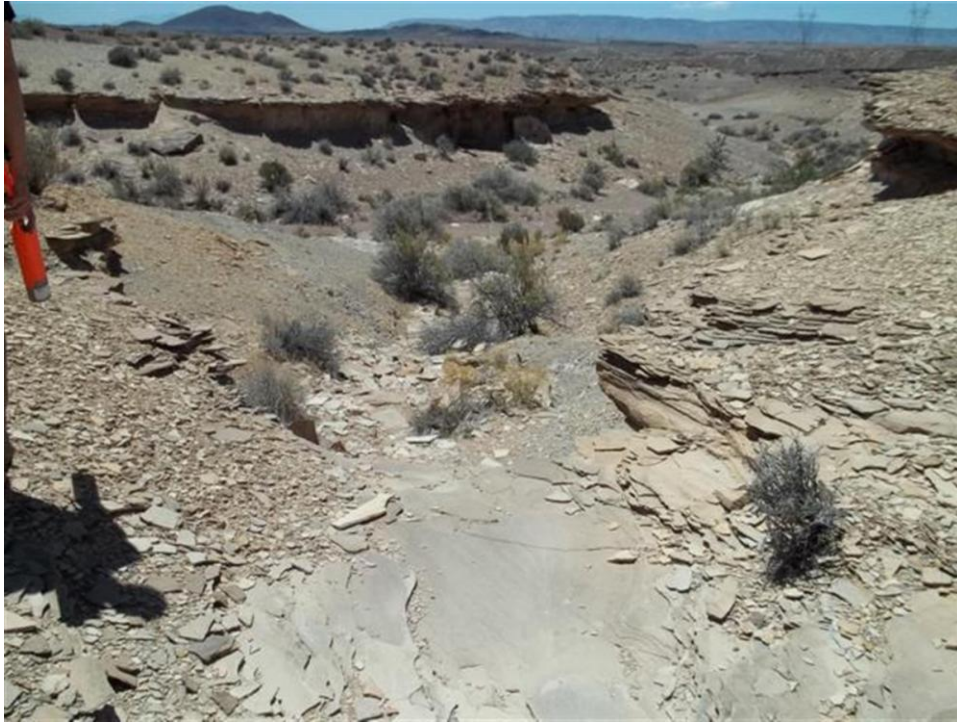
Photo 5: Mine Site #451; Drainage through site
