# **Navajo Abandoned Uranium Mine**

## **Site Screen Report**

### **New Liba Group AUM Site**

**Navajo AUM Western Region**

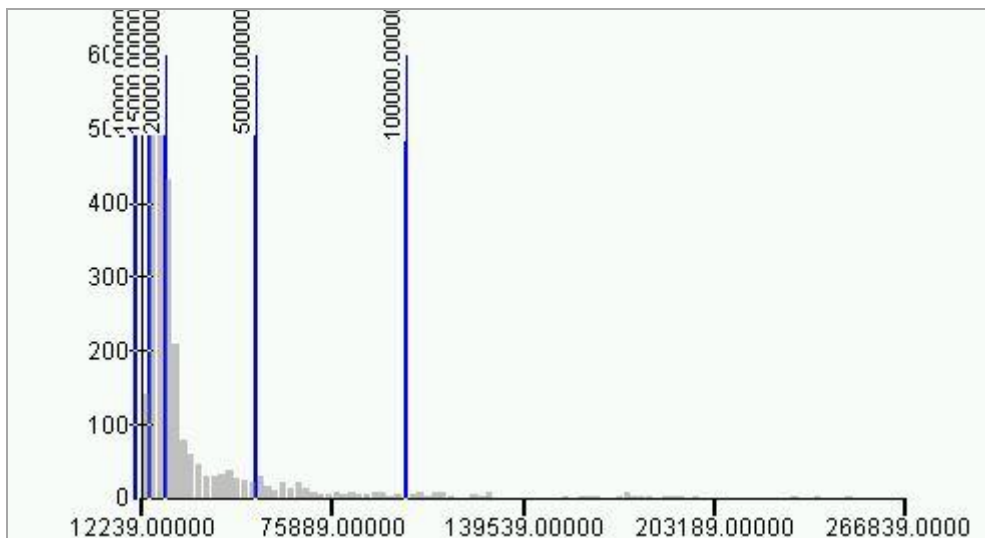
The following chart and statistics were generated by ESRI ArcGIS 9.3.1, and show the general distribution of the site gamma radiation measurements. The horizontal X axis represents the gamma radiation reading levels in cpm (lowest levels to the left). The vertical Y axis represents the frequency of each gamma radiation level.

Count:	2549
Minimum:	12239.00000
Maximum:	266839.00000
Sum:	80851762.00000
Mean:	31719.01216
Median:	20268.00000
Standard Deviation:	32842.48816

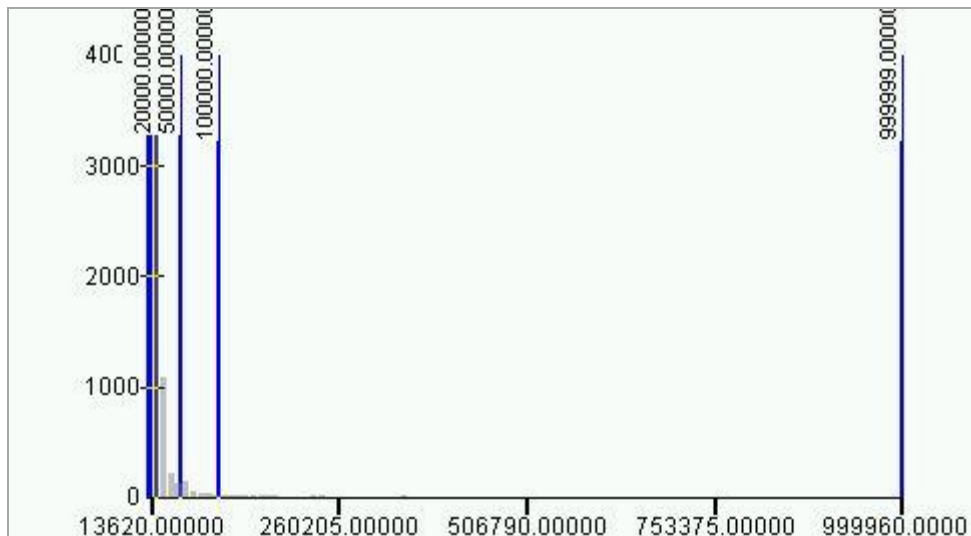
The following chart and statistics were generated by ESRI ArcGIS 9.3.1, and show the general distribution of the site gamma radiation measurements. The horizontal X axis represents the gamma radiation reading levels in cpm (lowest levels to the left). The vertical Y axis represents the frequency of each gamma radiation level.

Count:	5756
Minimum:	13620.00000
Maximum:	999960.00000
Sum:	236972511.00000
Mean:	41169.65097
Median:	21071.50000
Standard Deviation:	77676.95550

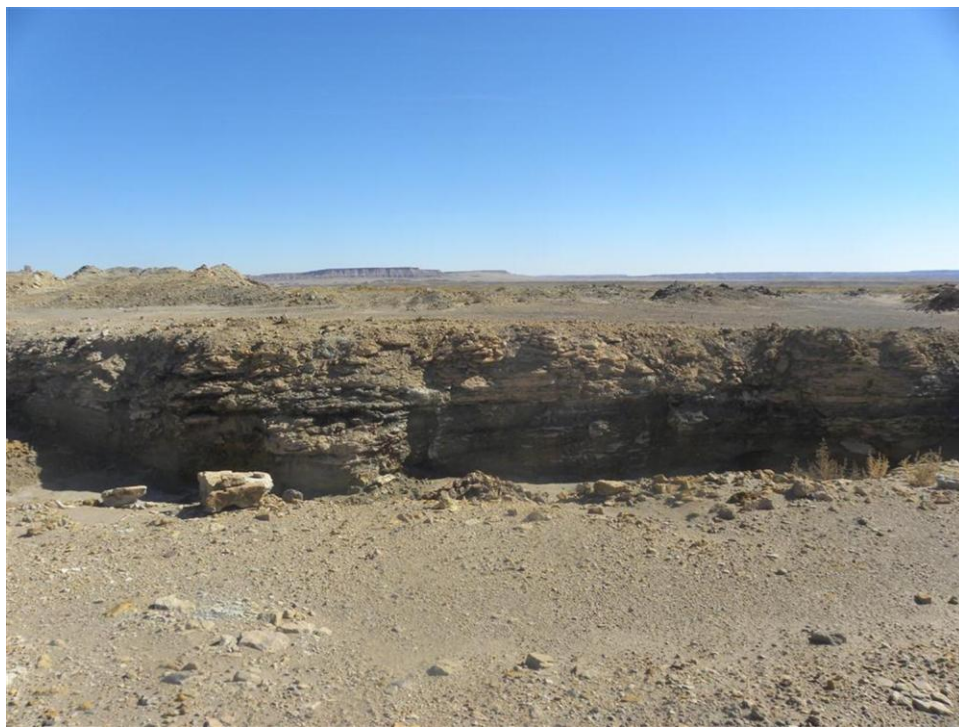
Photo 2. New Liba Group, Site #456, open pit

Open pit area in center of site, approximately 30' x 320' x 30' deep

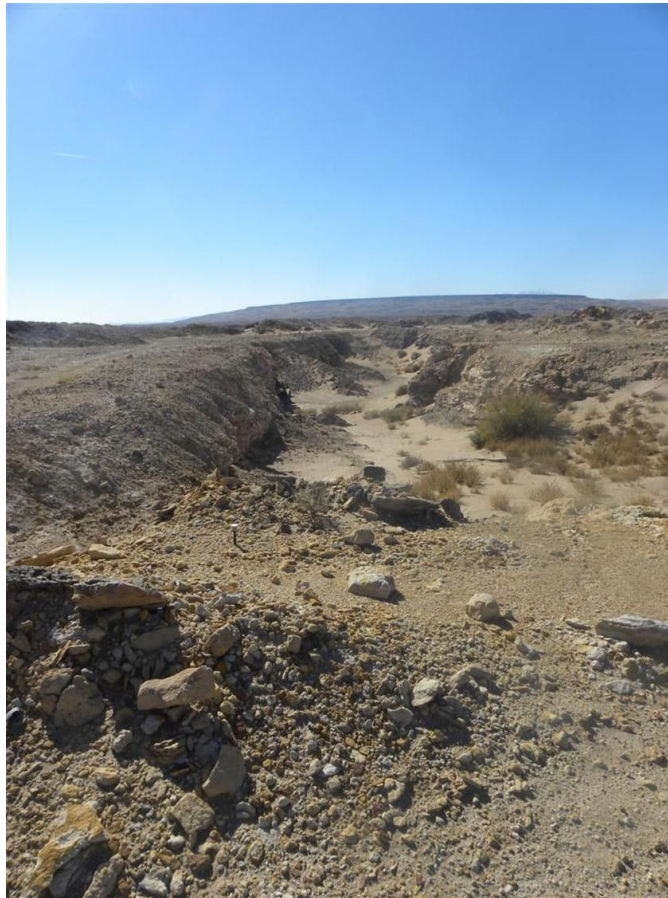
Photo 4. New Liba Group, Site #456, open pit and waste piles

Waste piles throughout site, surrounding open pit, estimated 720' x 360' x 10'

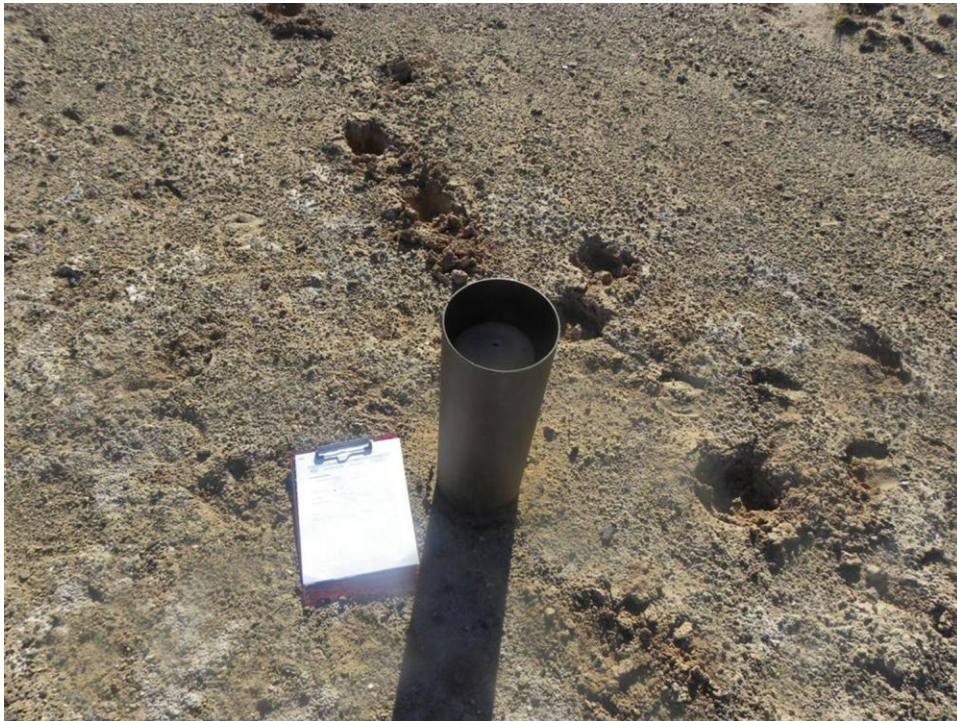
Photo 8. New Liba Group, Site #522, metal casing

Possible rim strip operation; various wood markers and metal boundary markers labeled "Western Nuclear" surrounded with black casings; several 6" metal casings around 4" PVC pipes south and west of site; large exposed ore rock

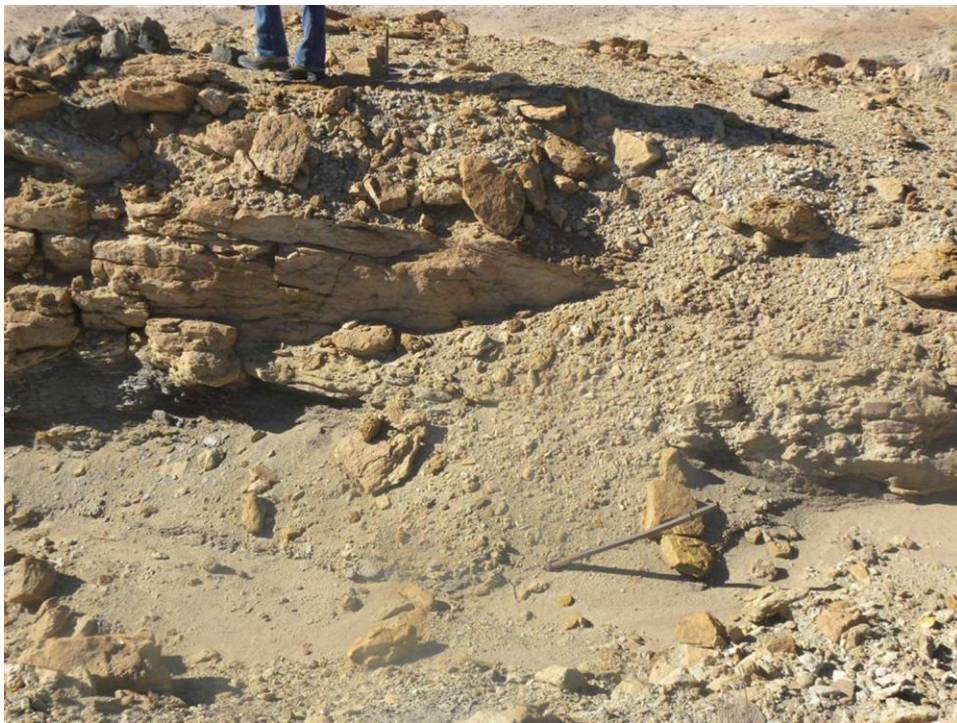
Photo 12. New Liba Group, Site #522, waste pile and mining debris

Majority of site is one large waste/workings pile, possible rim strip operation, estimated size 500' x 2,000' x 5'

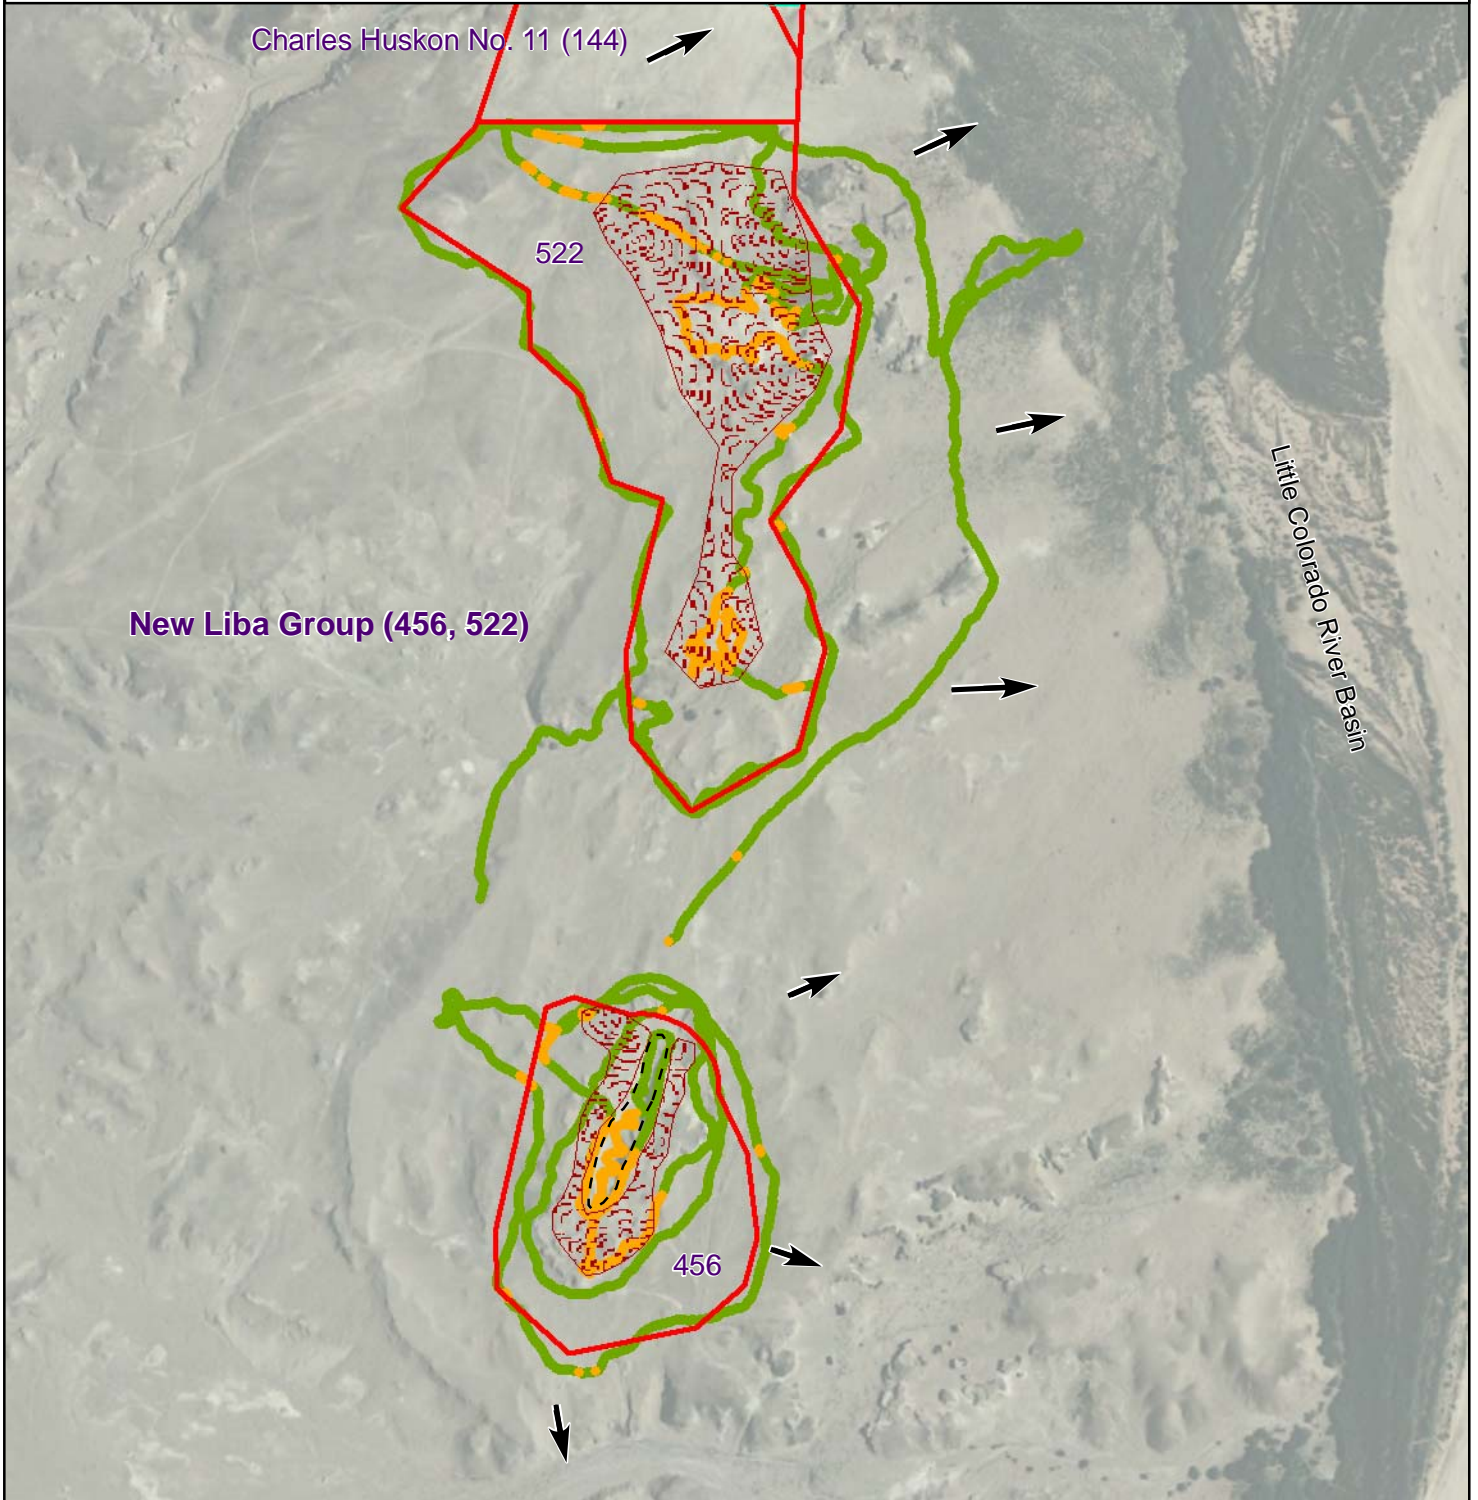
**Figure 1 - Gamma Radiation Measurements, Above Two Times Background  
New Liba Group (456, 522)  
Coconino County, Arizona**

A total of 2,549 gamma radiation measurements were collected from the mine site, ranging from 12,239 cpm to 266,839 cpm. The measurements collected inside the open pit were found at levels ranging from approximately 30,000 cpm to 200,000 cpm, and at the waste piles surrounding the pit at a maximum level of approximately 265,000 cpm. The measurements are represented in Figures 1, 2, 3, and 4.

A total of 5,756 gamma radiation measurements were collected from the mine site, ranging from 13,620 cpm to 999,960 cpm. The measurements collected throughout the waste rock area were found at levels ranging from approximately 40,000 cpm to 1,000,000 cpm, at the exposed ore at a maximum level of approximately 250,000 cpm, and in the downstream drainages at a maximum level of approximately 25,000 cpm. The measurements are represented in Figures 1, 2, 5, and 6.

Gamma survey conducted 11/2010  
Measured as counts per minute (cpm)

Average background 15,821 cpm

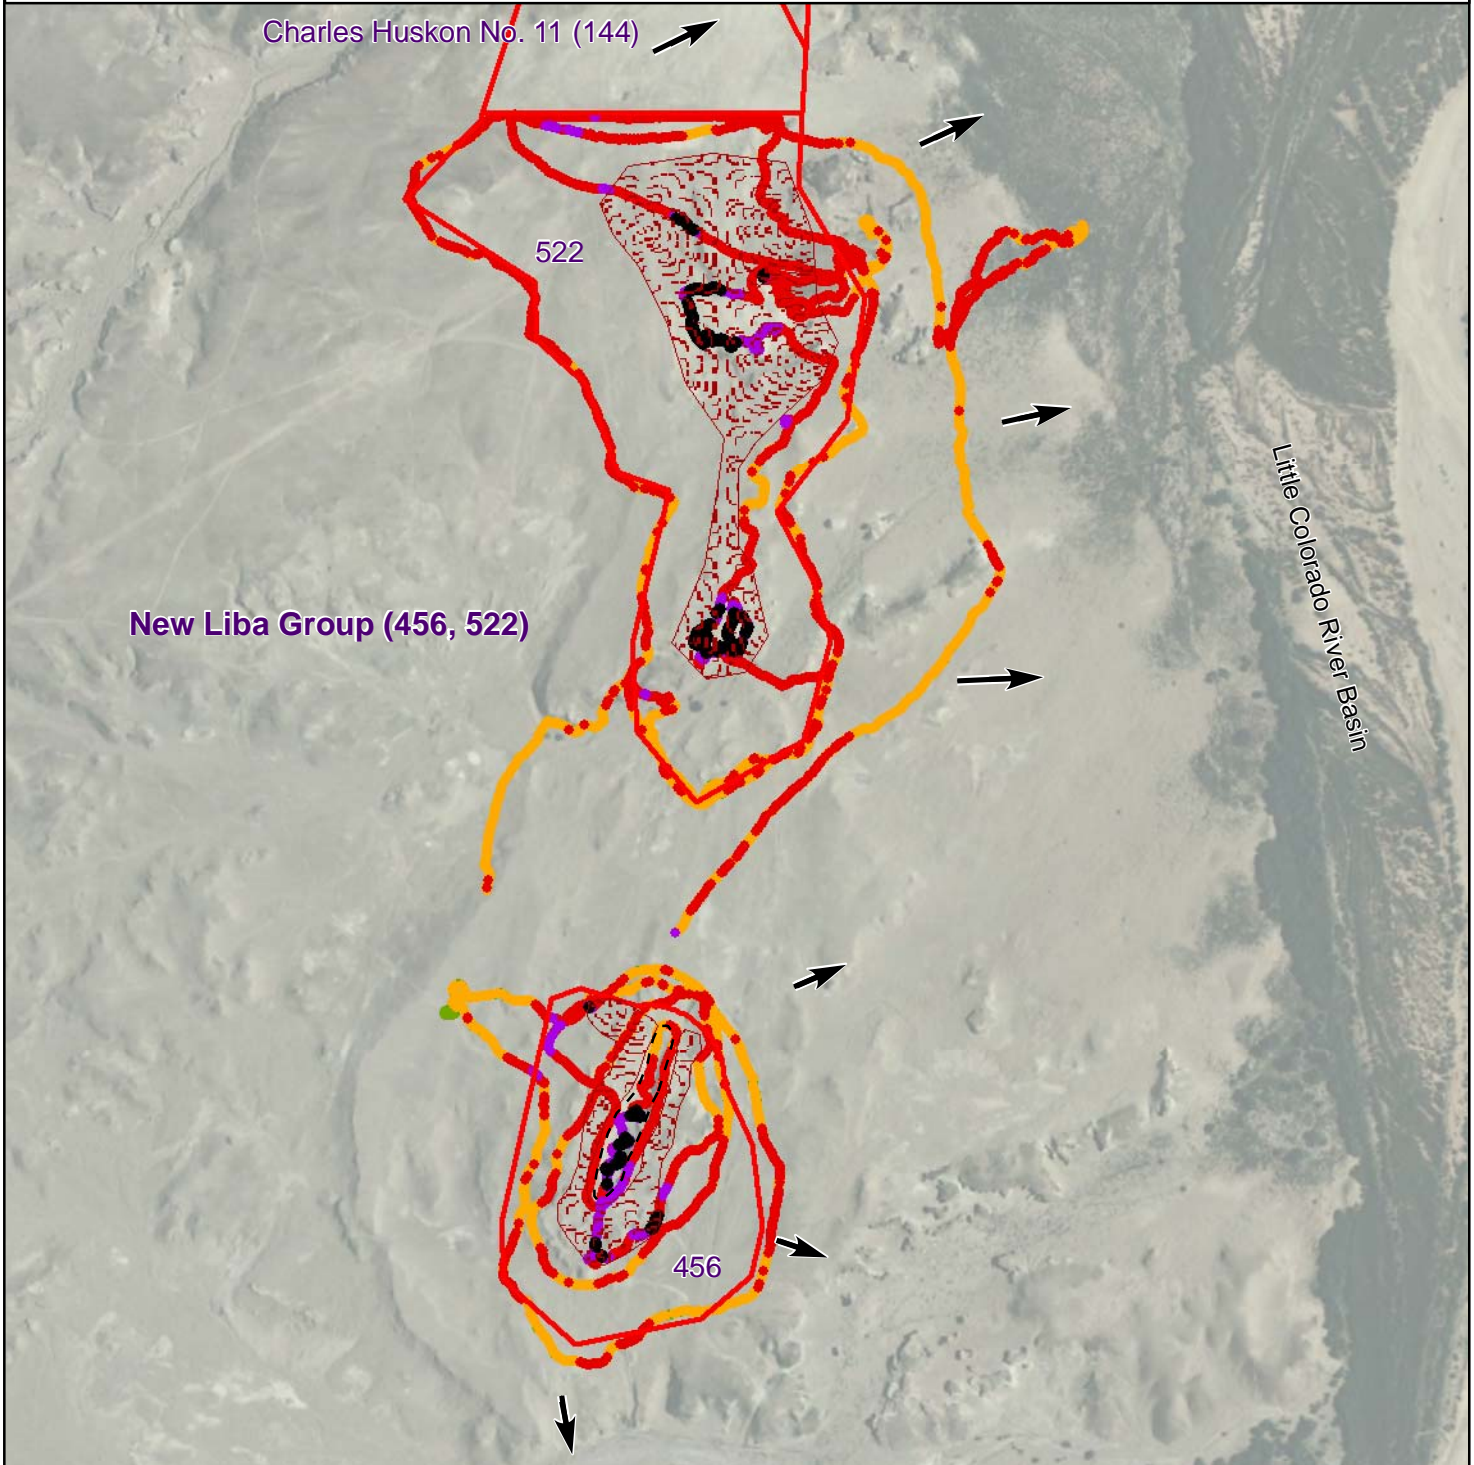
**Figure 2 - Gamma Radiation Measurements  
New Liba Group (456, 522)  
Coconino County, Arizona**

Gamma survey conducted 11/2010  
Measured as counts per minute (cpm)

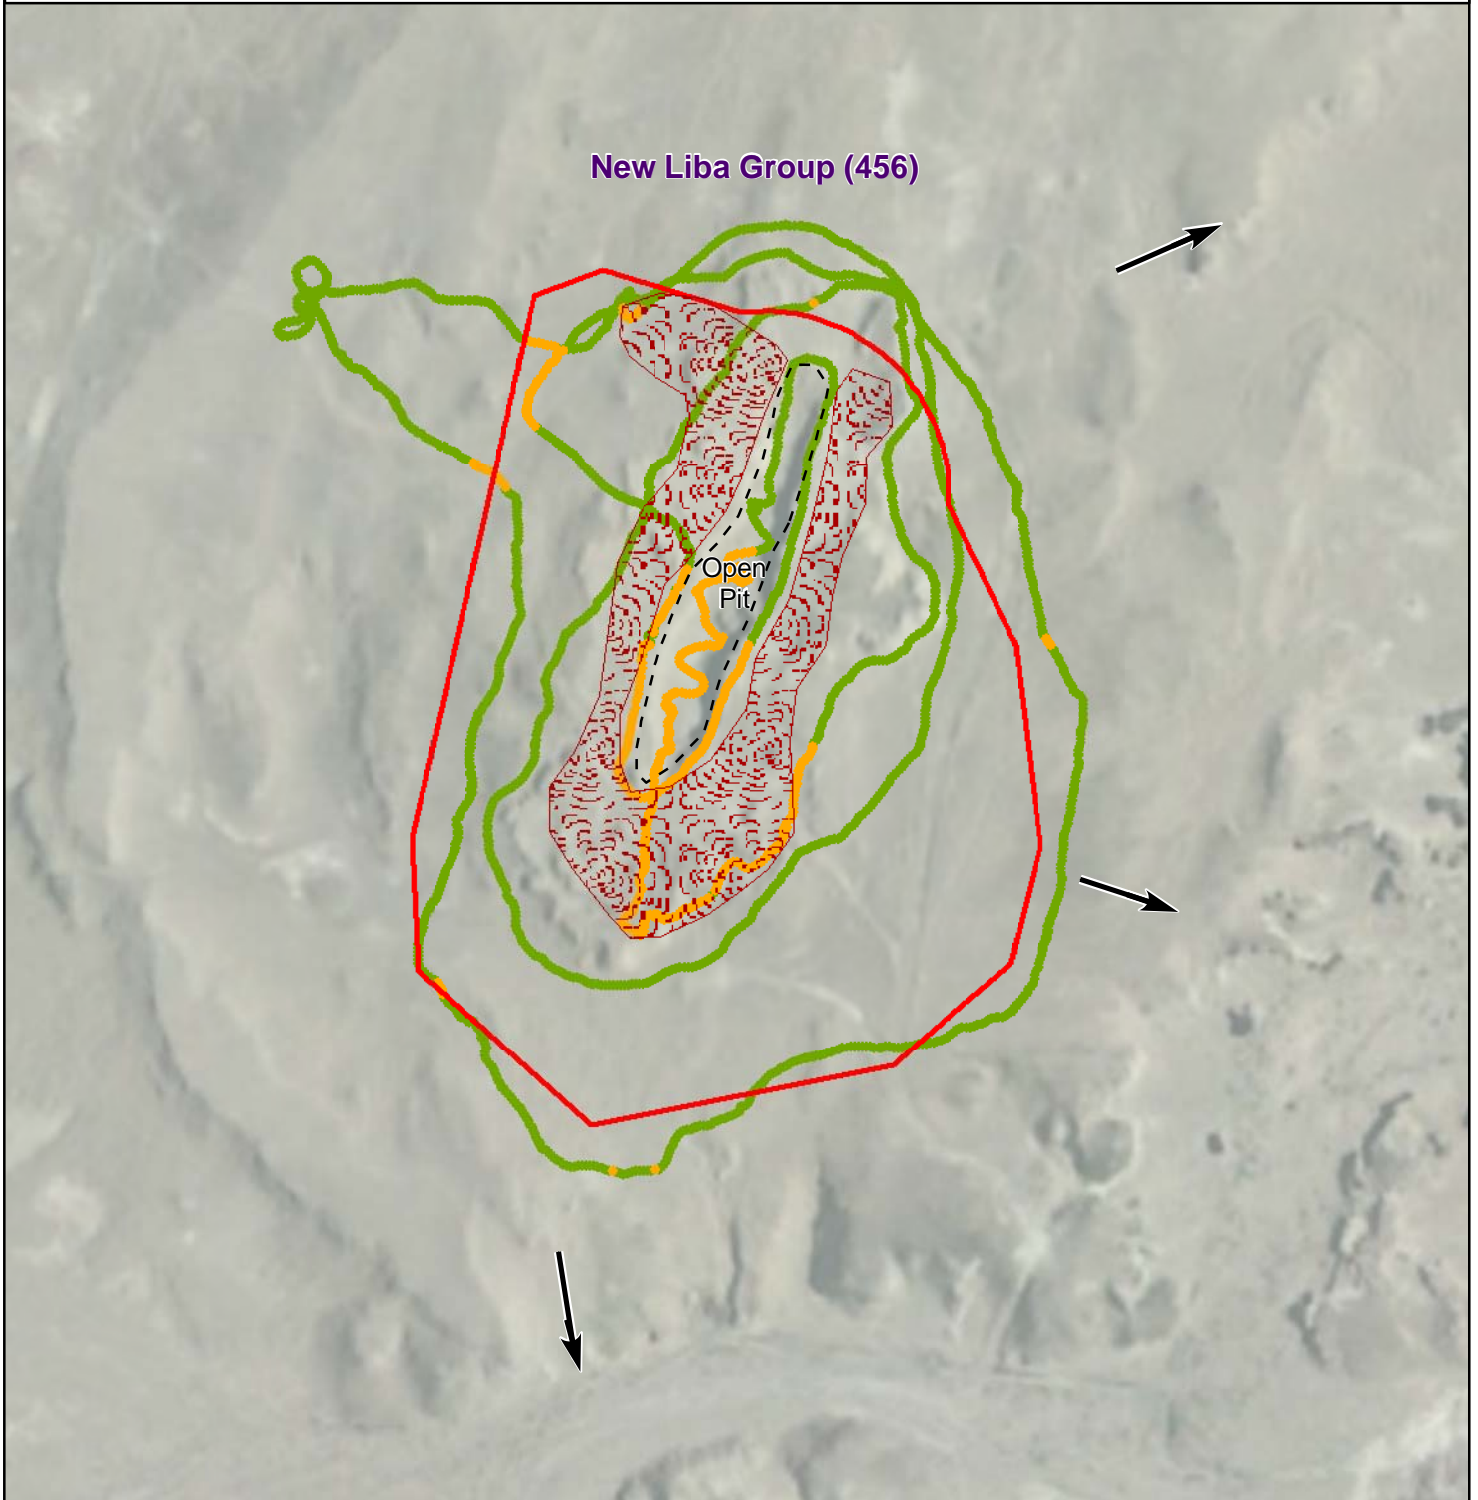
**Figure 3 - Gamma Radiation Measurements, Above Two Times Background  
New Liba Group (456)  
Coconino County, Arizona**

Gamma survey conducted 11/2010  
Measured as counts per minute (cpm)

Average background 15,821 cpm

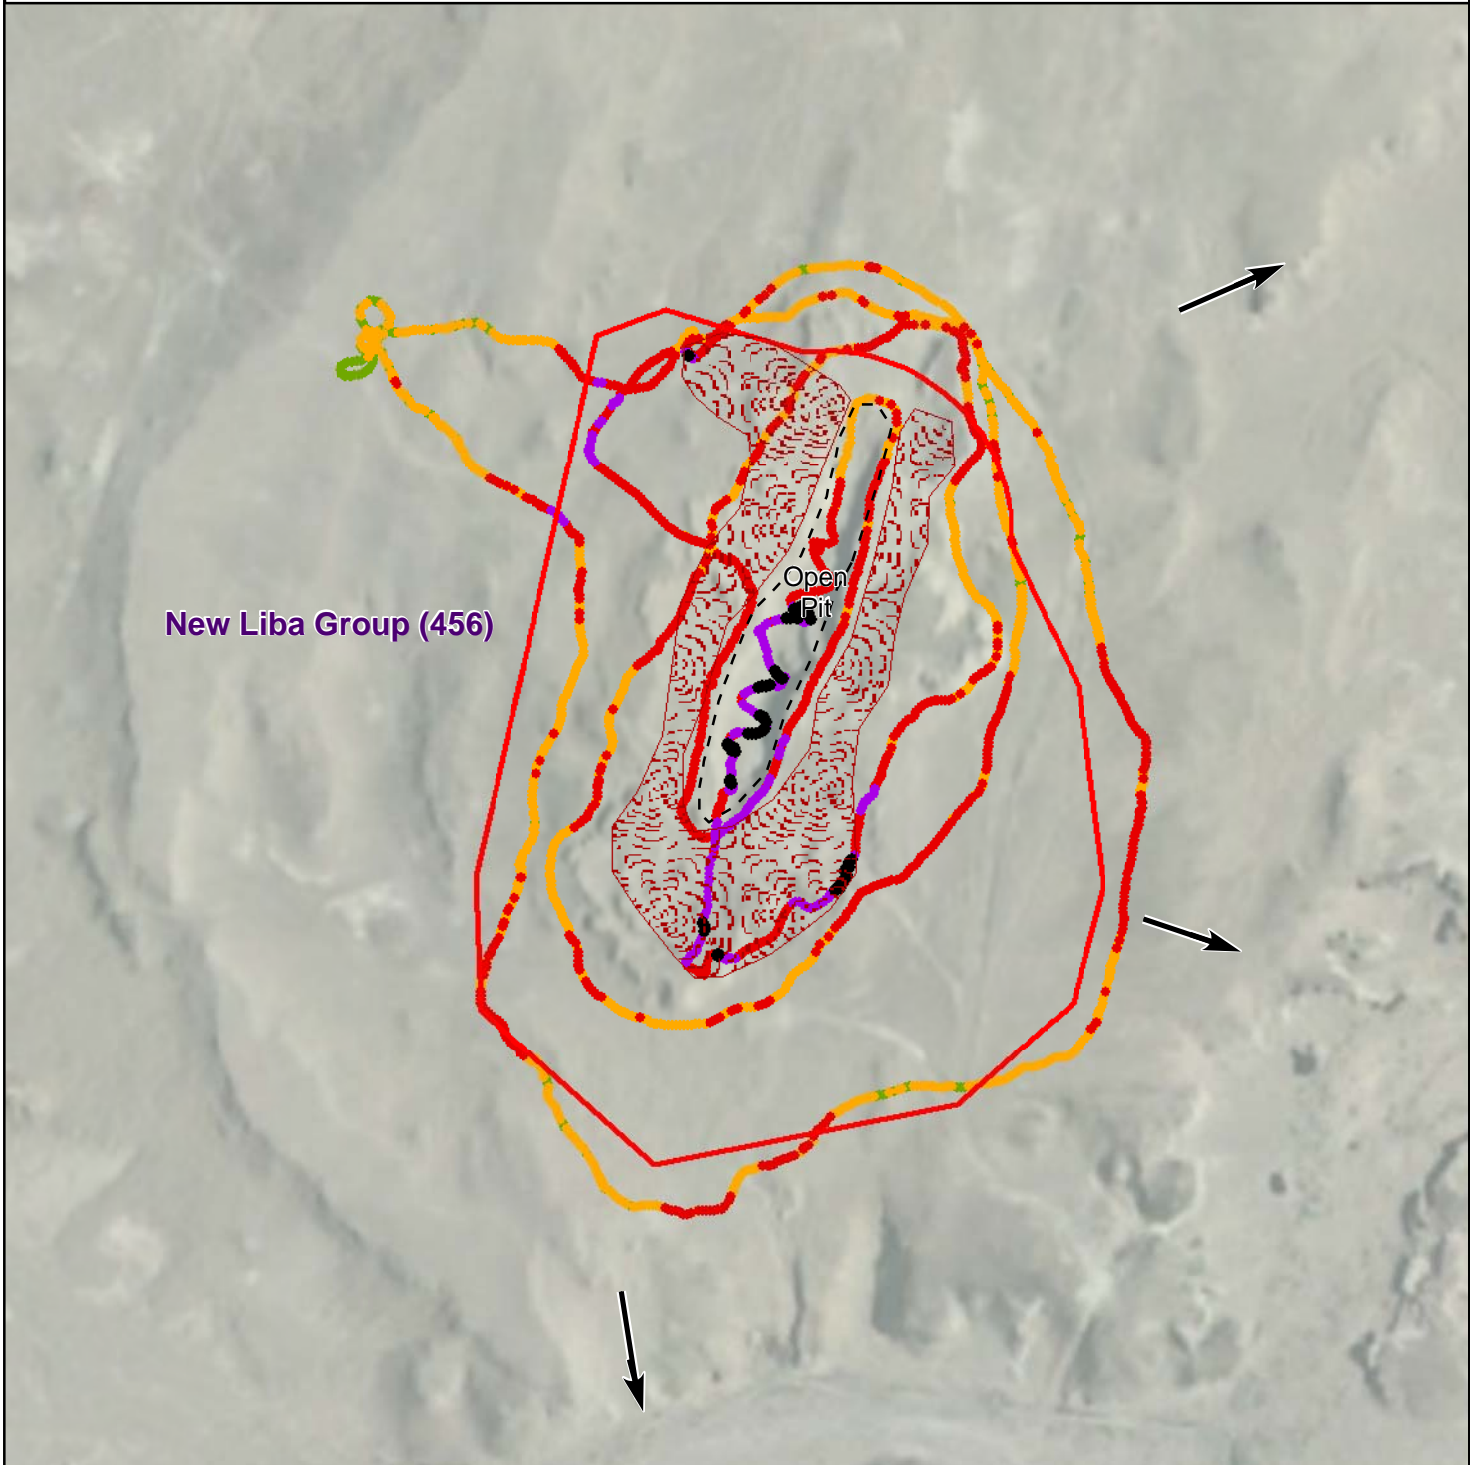
**Figure 4 - Gamma Radiation Measurements  
New Liba Group (456)  
Coconino County, Arizona**

Gamma survey conducted 11/2010  
Measured as counts per minute (cpm)

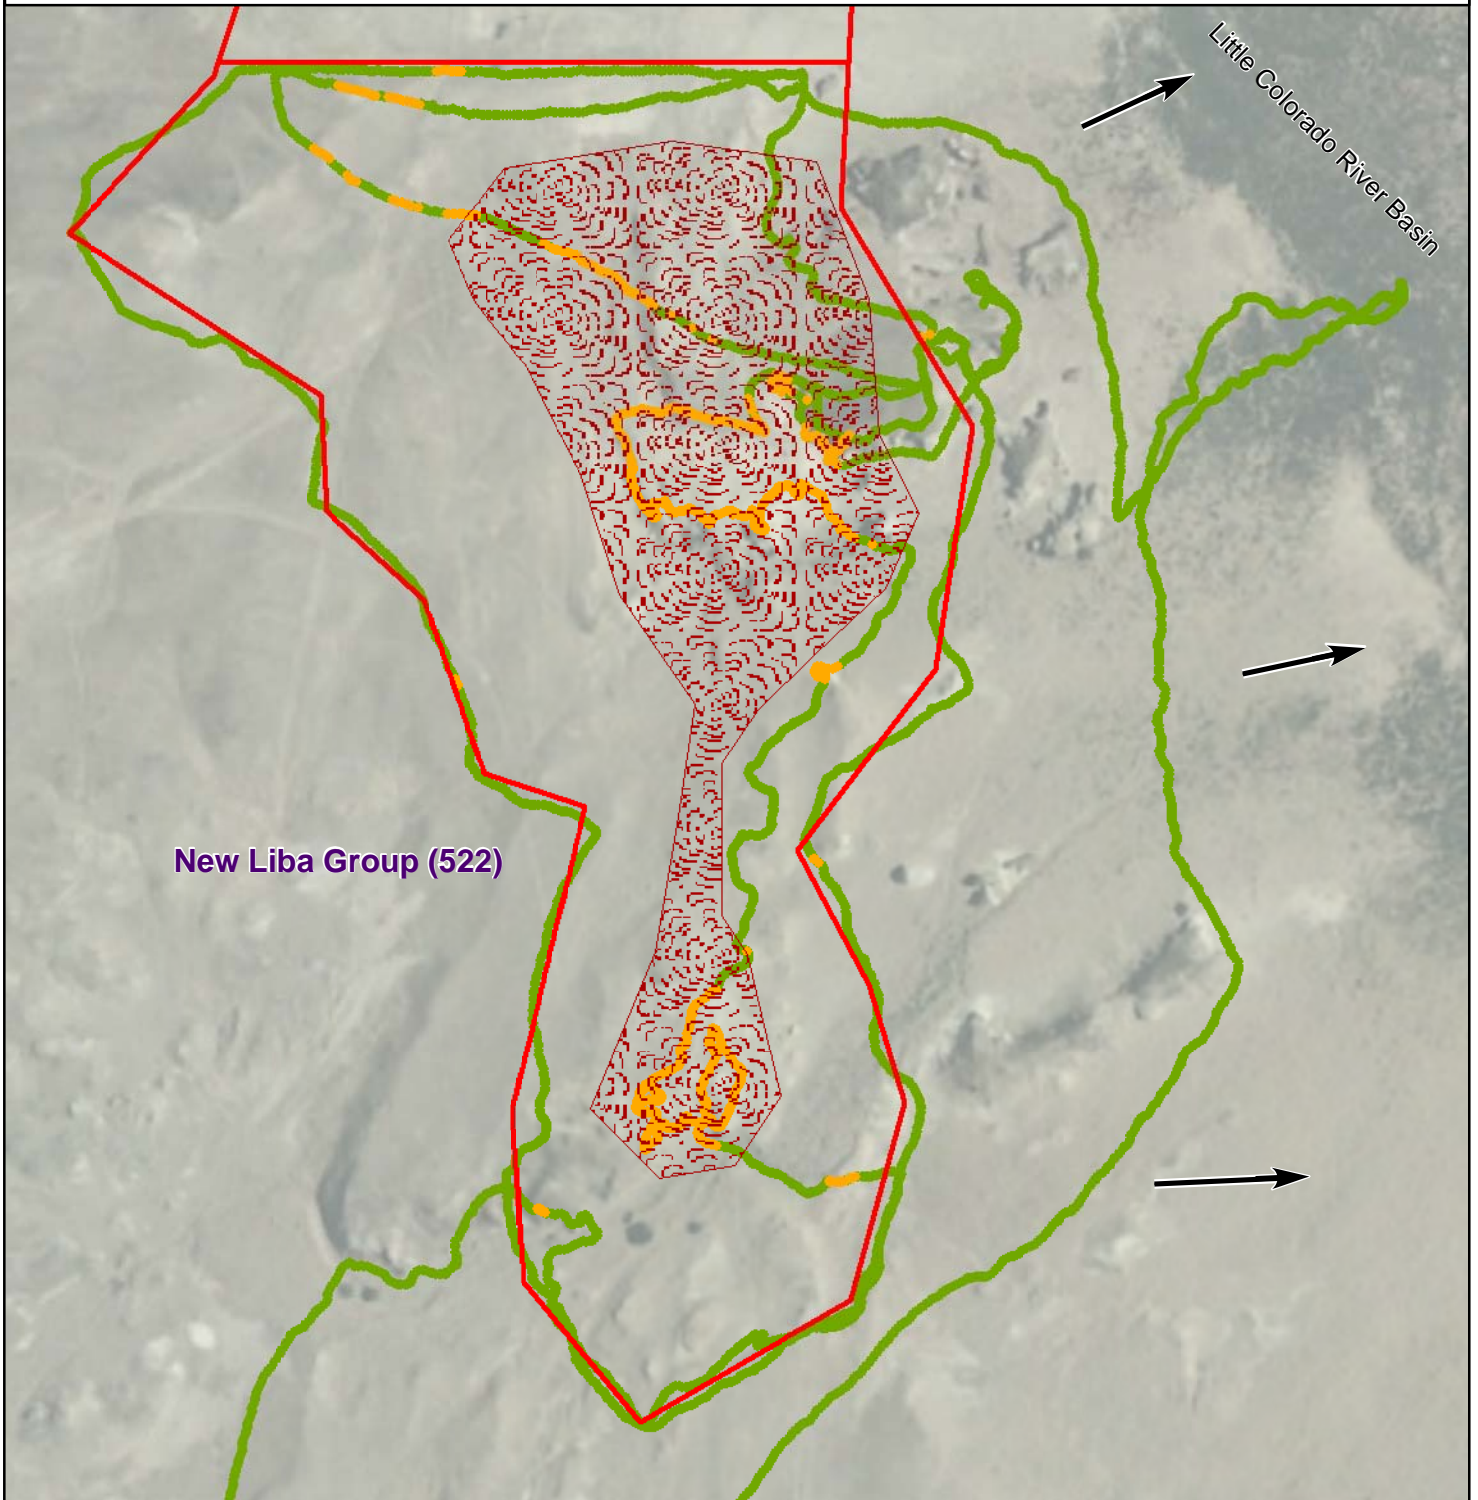
**Figure 5 - Gamma Radiation Measurements, Above Two Times Background  
New Liba Group (522)  
Coconino County, Arizona**

Gamma survey conducted 11/2010  
Measured as counts per minute (cpm)

Average background 15,821 cpm

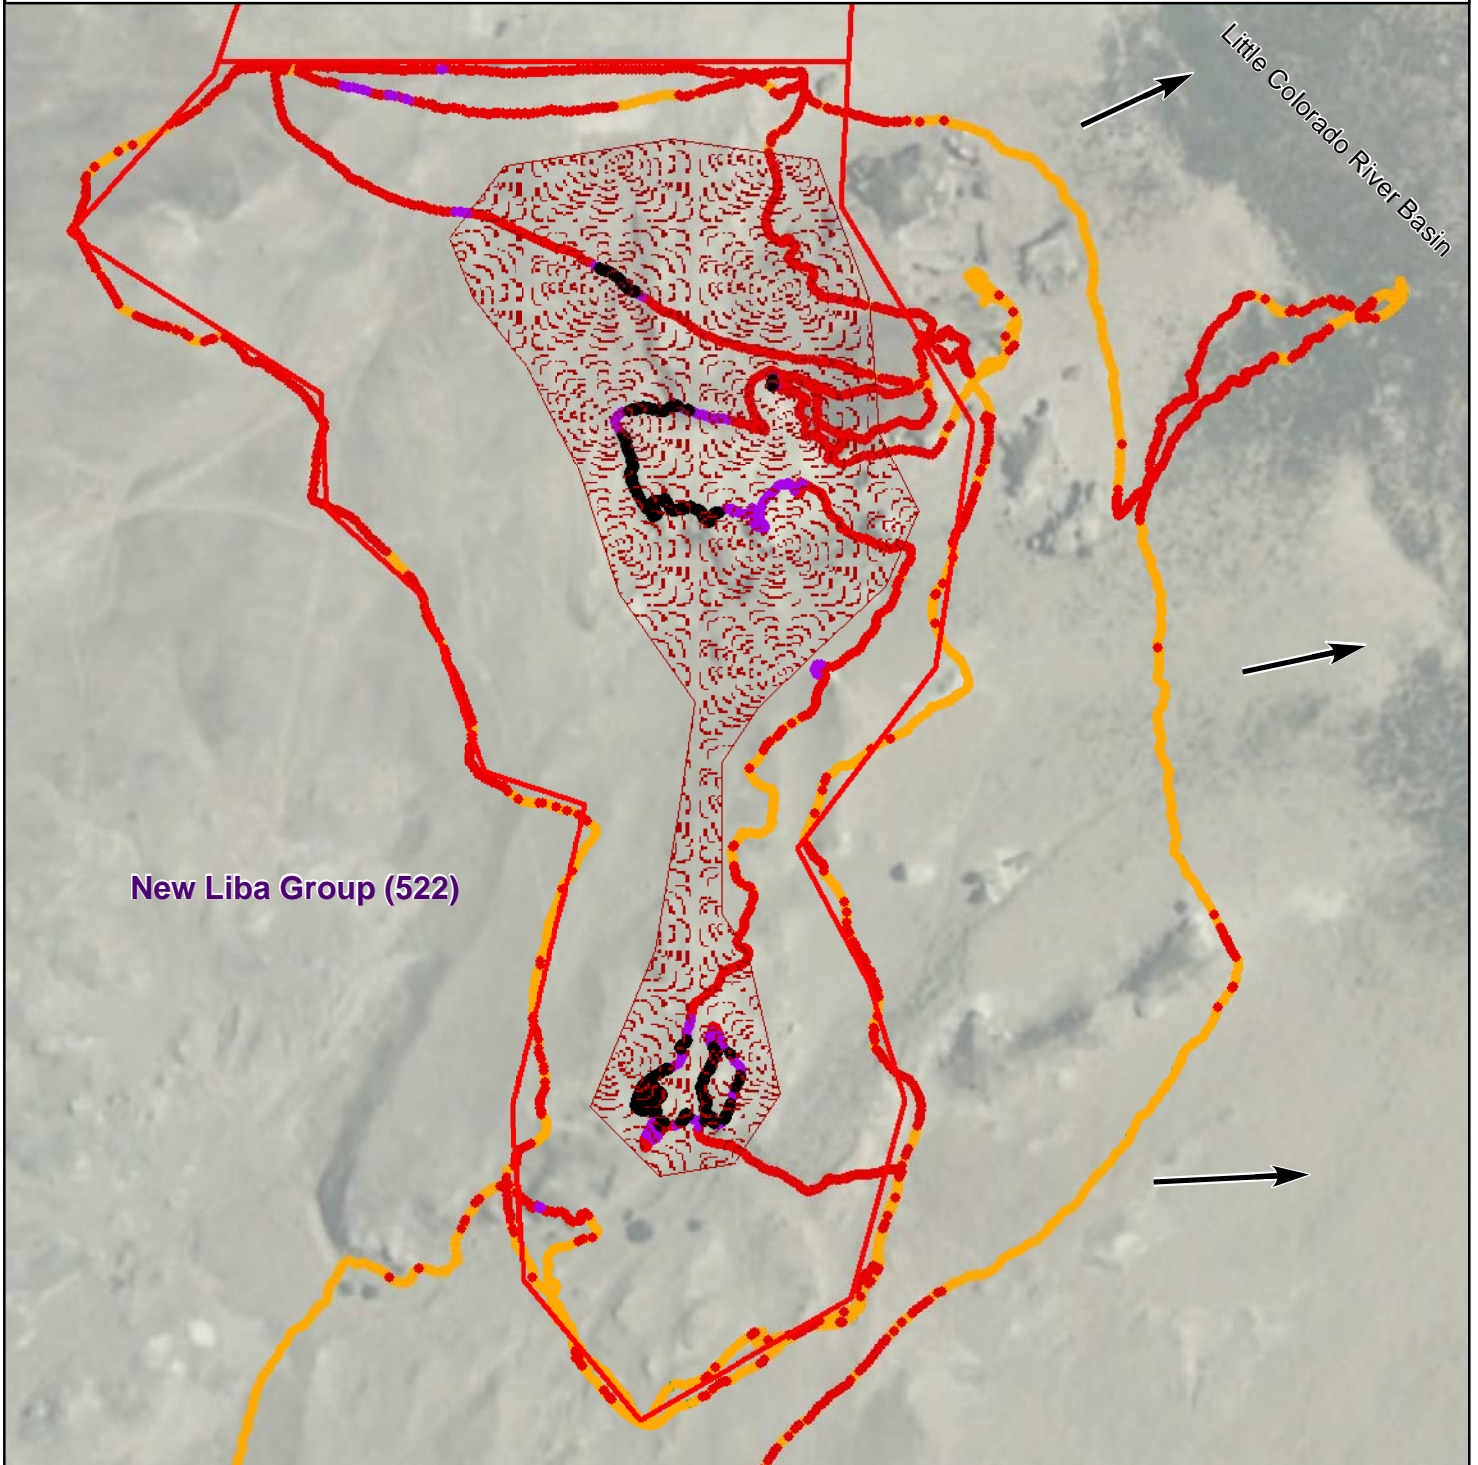
**Figure 6 - Gamma Radiation Measurements  
New Liba Group (522)  
Coconino County, Arizona**

Gamma survey conducted 11/2010  
Measured as counts per minute (cpm)
