Navajo Abandoned Uranium Mine

Site Screen Report

Horace Ben AUM Site

March 2010

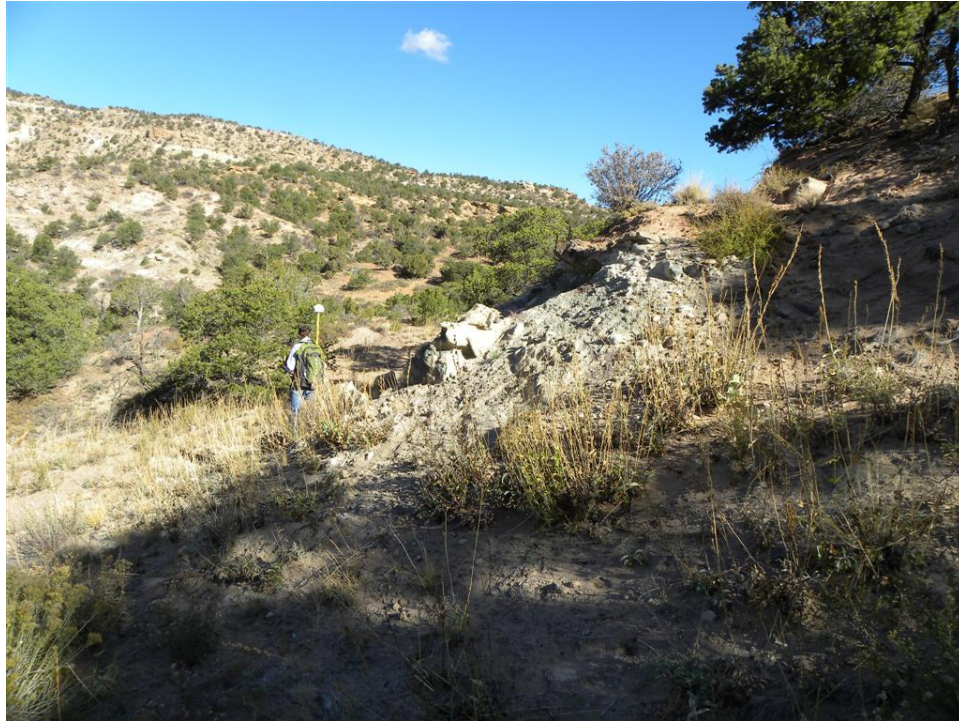
Waste rock debris down drainage wash 75' x 40', with a total estimated volume of 556 yd³

Photo 1. Waste rock

Unreclaimed waste pile

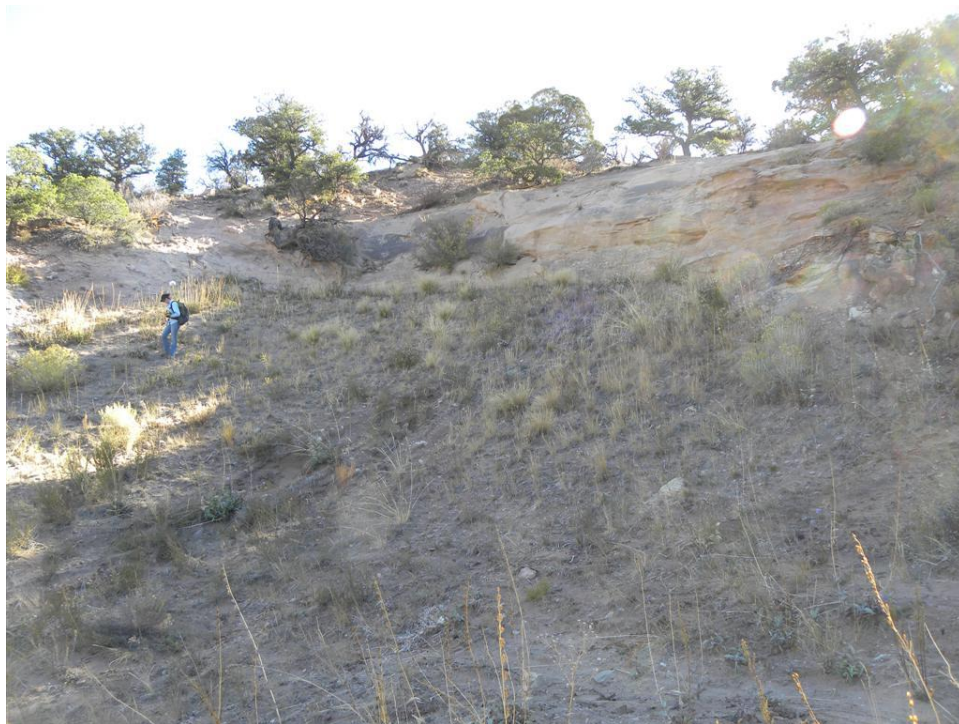
Photo 2. Down slope and waste rock

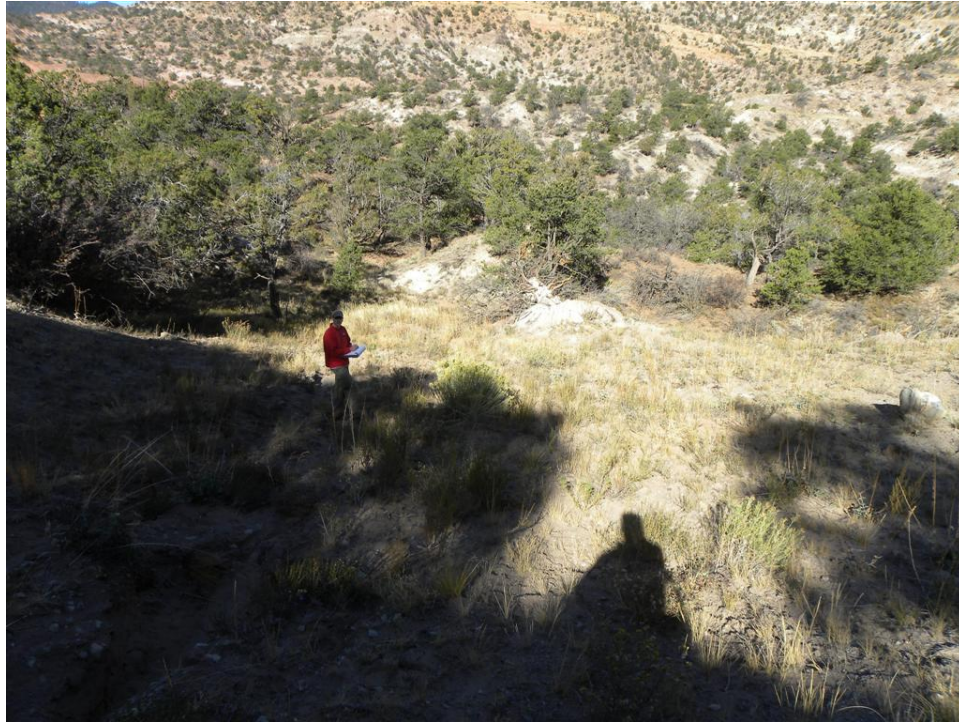
Photo 3. Down slope and waste rock
