Navajo Abandoned Uranium Mine

Site Screen Report

Tony Tuc AUM Site

Navajo AUM Northern Region

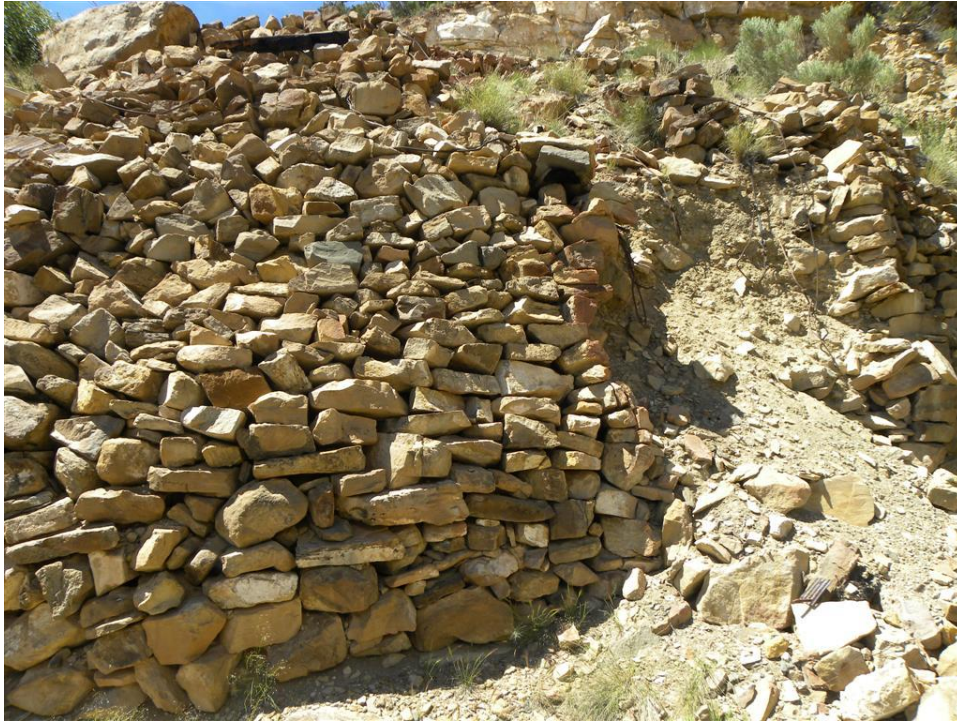
Large stone sealed adit, 30'x20' with various metal debris around base

Photo 3. Tony Tuc site, sealed adit

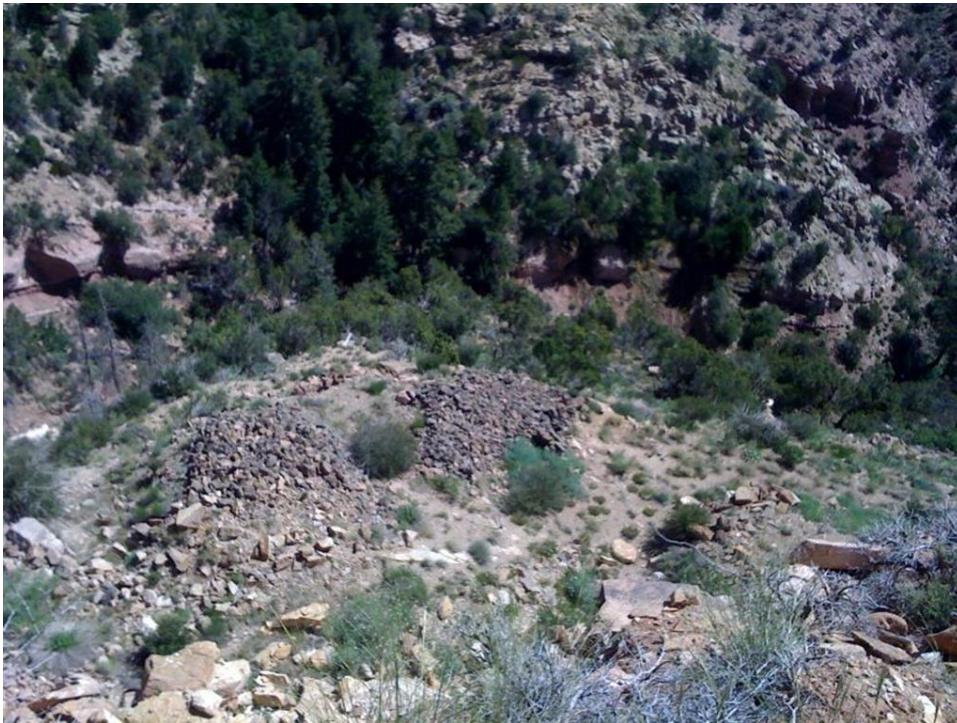
2 waste piles side by side above adit; dark grey rocks, 15'x15'x3'; small dark grey rock 5'x5'x3' pile below adit; scattered dark grey rocks along haul road

Photo 4. Tony Tuc site, waste piles

Sealed adit; unreclaimed waste piles

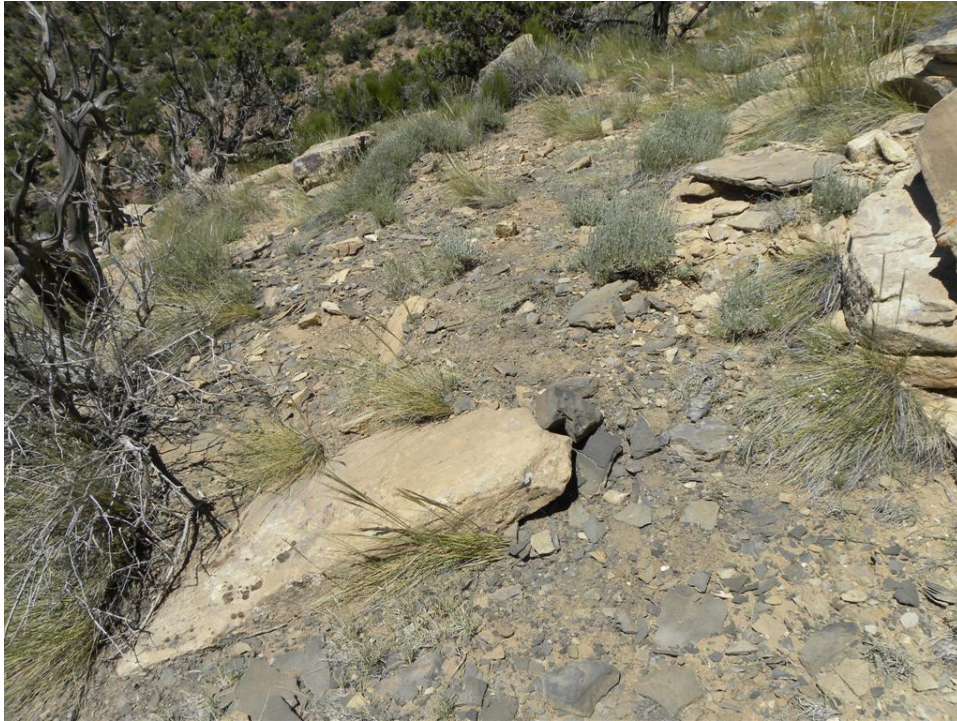
Photo 5. Tony Tuc site, scattered waste rock
