Navajo Abandoned Uranium Mine

Site Screen Report

Tse079 AUM Site

Navajo AUM Northern Region

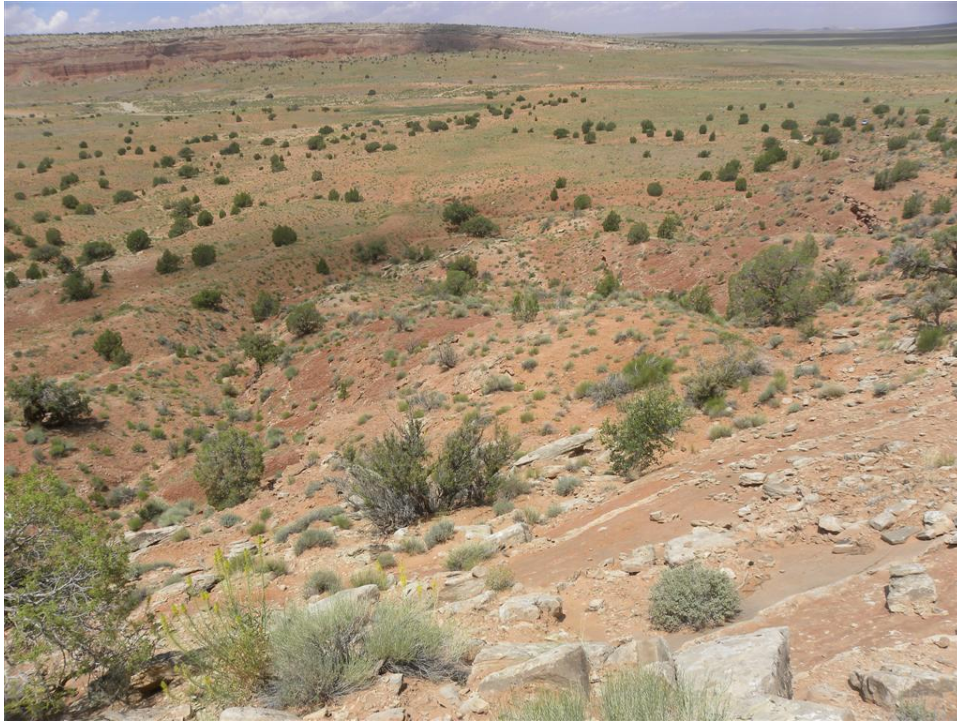
Photo 1. Tse079 site

Tse079 mine consists of an area of 15,782.9 m². The mine was not identified as ever being operational. No other historical information or any additional ownership / lease information was identified in the EPA/AUM database.
