Navajo Abandoned Uranium Mine

Site Screen Report

Cov087 Site

March 2010

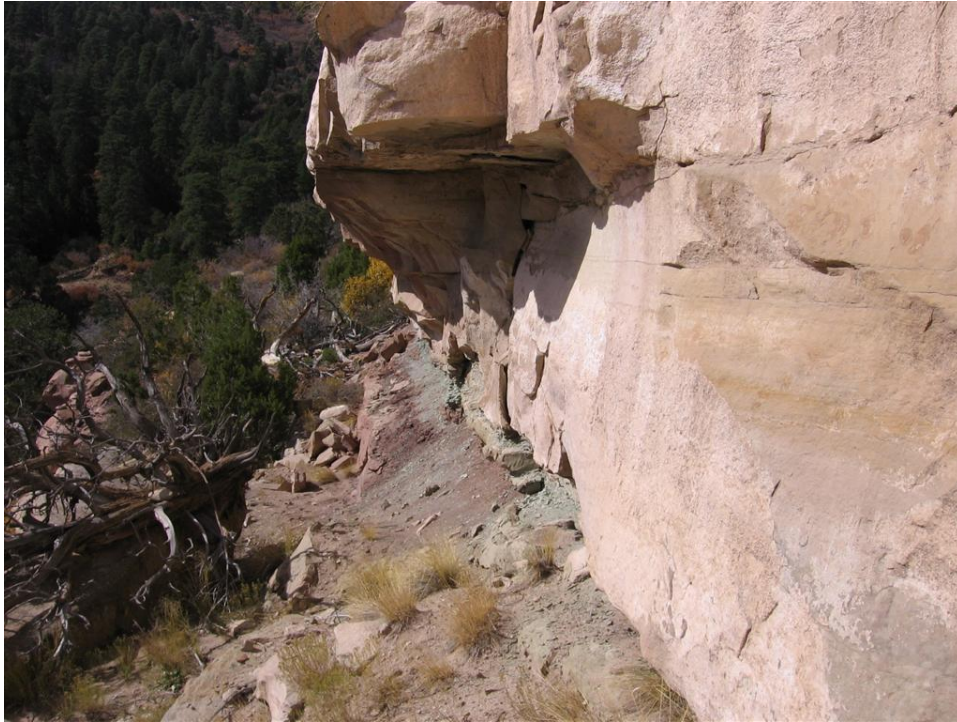
Photo 3. Cliff earea

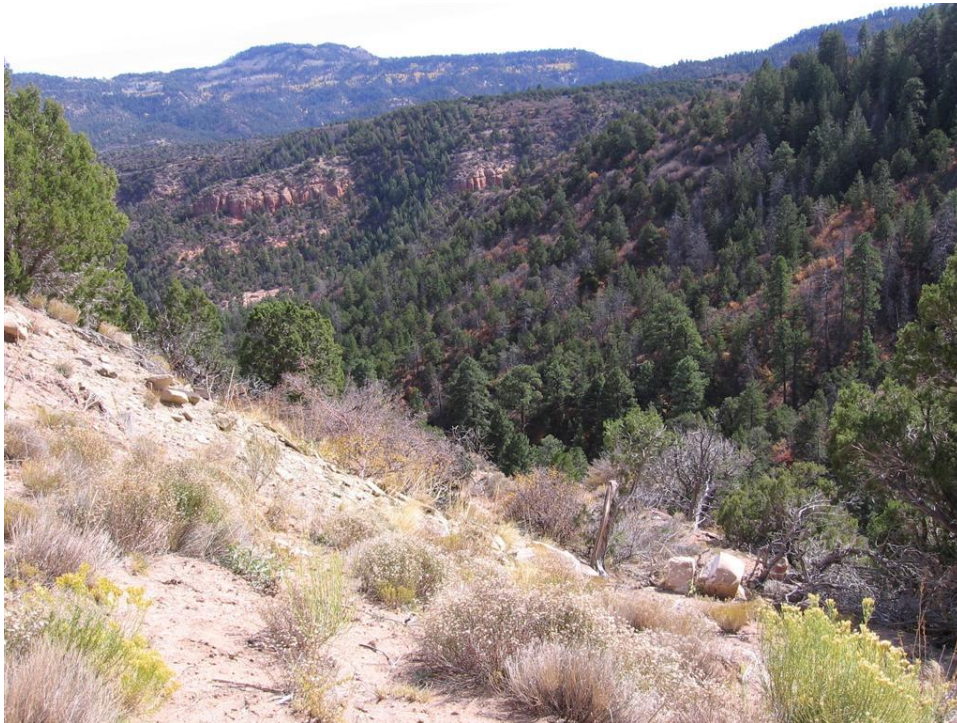
Photo 4. Down slope edge
