Navajo Abandoned Uranium Mine

Site Screen Report

Black No. 1 AUM Site

Navajo AUM Northern Region

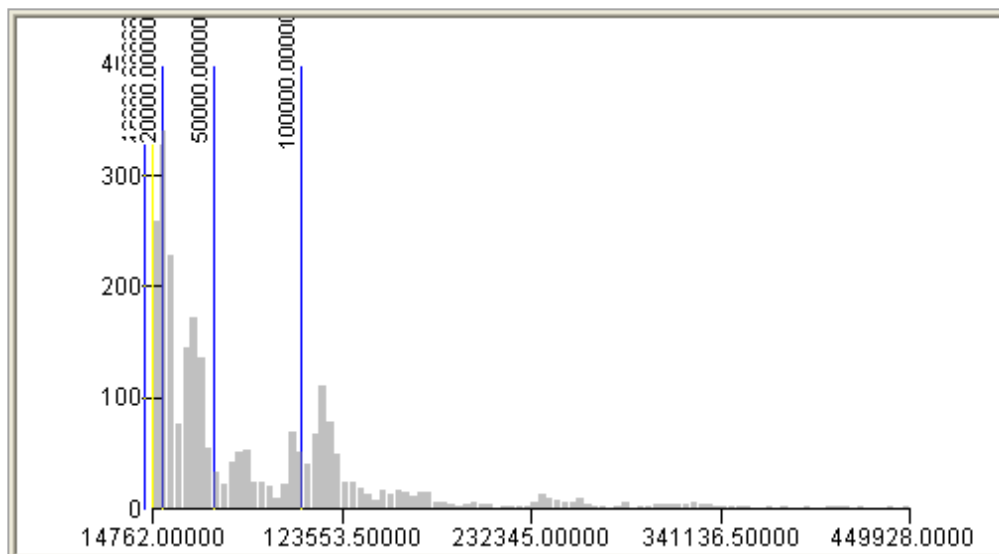
The following chart and statistics were generated by ESRI ArcGIS 9.3.1, and show the general distribution of the site gamma radiation measurements. The horizontal X axis represents the gamma radiation reading levels in cpm (lowest levels to the left). The vertical Y axis represents the frequency of each gamma radiation level.

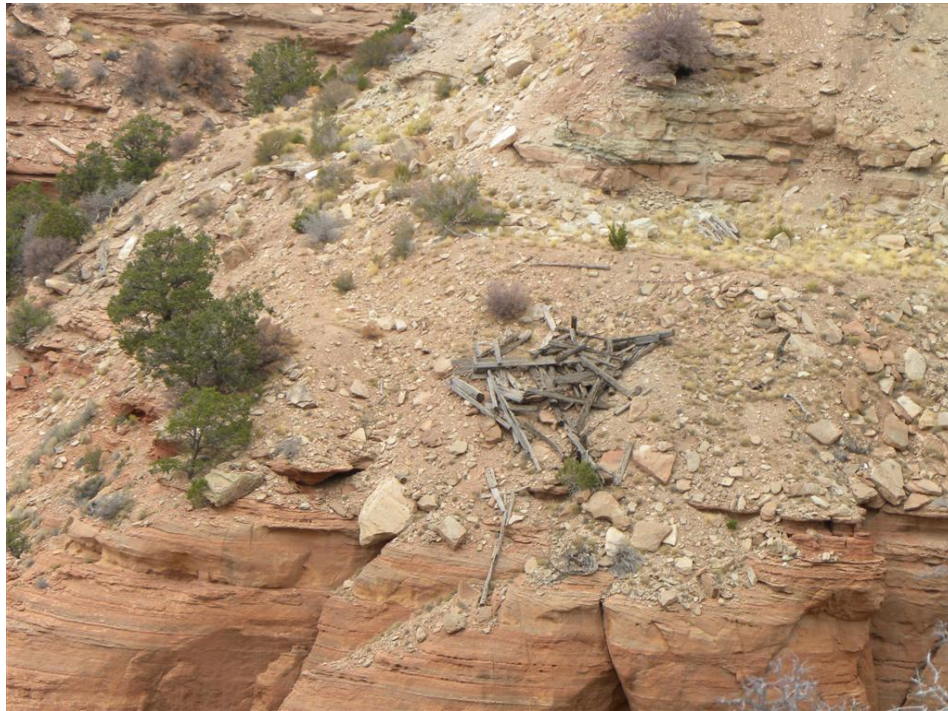
Two stone-sealed adits were observed in the eastern portion of the site; one possible adit, marked with white paint along an inaccessible cliff face

Inaccessible waste rock and wood debris down the eastern slope, approximately 75' x 100' x 5', with a total estimated volume of 1,389 yd³

Photo 1. Mine debris along cliff face, and two sealed adits

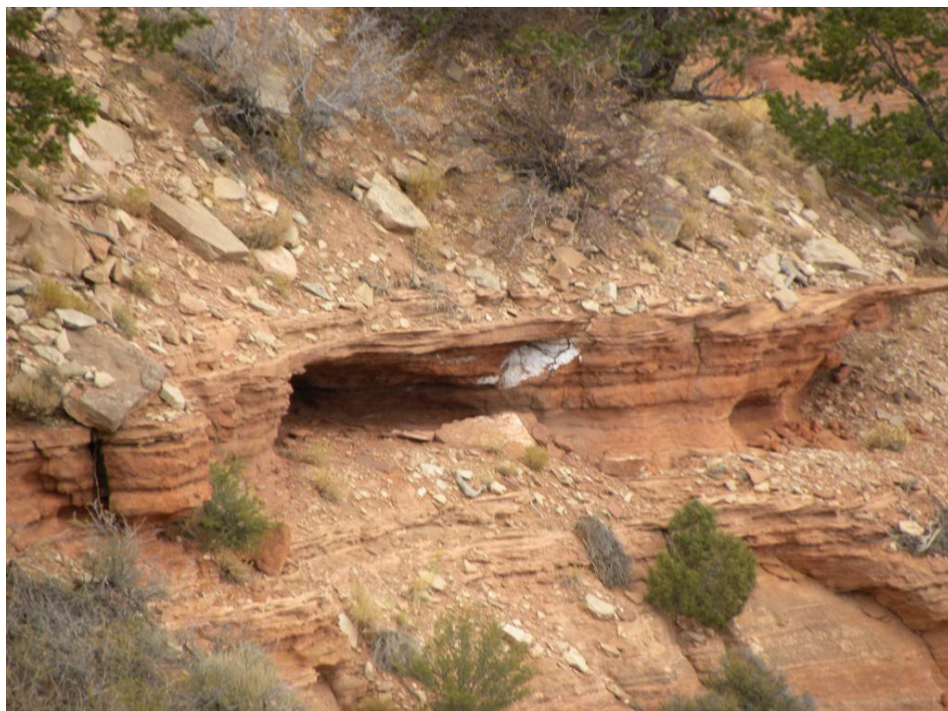
Photo 2. Possible adit/portal, inaccessible

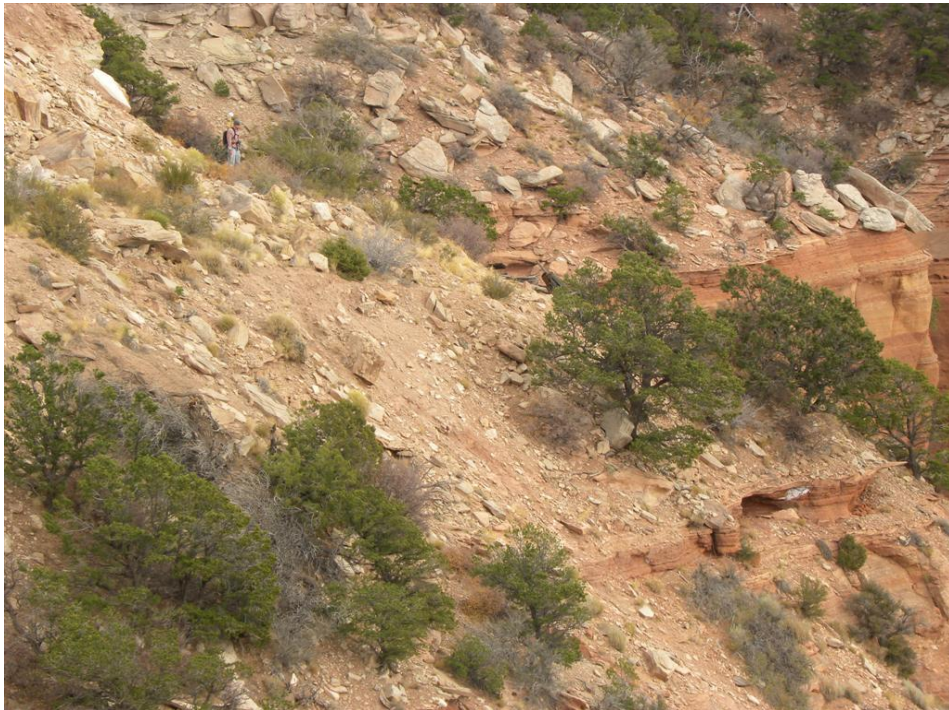
2 sealed adits; 1 inaccessible possible adit; unreclaimed waste pile found heading down inaccessible cliff face

Photo 4. Debris down steep grades, and inaccessible possible adit

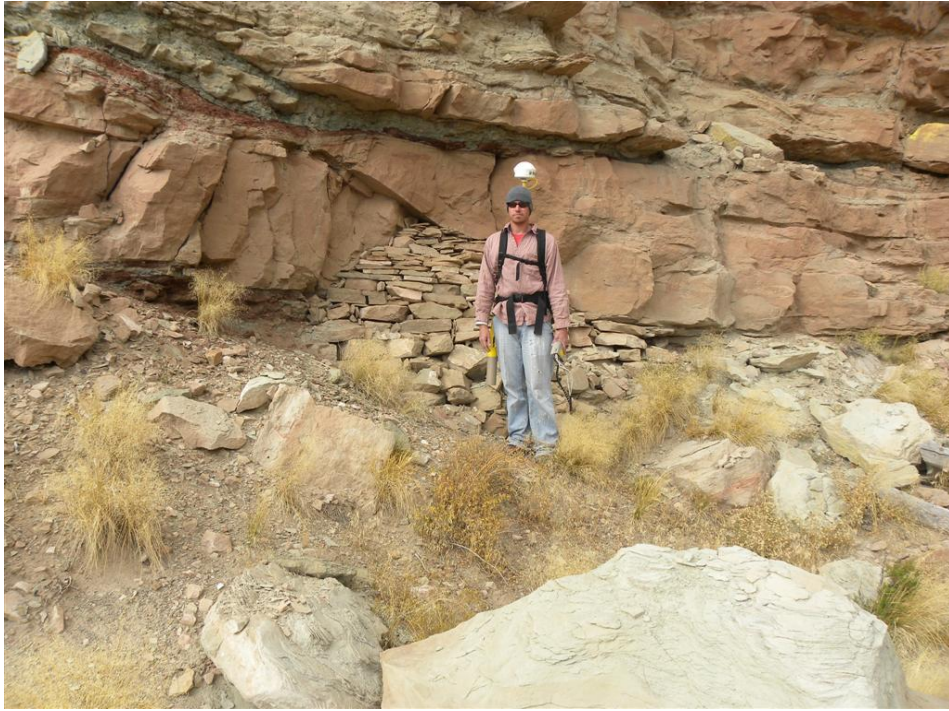
Photo 5. Sealed adit

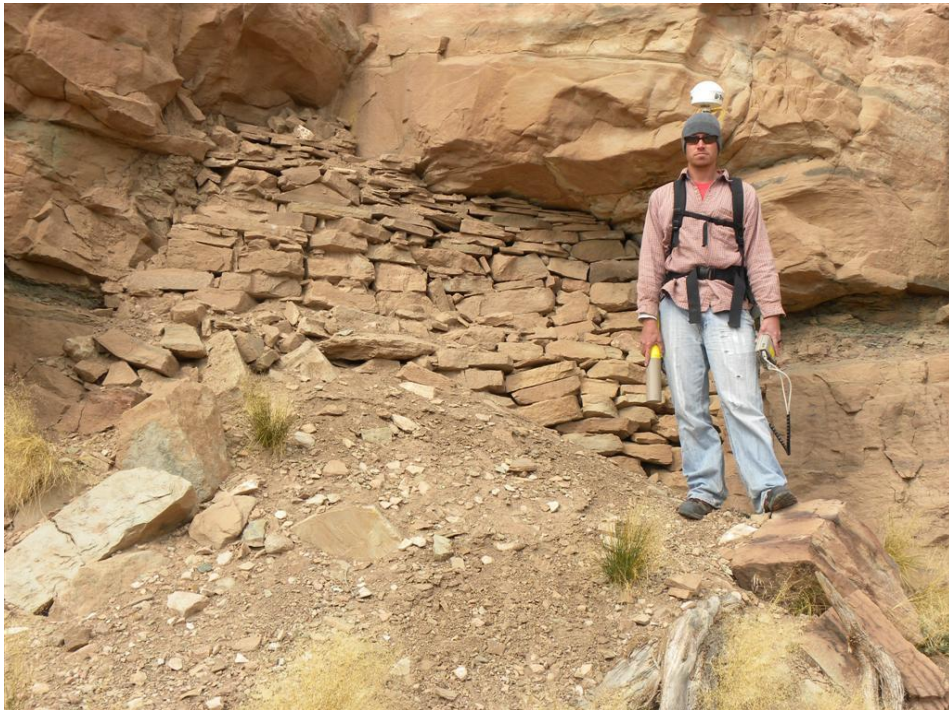
Photo 6. Additional sealed adit

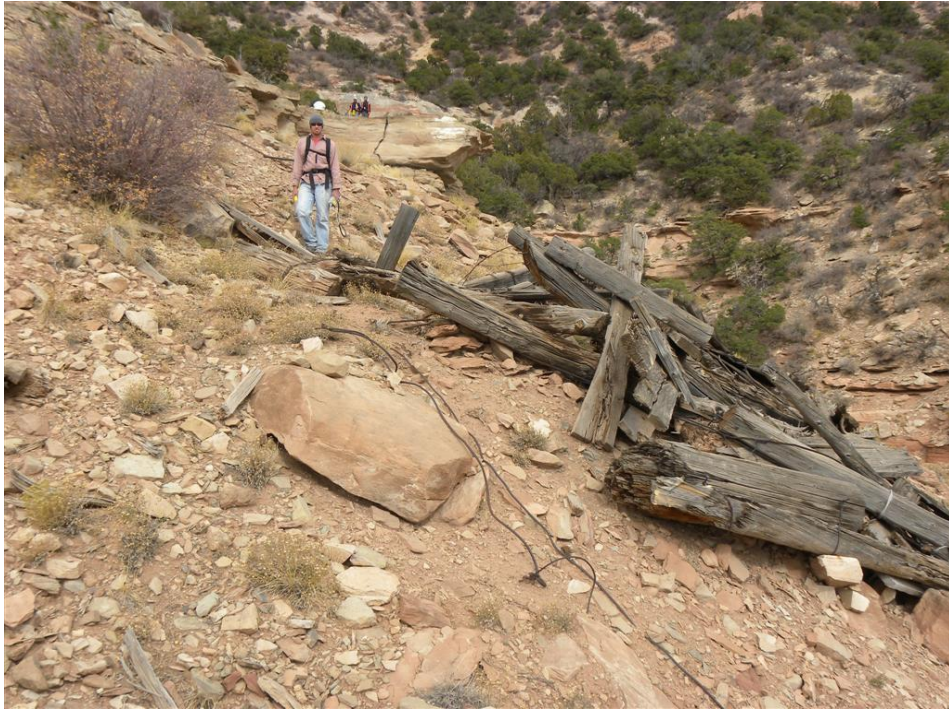
Wood mining-debris was observed atop the main waste debris pile

Photo 7. Wood mine debris

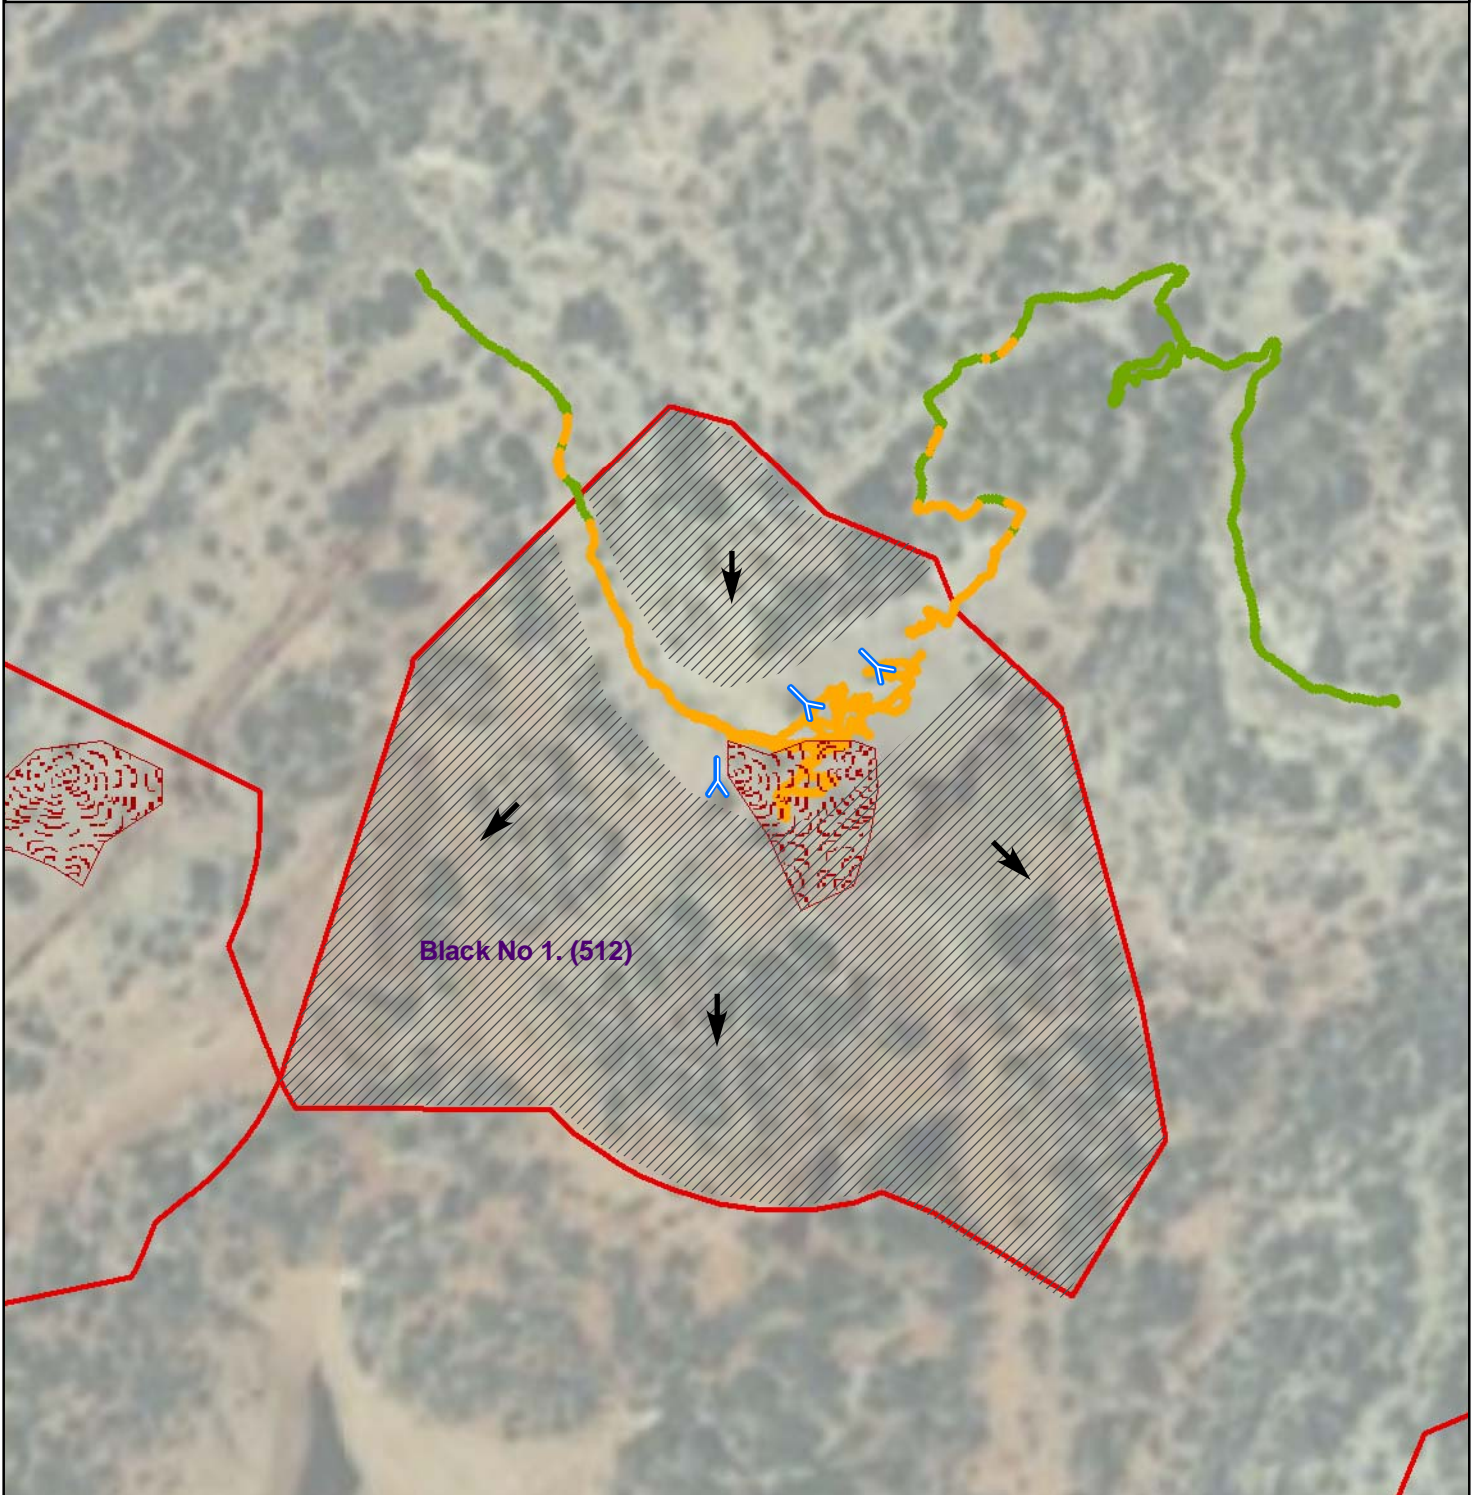
**Figure 1 - Gamma Radiation Measurements, Above Two Times Background
Black No. 1 Mine (512)
Round Rock Chapter, Navajo Nation, Arizona**

A total of 2,510 gamma radiation measurements were collected from the mine site, ranging from 14,762 cpm to 449,928 cpm. Measurements in the vicinity of the waste debris were found at levels in up to 122,000 cpm. Measurements near the adits were found at levels up to 449,928 cpm. The measurements are represented in Figures 1 and 2.

Gamma survey conducted 10/2009
Measured as counts per minute (cpm)

Average background = 13,969 cpm

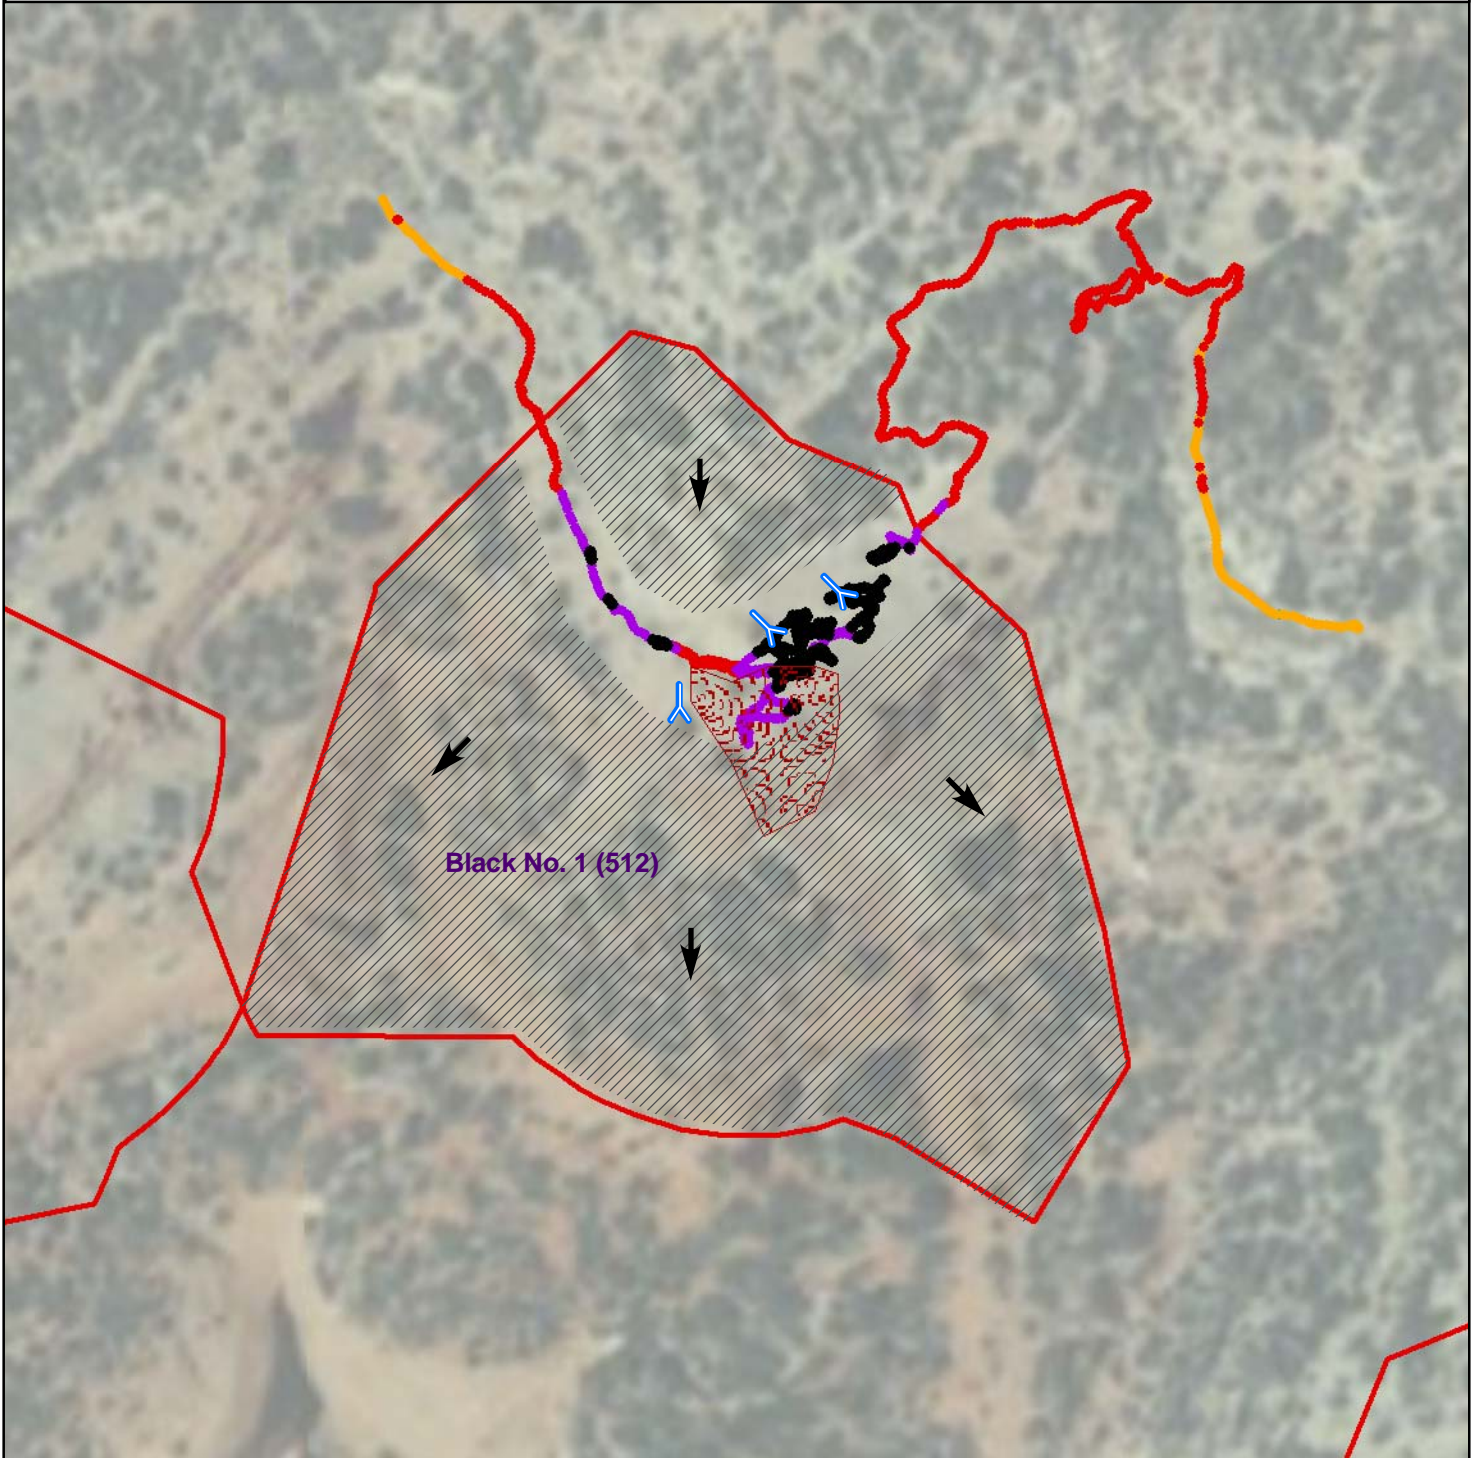
**Figure 2 - Gamma Radiation Measurements
Black No. 1 Mine (512)
Round Rock Chapter, Navajo Nation, Arizona**

Gamma survey conducted 10/2009
Measured as counts per minute (cpm)

Average background = 13,969 cpm
