Navajo Abandoned Uranium Mine

Site Screen Report

Mine Name: Tom Holliday
Mine ID: 517

Navajo AUM North Central Region

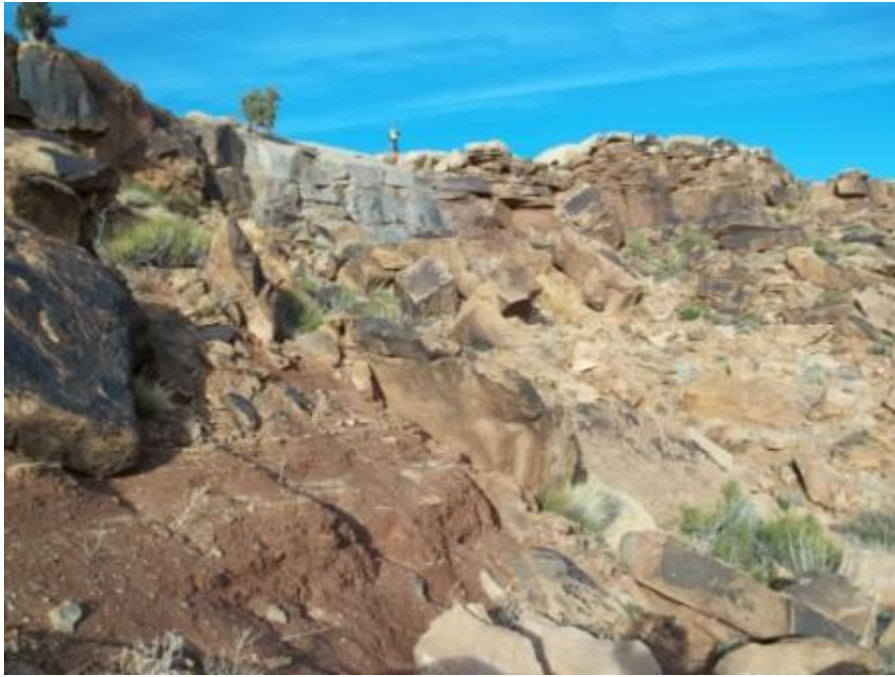
Photo 1

Mine Site #517

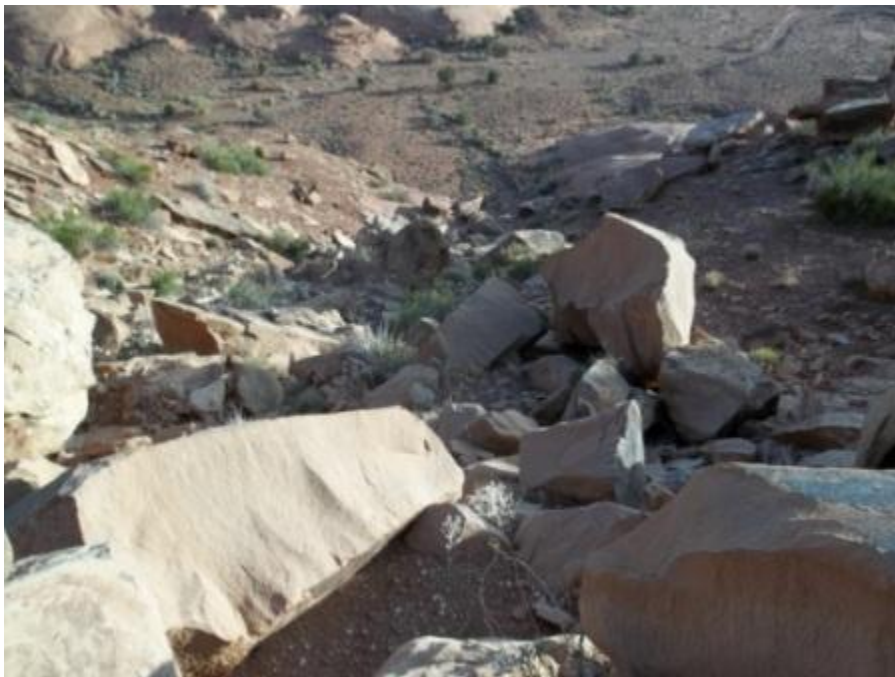
Photo 2

Mine Site #517

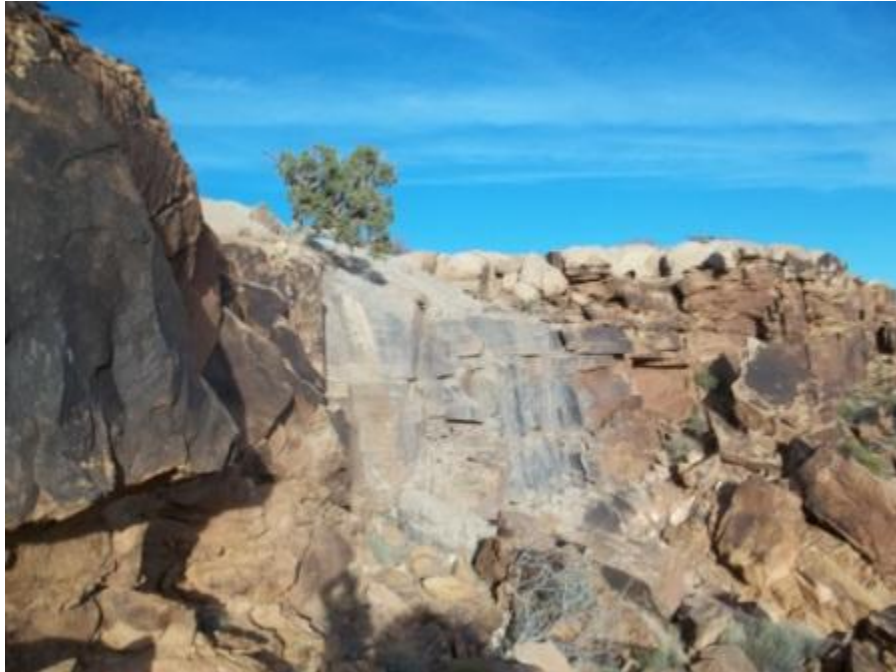
Photo 3

Mine Site #517
