Navajo Abandoned Uranium Mine

Site Screen Report

Charles Huskon No. 26 AUM Site

January 2011

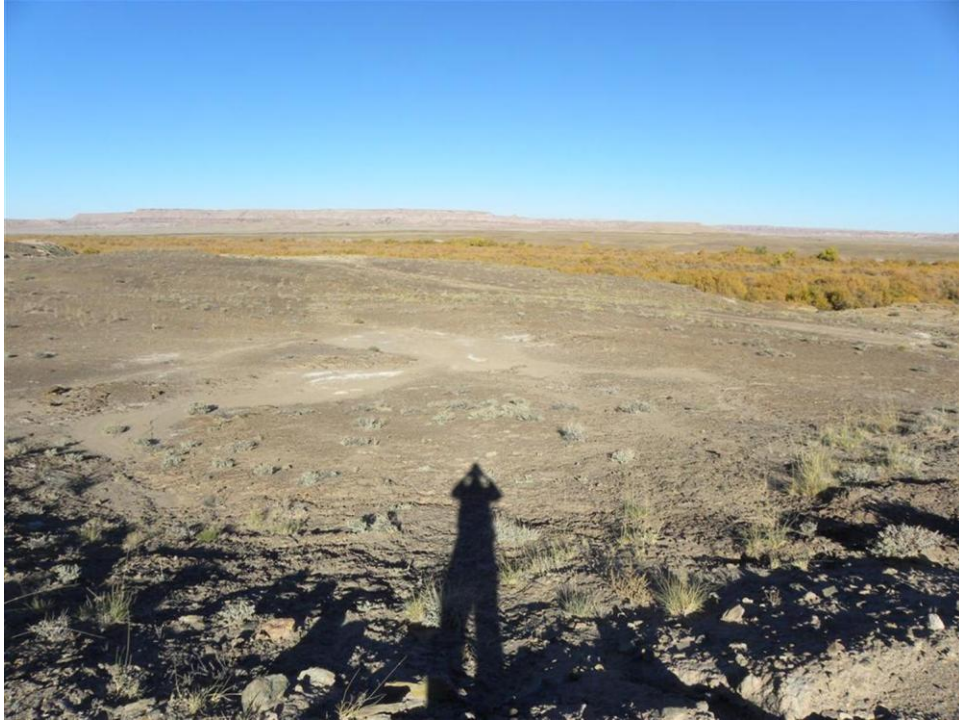
Photo 1. Charles Huskon No. 26 mine site

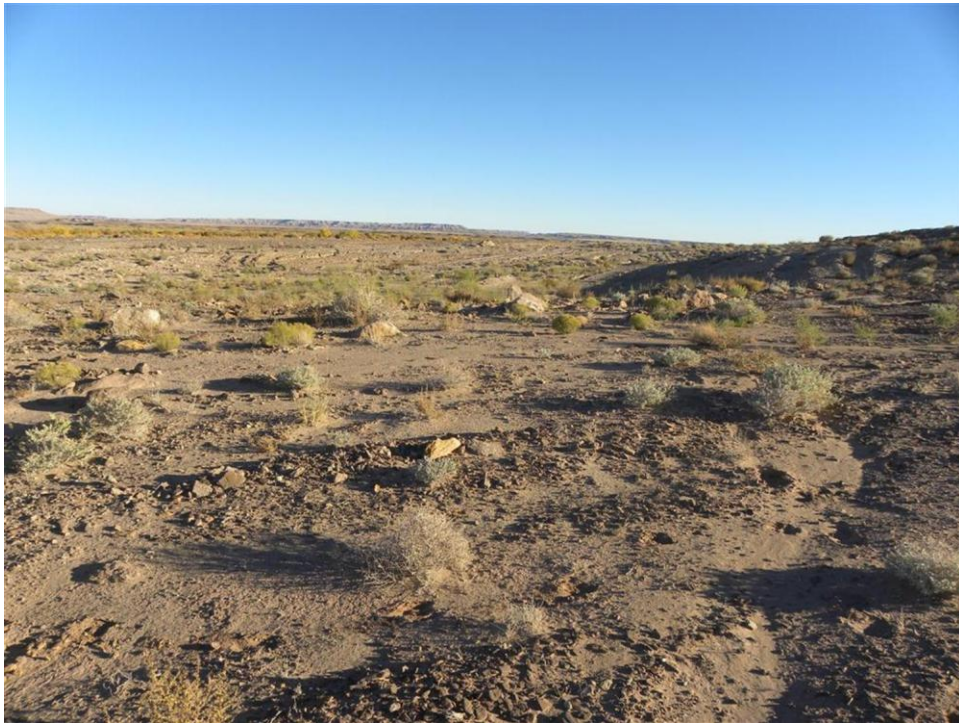
Many 2" black vent/drill holes throughout site; Majority of S end site appeared to be reclamation cap/furrows

Photo 2. Charles Huskon No. 26 mine site, reclamation area

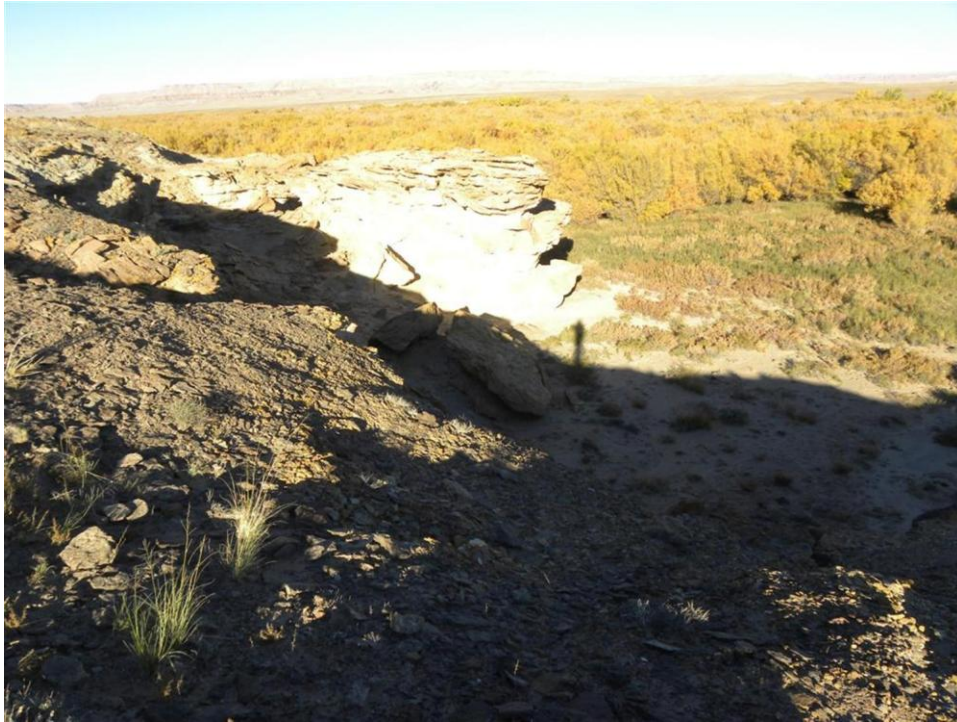
Little Colorado River Basin approximately 0.25 mi E of the site, possible wetlands

Photo 3. Charles Huskon No. 26 mine site, alongside Little Colorado River Basin

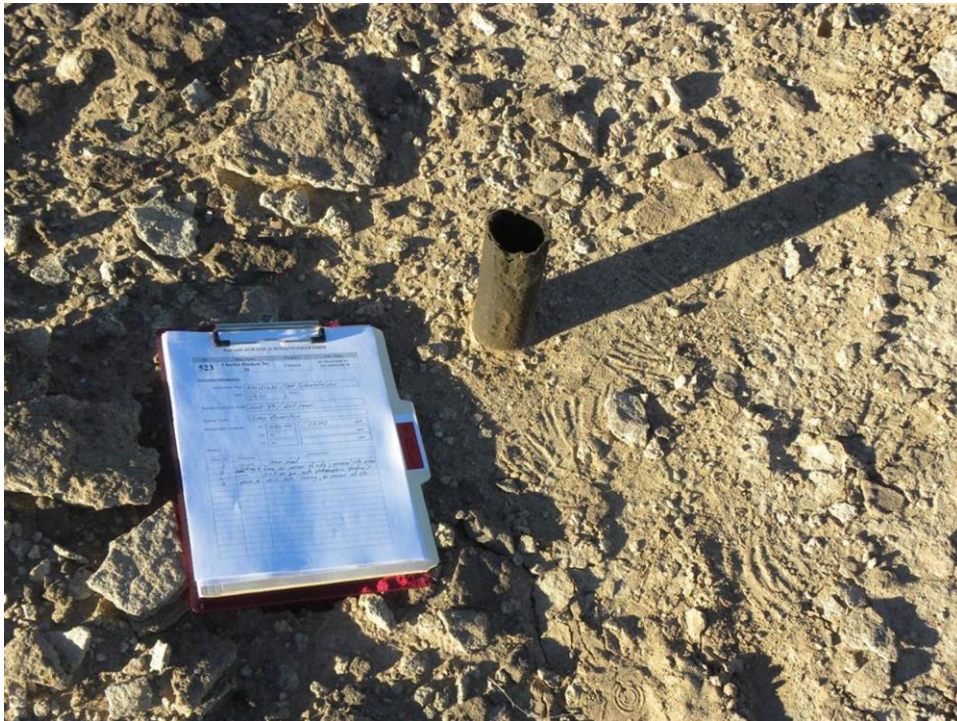
Photo 4. Charles Huskon No. 26 mine site, protruding casing

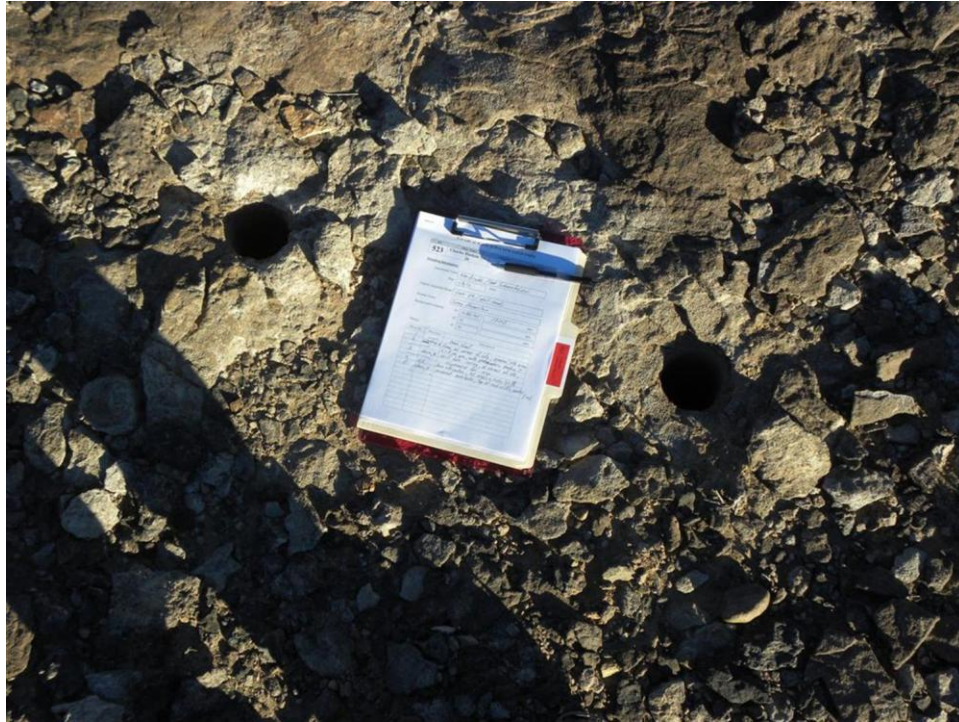
Photo 5. Charles Huskon No. 26 mine site, drill holes
