Navajo Abandoned Uranium Mine

Site Screen Report

Grub No. 14 AUM Site

January 2011

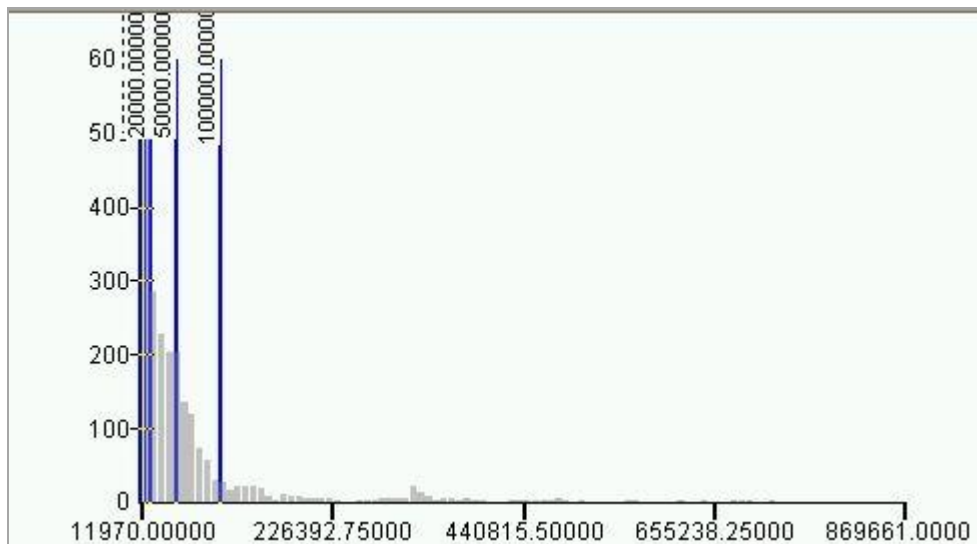
The following chart and statistics were generated by ESRI ArcGIS 9.3.1, and show the general distribution of the site gamma radiation measurements. The horizontal X axis represents the gamma radiation reading levels in cpm (lowest levels to the left). The vertical Y axis represents the frequency of each gamma radiation level.

Count:	2252
Minimum:	11970.00000
Maximum:	869661.00000
Sum:	166622155.00000
Mean:	73988.52353
Median:	39642.50000
Standard Deviation:	108876.02716

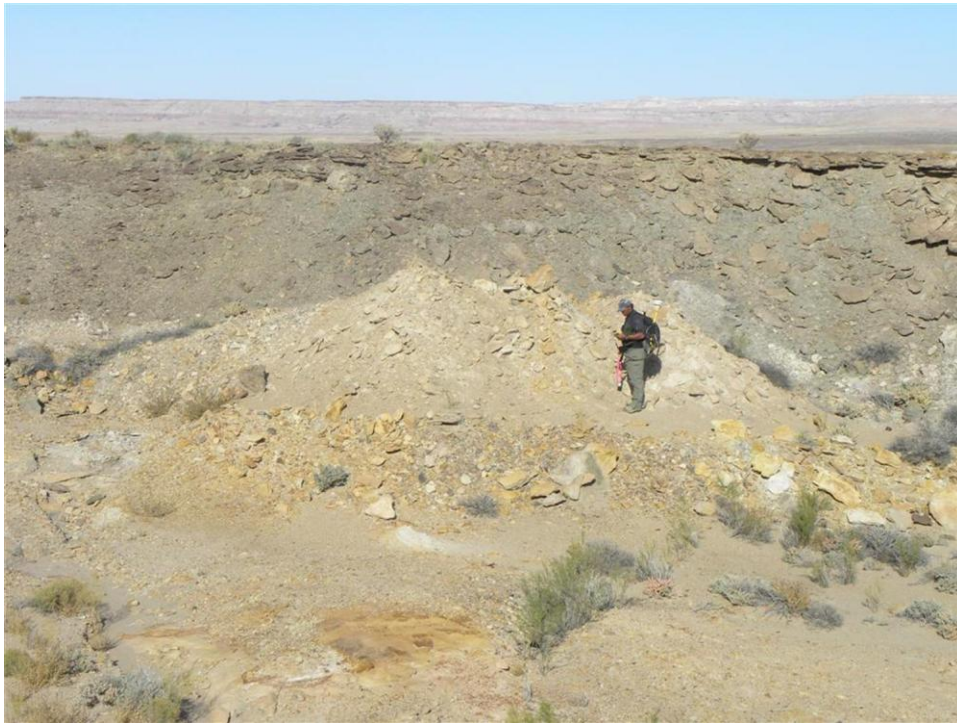
Waste debris pile 30' x 10' x 10', yellow-brown soil in northern portion of site

Photo 2. Grub No. 14 mine site, waste pile

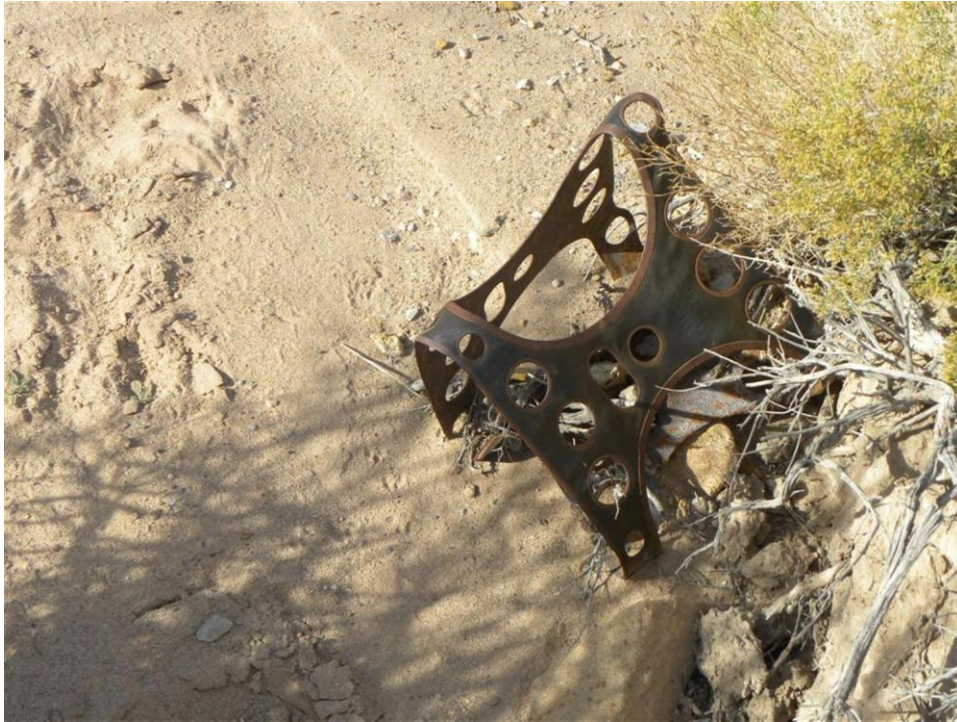
Mining debris in drainage, wooden markers

Photo 7. Grub No. 14 mine site, debris

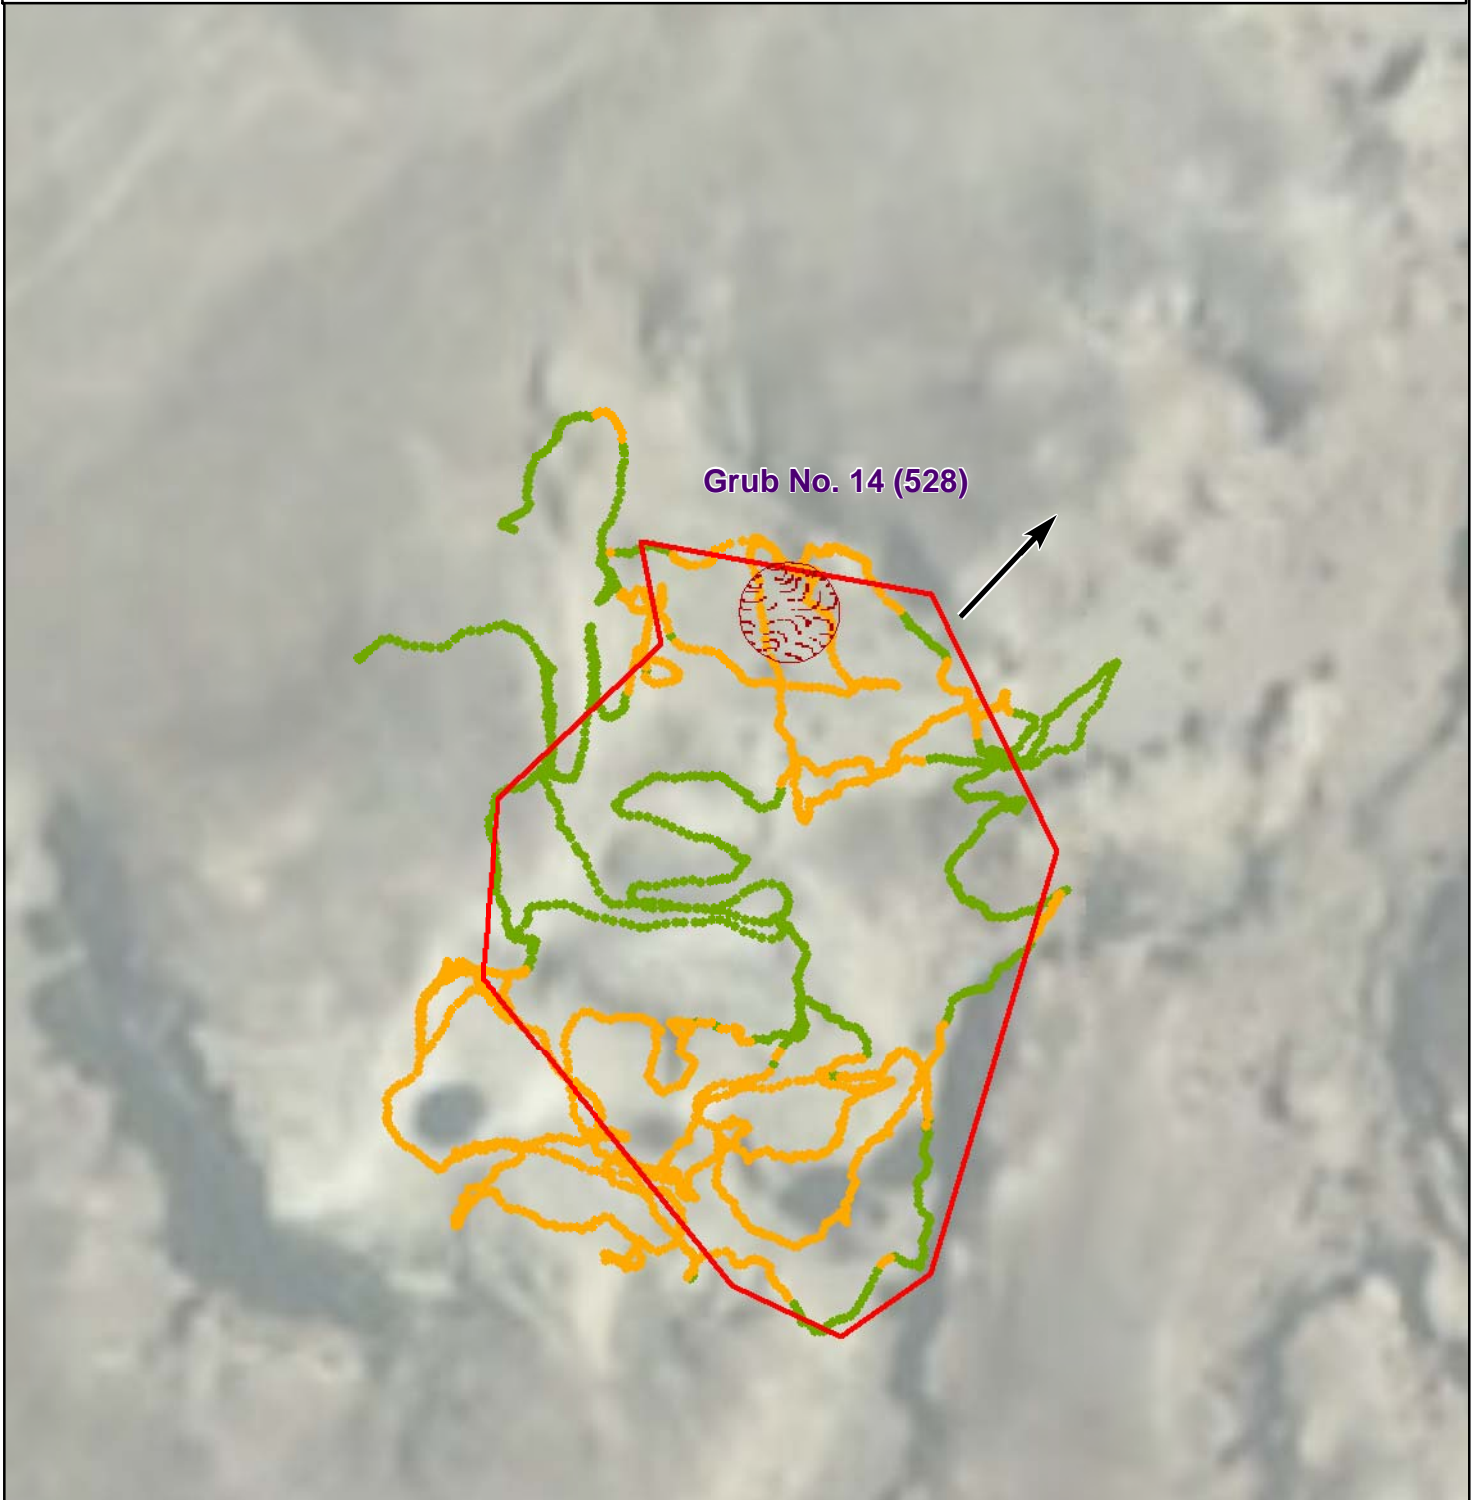
**Figure 1 - Gamma Radiation Measurements, Above Two Times Background
Grub No. 14 (528)
Coconino County, Arizona**

A total of 2,252 gamma radiation measurements were collected from the mine site, ranging from 11,970 cpm to 869,661 cpm. The measurements collected at the waste pile were found at a maximum level of approximately 300,000 cpm, and within the mining debris area at a maximum level of approximately 850,000 cpm. The measurements are represented in Figures 1 and 2.

Gamma survey conducted 11/2010
Measured as counts per minute (cpm)

Average background 15,327 cpm

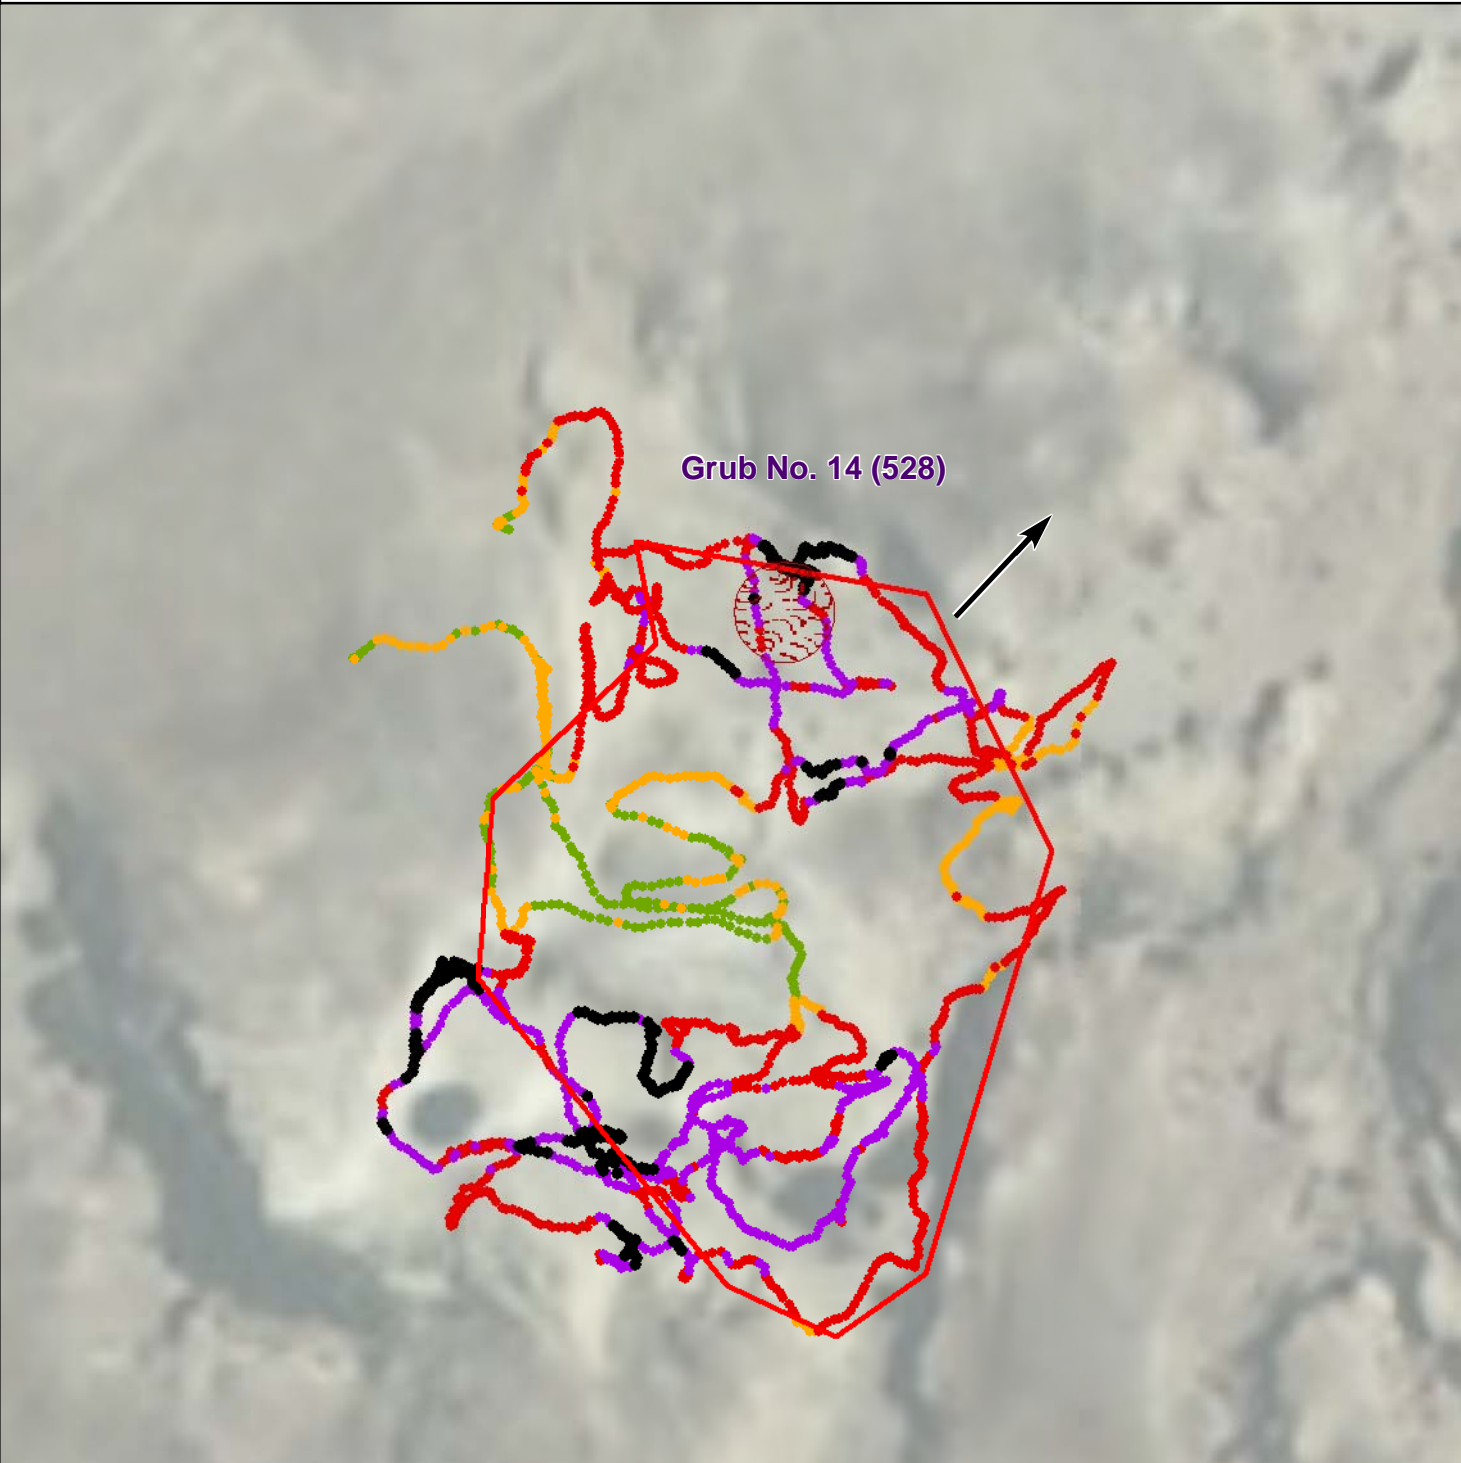
**Figure 2 - Gamma Radiation Measurements
Grub No. 14 (528)
Coconino County, Arizona**

**Gamma survey conducted 11/2010
Measured as counts per minute (cpm)**

Average background 15,327 cpm
