Navajo Abandoned Uranium Mine

Site Screen Report

Ada and Nordell AUM Site

January 2011

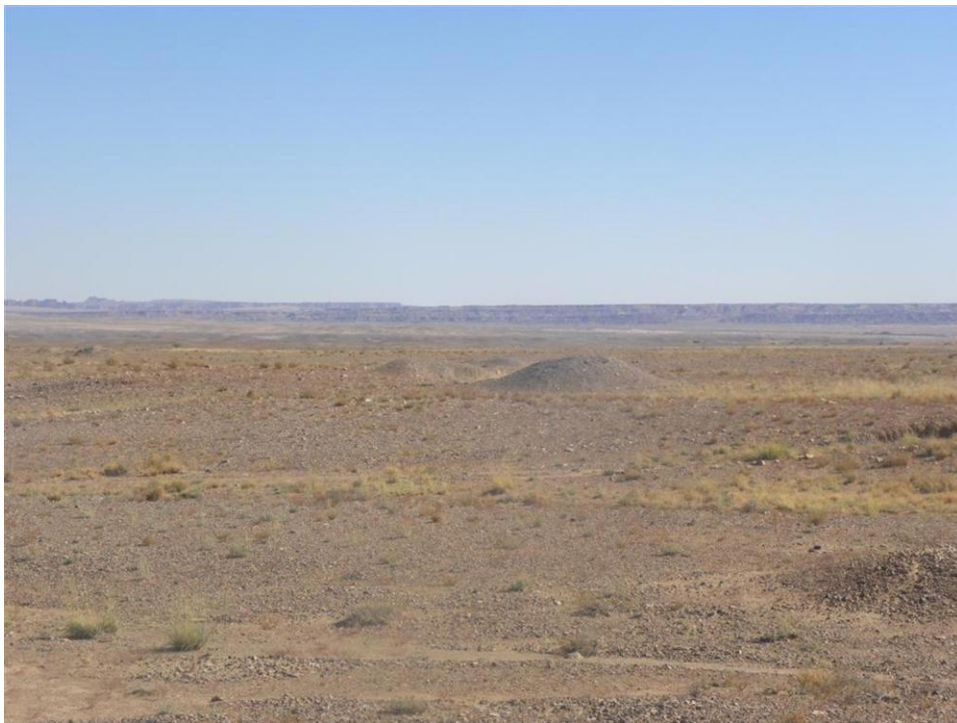
6 small waste piles with yellow brown soil, each 10' x 10' x 3'; 6 medium waste piles each 15' x 15' x 5' with grey coarse material

Photo 2. Ada and Nordell mine site, medium waste piles

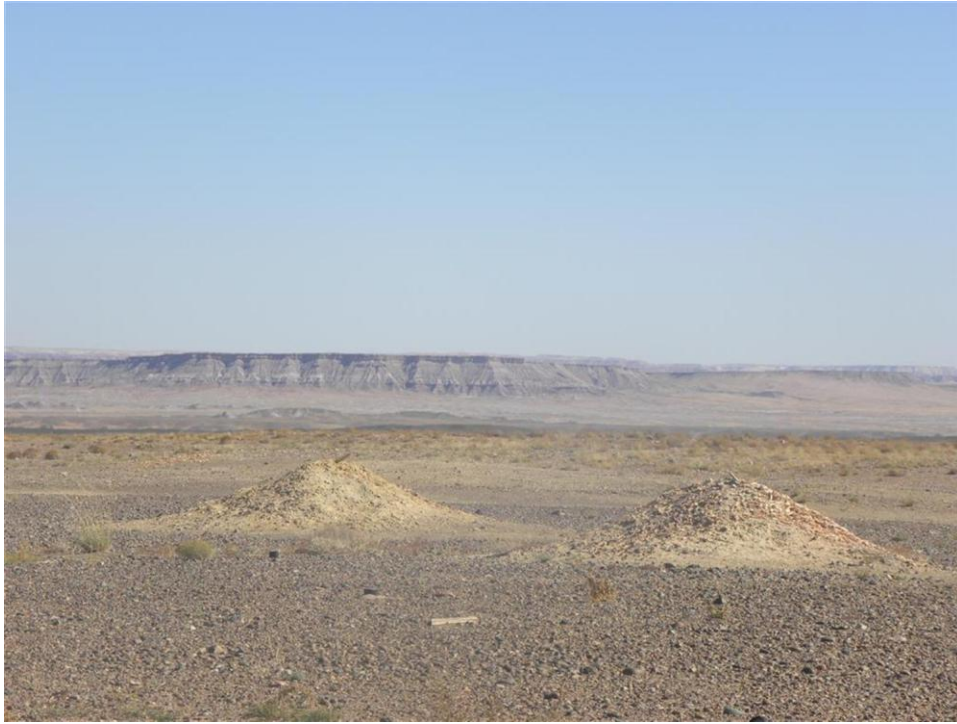
Photo 3. Ada and Nordell mine site, small waste piles

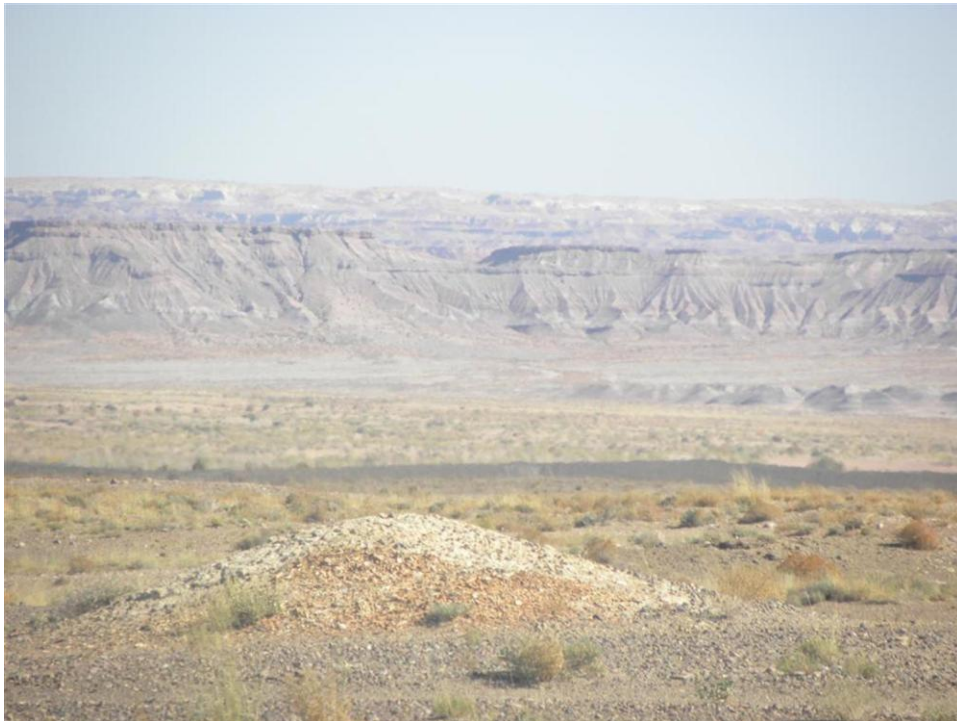
Photo 4. Ada and Nordell mine site, waste pile

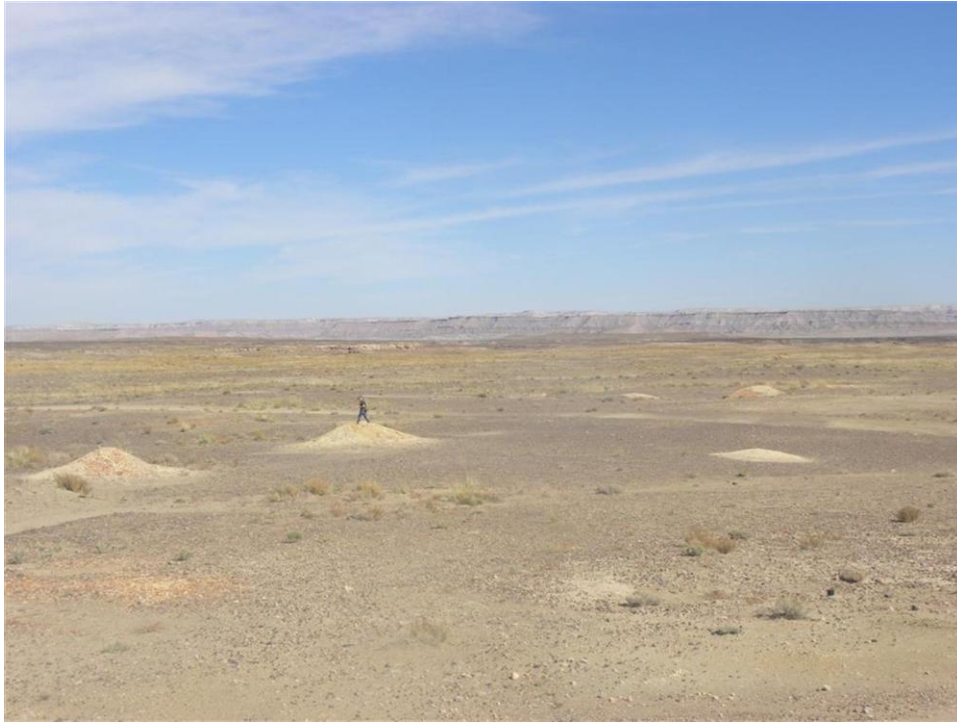
Photo 5. Ada and Nordell mine site, waste piles

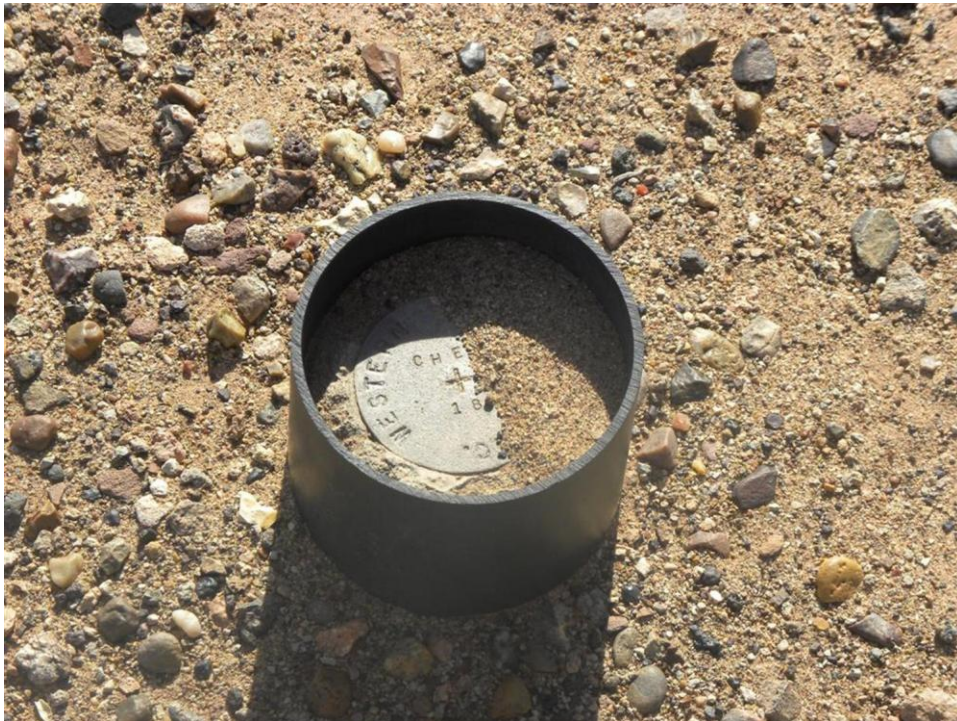
Wood and metal boundary markers labeled "Western Nuclear"

Photo 6. Ada and Nordell mine site, boundary marker

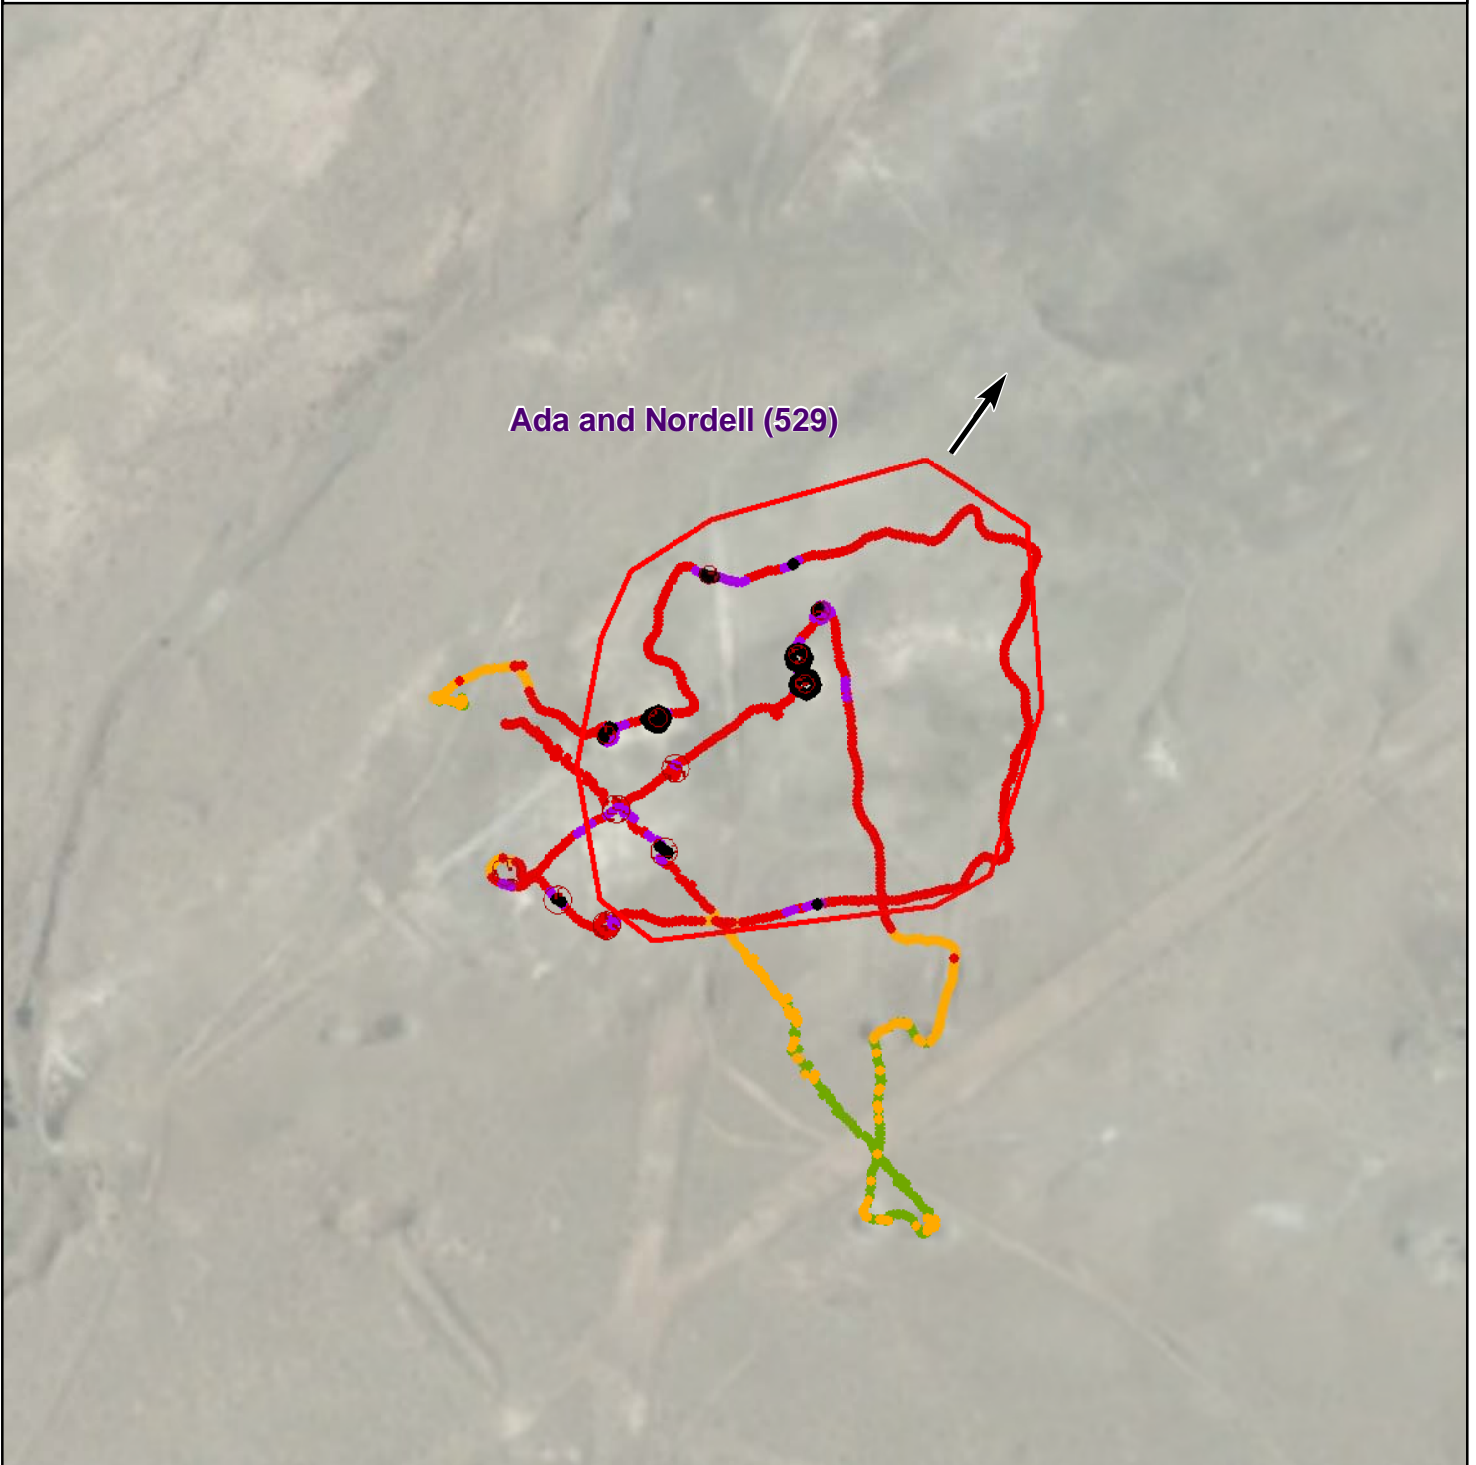
A total of 1,515 gamma radiation measurements were collected from the mine site, ranging from 11,117 cpm to 289,861 cpm. The measurements collected at the waste piles were found at maximum levels ranging from approximately 150,000 cpm to 250,000 cpm. The measurements are represented in Figures 1 and 2.

**Figure 2 - Gamma Radiation Measurements
Ada and Nordell (529)
Coconino County, Arizona**

**Gamma survey conducted 11/2010
Measured as counts per minute (cpm)**

Average background 16,540 cpm
