Navajo Abandoned Uranium Mine

Site Screen Report

Harry Walker No. 16 AUM Site

Navajo AUM Western Region

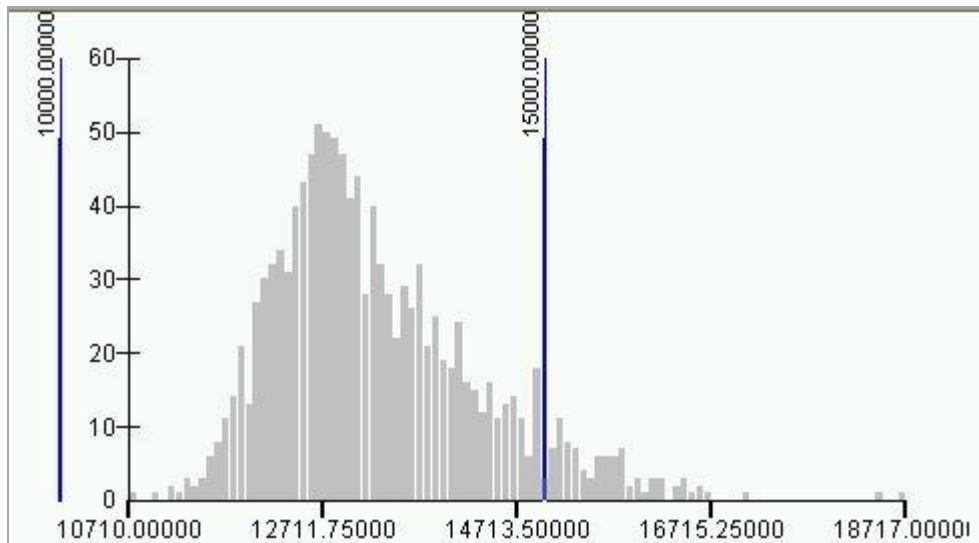
The following chart and statistics were generated by ESRI ArcGIS 9.3.1, and show the general distribution of the site gamma radiation measurements. The horizontal X axis represents the gamma radiation reading levels in cpm (lowest levels to the left). The vertical Y axis represents the frequency of each gamma radiation level.

Count:	1220
Minimum:	10710.00000
Maximum:	18717.00000
Sum:	16175685.00000
Mean:	13258.75820
Median:	13039.50000
Standard Deviation:	1058.48996

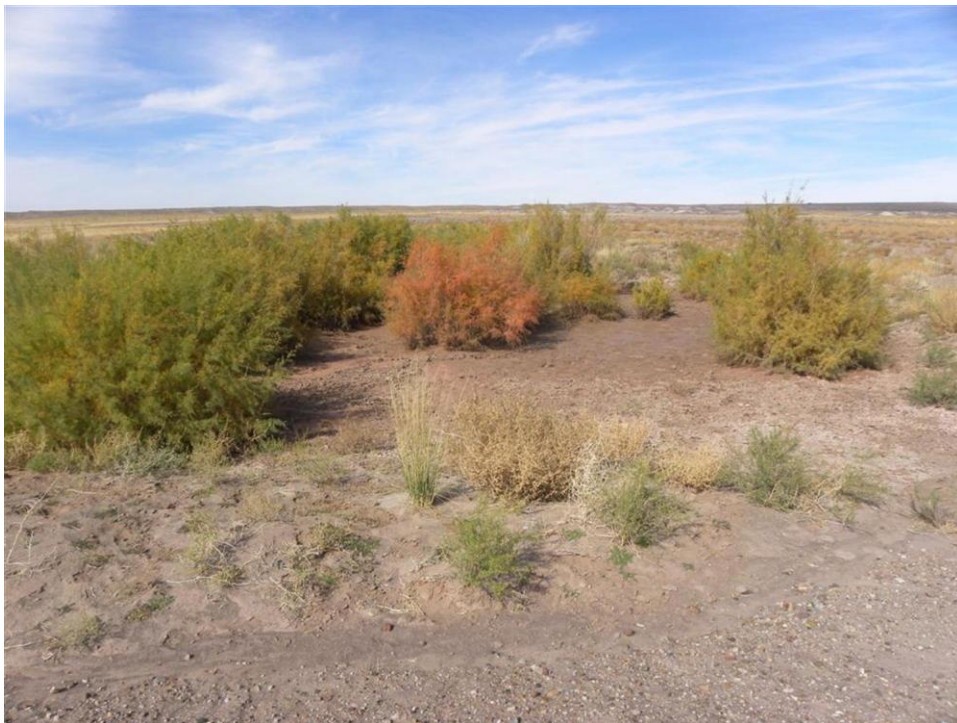
Photo 2. Harry Walker No. 16 mine site, small pond area

0 to 0.25 miles: Small pond in the center of the site, water maybe be attributable to flow from the north

Pond area had evidence of livestock (cattle, horses)

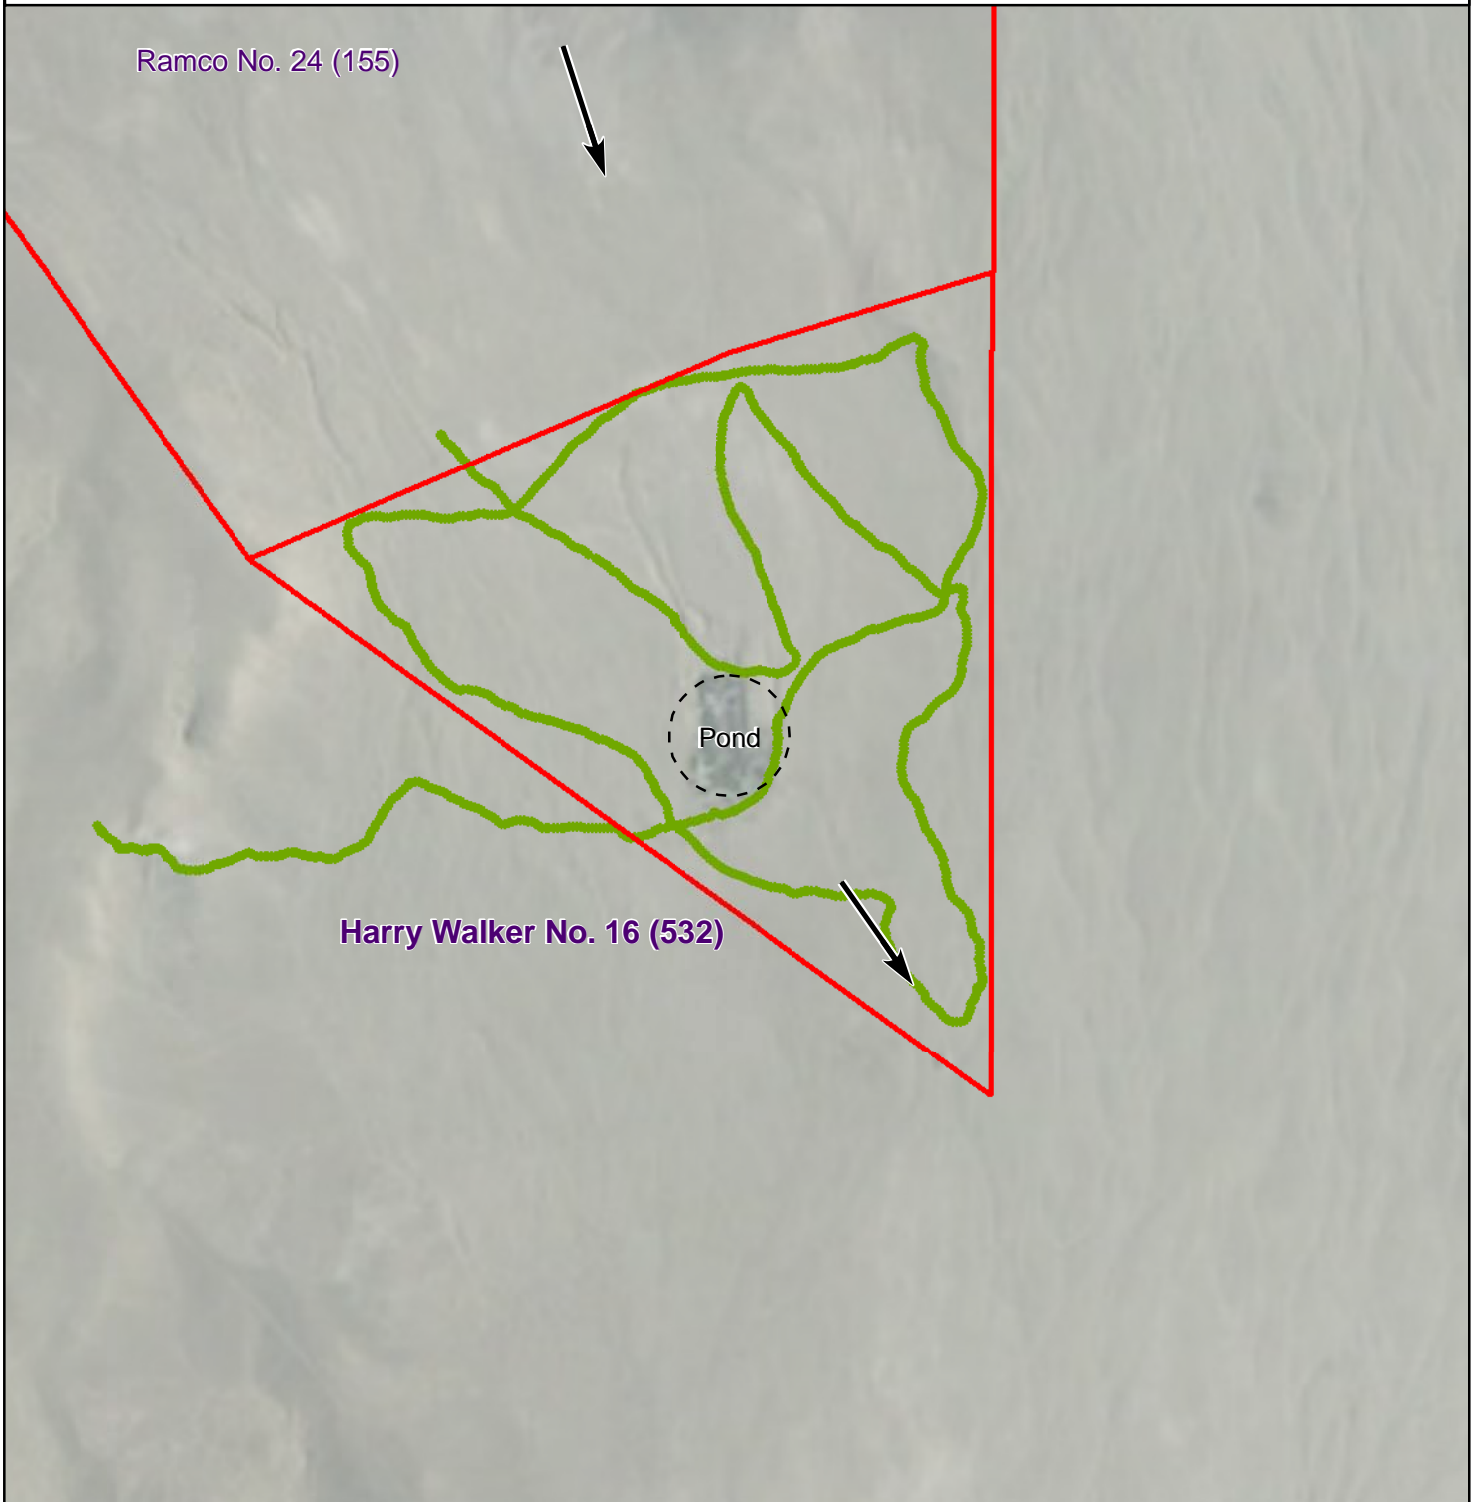
**Figure 1 - Gamma Radiation Measurements, Above Two Times Background
 Ramco No. 24 (155)
 Coalmine Mesa Chapter, Navajo Nation**

A total of 1,220 gamma radiation measurements were collected from the mine site, ranging from 10,710 cpm to 18,717 cpm. The measurements are represented in Figures 1 and 2.

Gamma survey conducted 11/2010
 Measured as counts per minute (cpm)

Average background 12,341 cpm

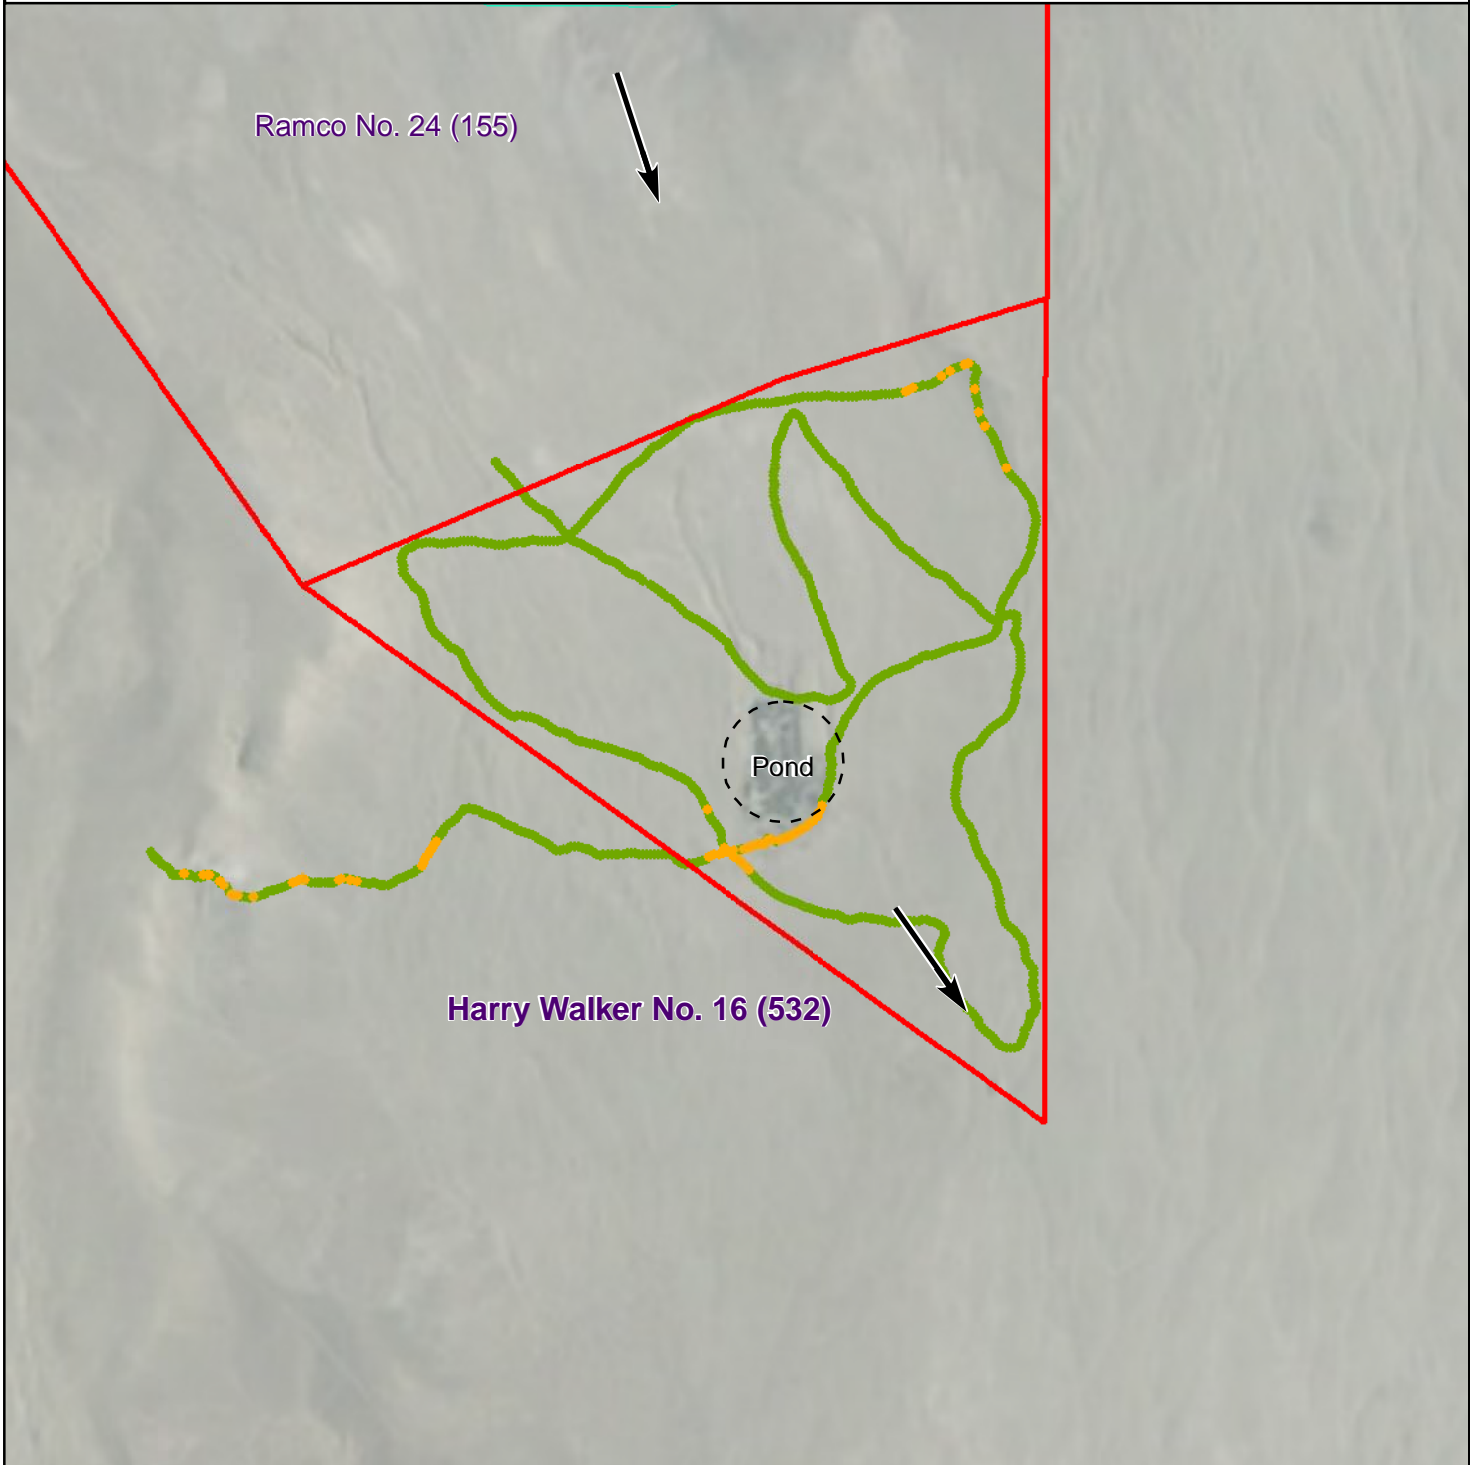
**Figure 2 - Gamma Radiation Measurements
 Ramco No. 24 (155)
 Coalmine Mesa Chapter, Navajo Nation**

**Gamma survey conducted 11/2010
 Measured as counts per minute (cpm)**

Average background 12,341 cpm
