# Navajo Abandoned Uranium Mine

# Site Screen Report

Mine Name: Charles Huskon No. 5
Mine ID: 536

August 2011

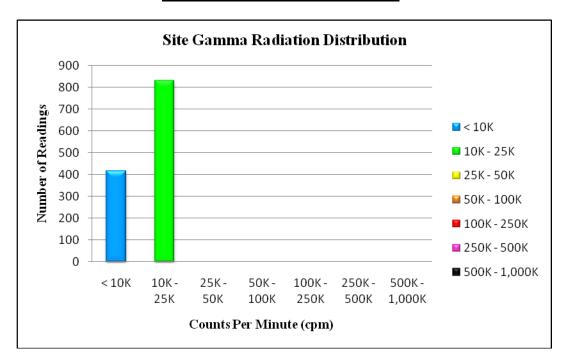
#### **Distribution Chart and Statistics:**

<b>Site Gamma Radiation Statistics</b>				
Number of Readings	1,249			
Minimum (cpm)	6,823			
Maximum (cpm)	24,617			
Mean (cpm)	11,991			
Median (cpm)	11,407			
Standard Deviation	3,146

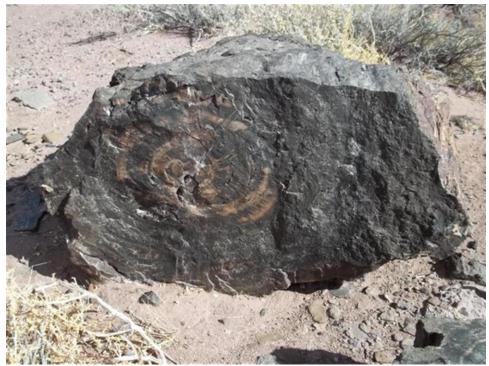
Photo 3: Mine Site #536; Petrified wood

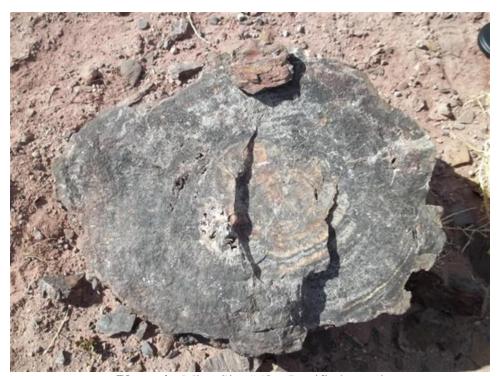
**Photo 4:** Mine Site #536; Petrified wood

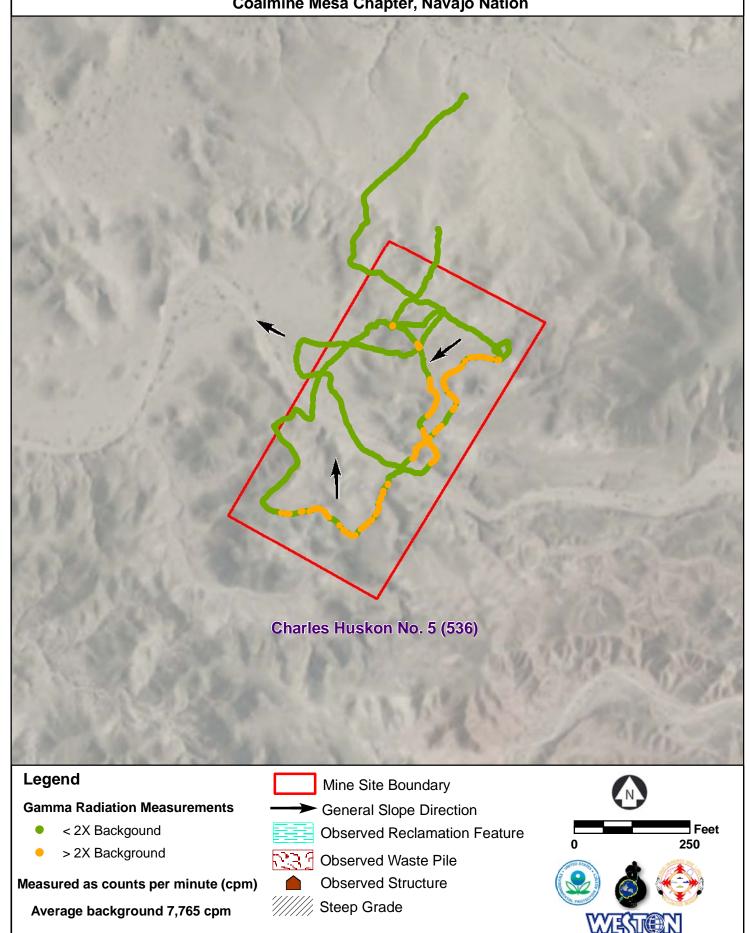
**Highest gamma radiation measurement:** 24,617 counts per minute (cpm)

**Background Average:** 7,765 cpm **Two Times Background:** 15,530 cpm

A total of 1,249 gamma radiation measurements were collected from the mine site, ranging from 6,823 cpm to 24,617 cpm. The measurements are represented in Figures 1 and 2.

Figure 1 - Gamma Radiation Measurements, Above Two Times Background
Charles Huskon No. 5 (536)
Coalmine Mesa Chapter, Navajo Nation

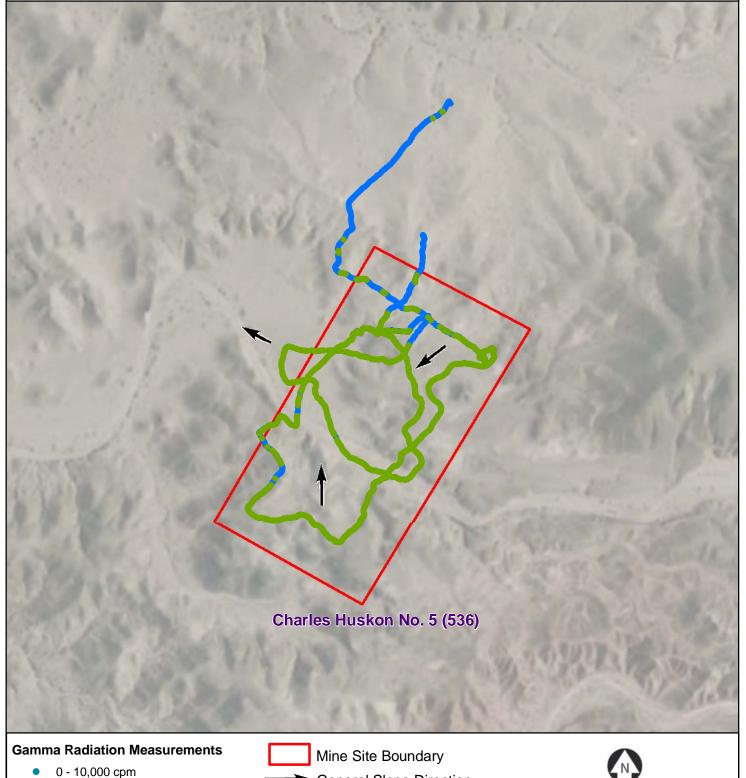
Figure 2 - Gamma Radiation Measurements Charles Huskon No. 5 (536) Coalmine Mesa Chapter, Navajo Nation

Average background 7,765 cpm
