# Navajo Abandoned Uranium Mine

## Site Screen Report

### Paul Huskie No. 3 AUM Site

**January 2011**

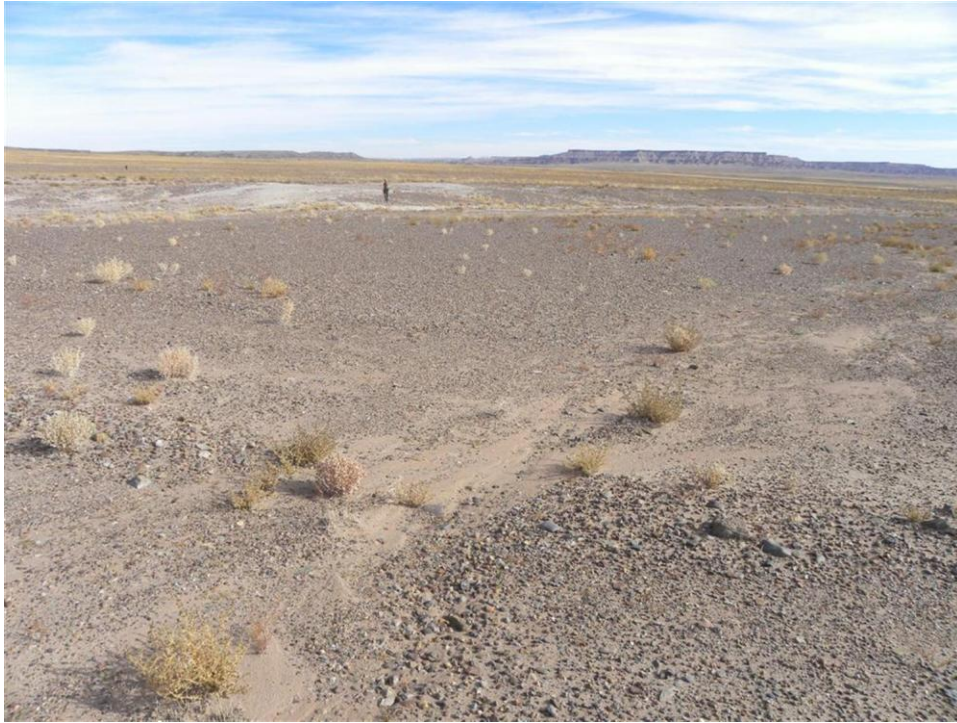
Photo 1. Paul Huskie No. 3 mine site

Waste pile with fine yellow-brown soil, 70' x 100' x 15'

Some mining debris (cables, cans)
