# **Navajo Abandoned Uranium Mine**

## **Site Screen Report**

### **Harry Walker No. 19 AUM Site**

**January 2011**

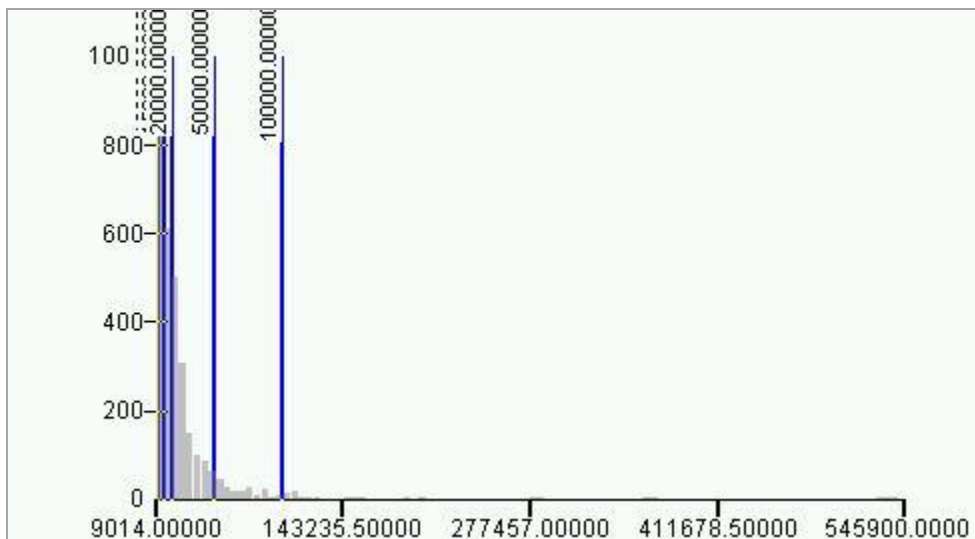
The following chart and statistics were generated by ESRI ArcGIS 9.3.1, and show the general distribution of the site gamma radiation measurements. The horizontal X axis represents the gamma radiation reading levels in cpm (lowest levels to the left). The vertical Y axis represents the frequency of each gamma radiation level.

Count:	2990
Minimum:	9014.00000
Maximum:	545900.00000
Sum:	100393742.00000
Mean:	33576.50234
Median:	20233.50000
Standard Deviation:	54564.21079

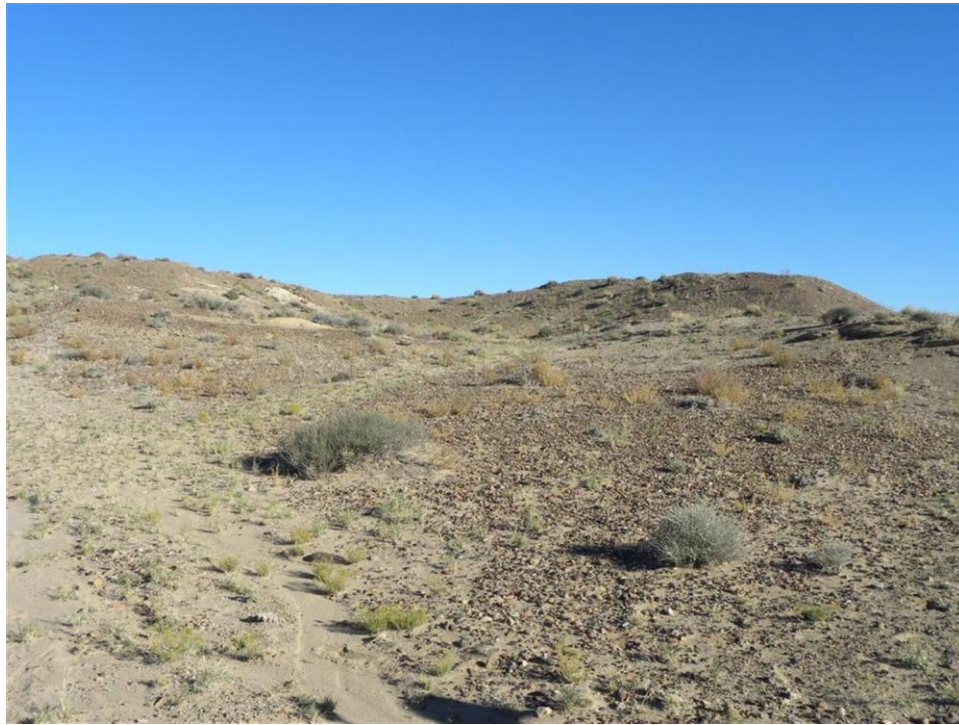
Photo 1. Harry Walker No. 19 mine site

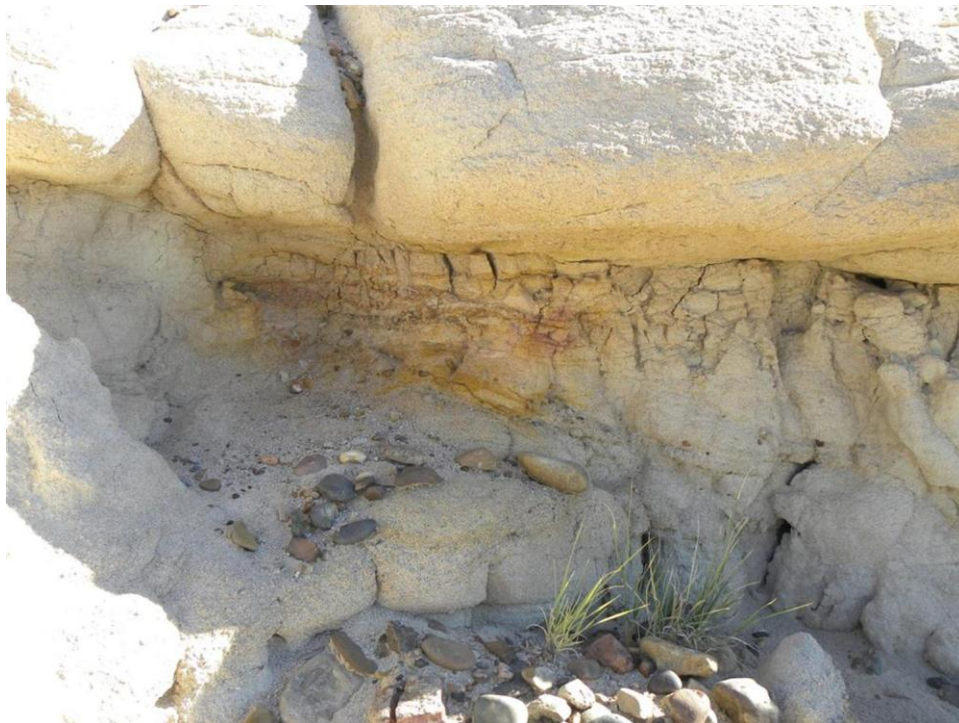
Reclamation cap, site has been reclaimed but exposed material in southern area due to erosion

Photo 2. Harry Walker No. 19 mine site, exposed ore

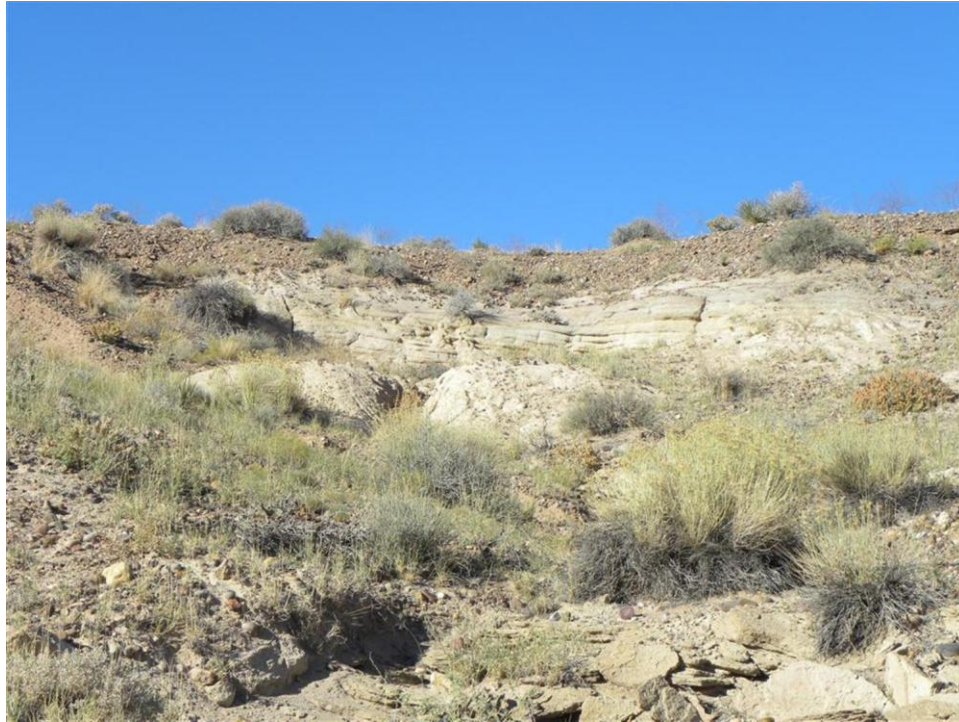
Waste pile 3' x 8' x 1.5', yellow-brown fine material

Photo 3. Harry Walker No. 19 mine site, waste pile

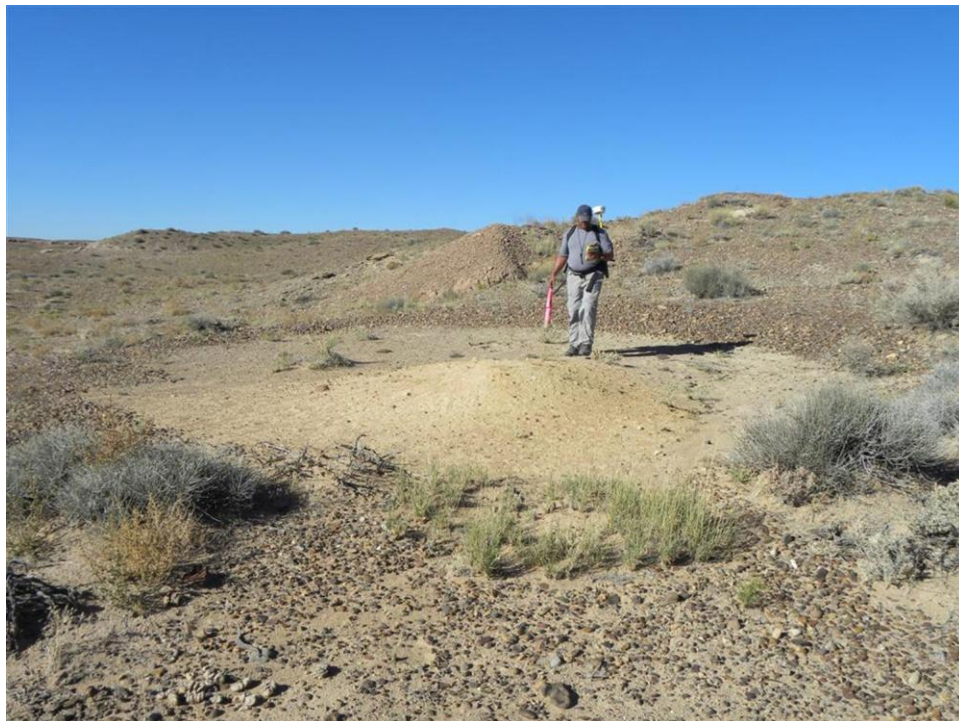
A total of 2,990 gamma radiation measurements were collected from the mine site, ranging from 9,014 cpm to 545,900 cpm. The measurements collected at the waste pile were found at a maximum level of approximately 550,000 cpm, and within the reclamation cap drainage at a maximum level of approximately 150,000 cpm. The measurements are represented in Figures 1 and 2.

Photo 4. Harry Walker No. 19 mine site, elevated gamma radiation readings

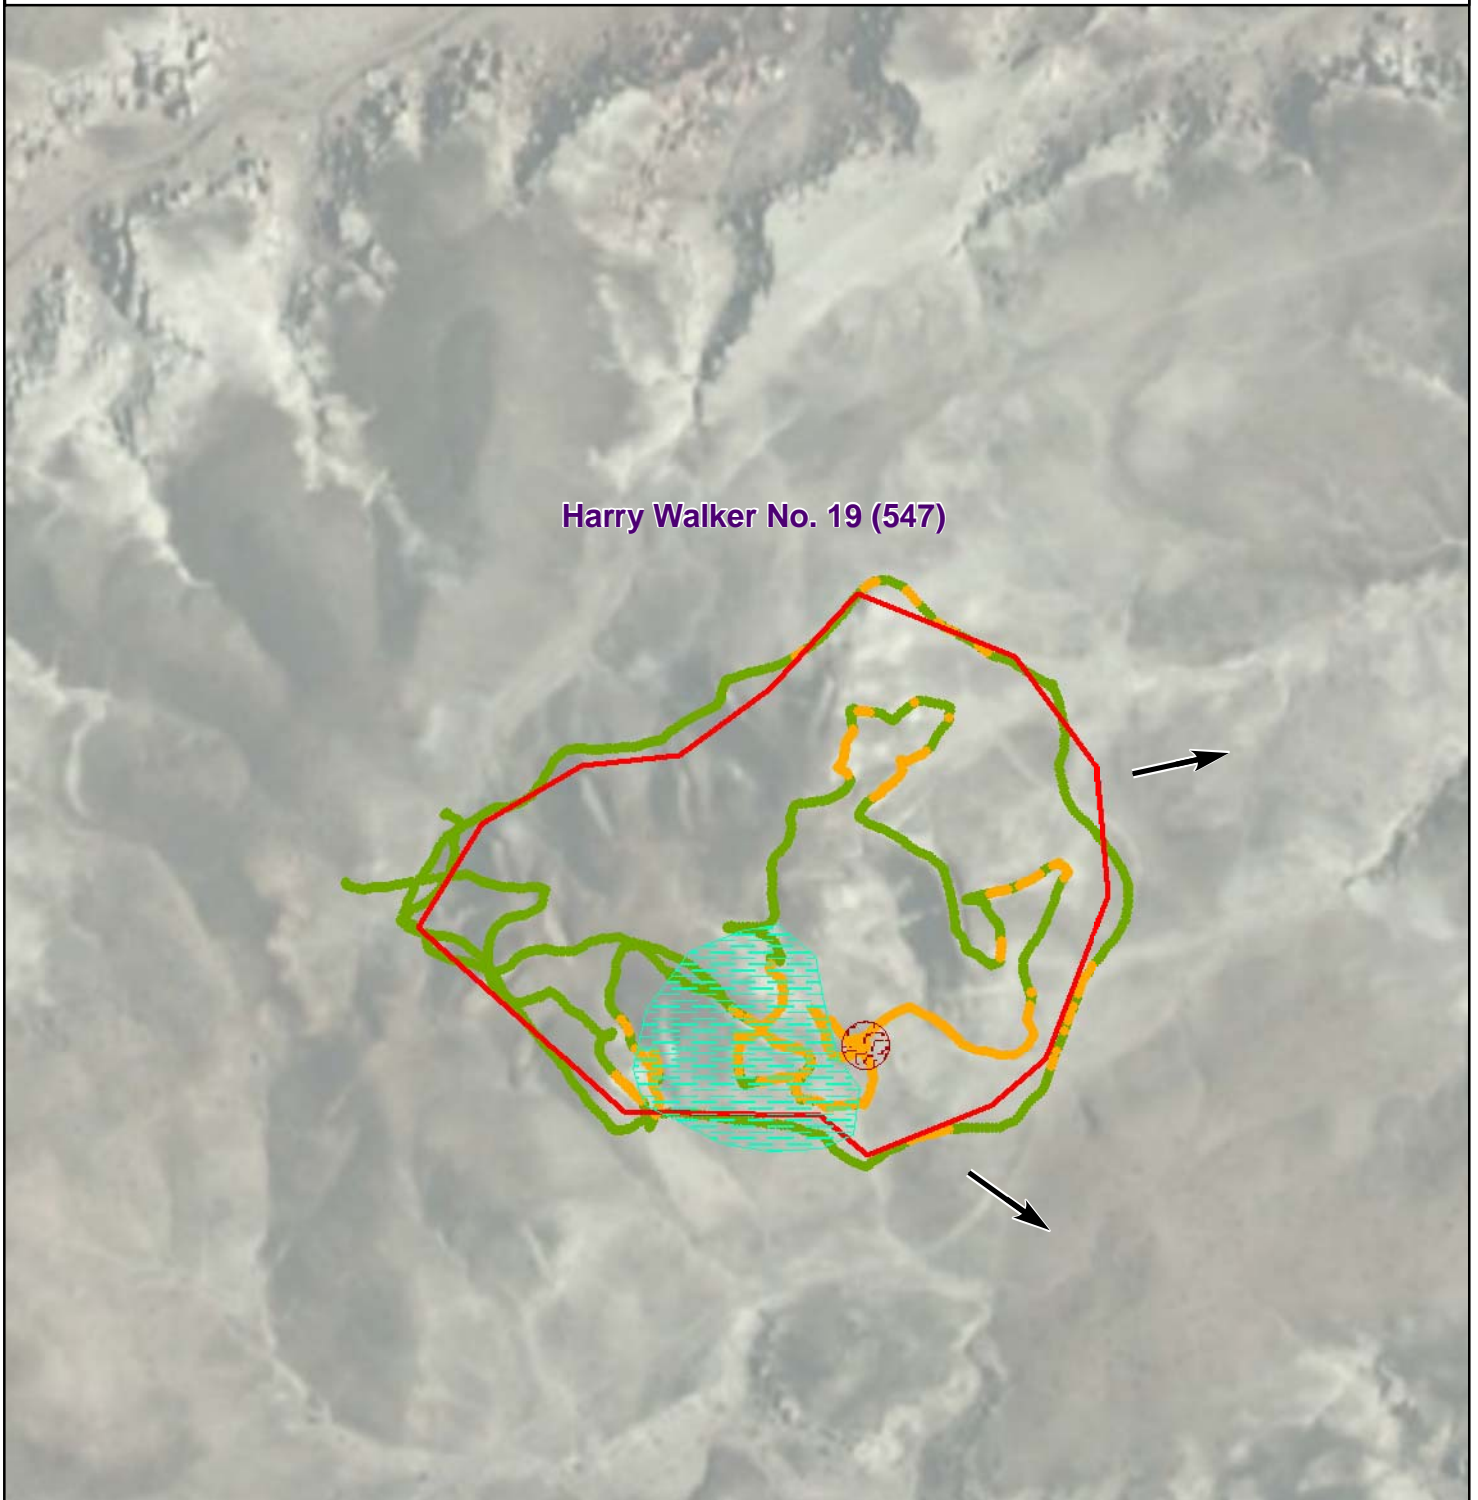
**Figure 1 - Gamma Radiation Measurements, Above Two Times Background  
 Harry Walker No. 19 (547)  
 Cameron Chapter, Navajo Nation**

Gamma survey conducted 11/2010  
 Measured as counts per minute (cpm)

Average background 13,338 cpm

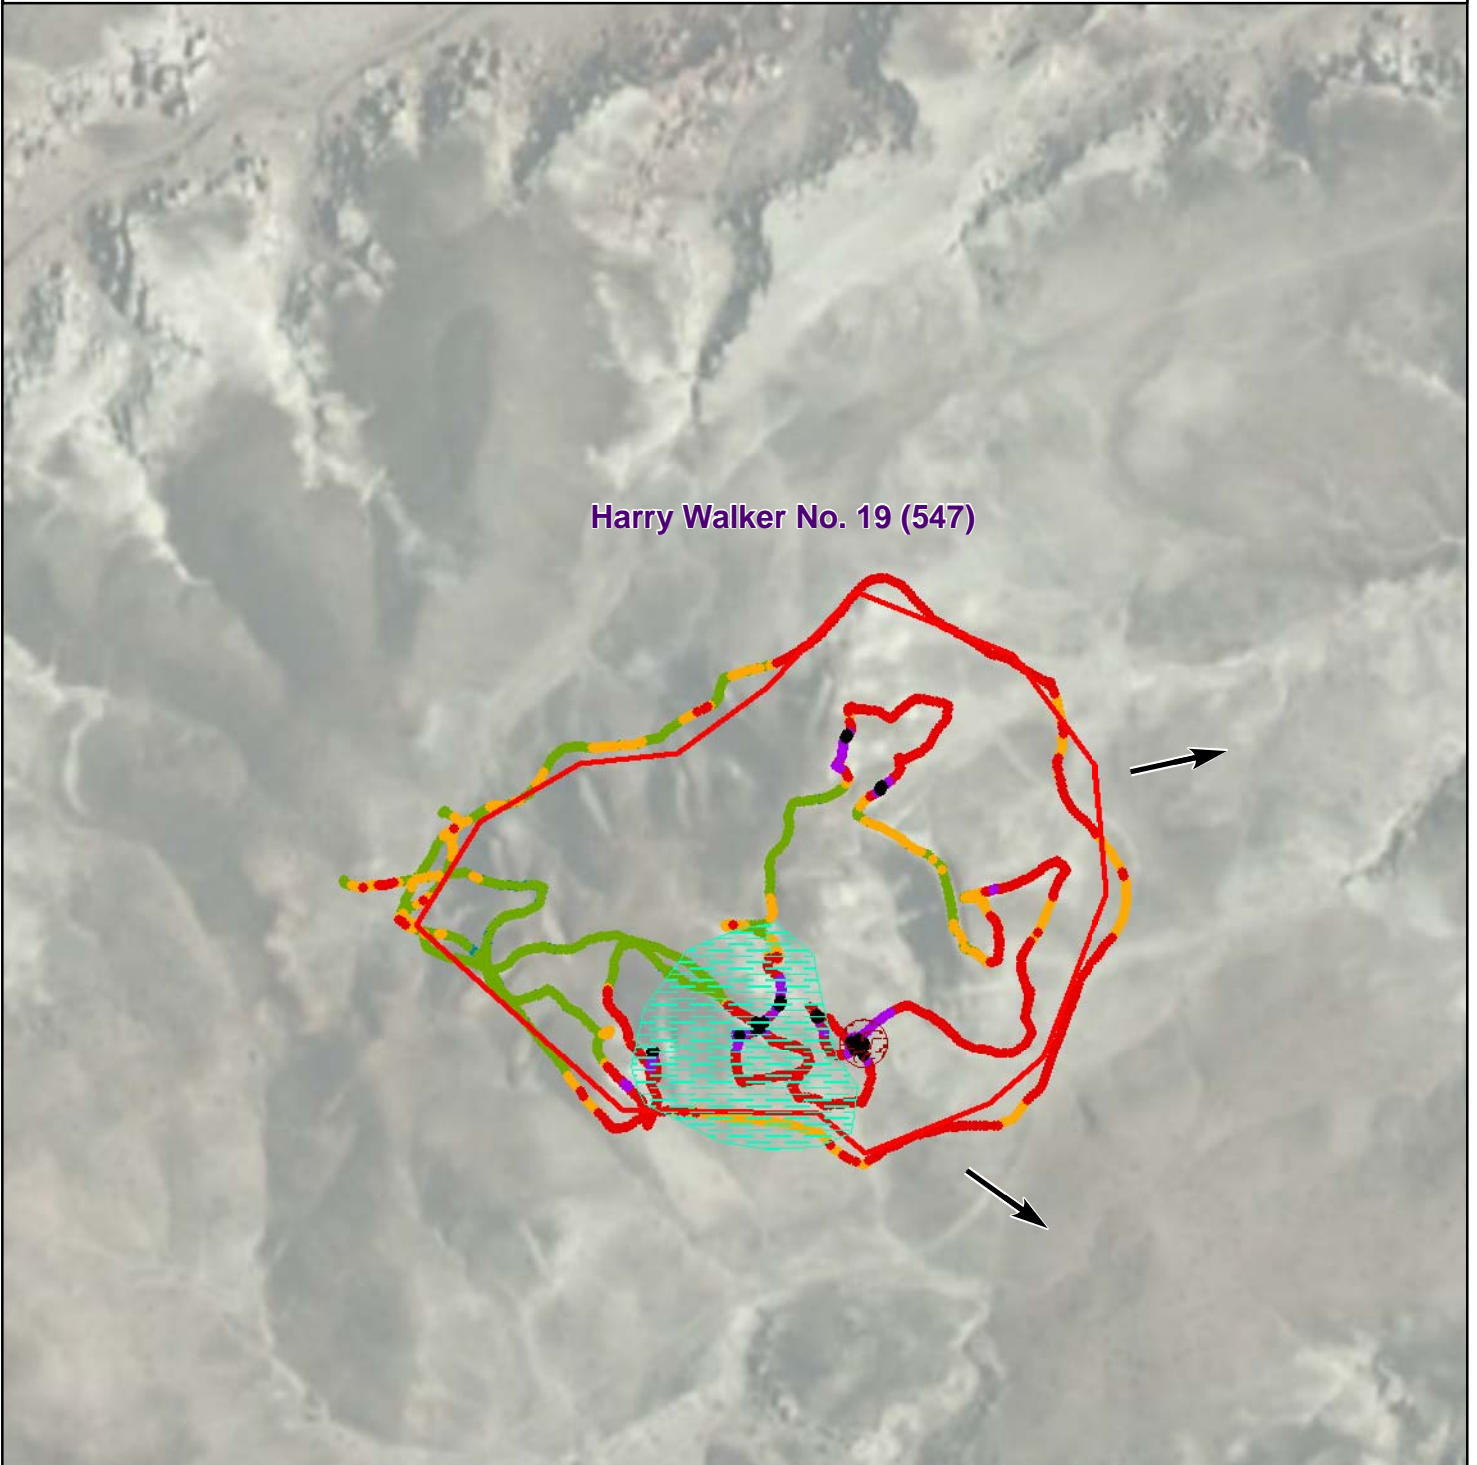
**Figure 2 - Gamma Radiation Measurements  
Harry Walker No. 19 (547)  
Cameron Chapter, Navajo Nation**

**Gamma survey conducted 11/2010  
Measured as counts per minute (cpm)**

**Average background 13,338 cpm**
