Navajo Abandoned Uranium Mine

Site Screen Report

Ryan No. 3 AUM Site

January 2011

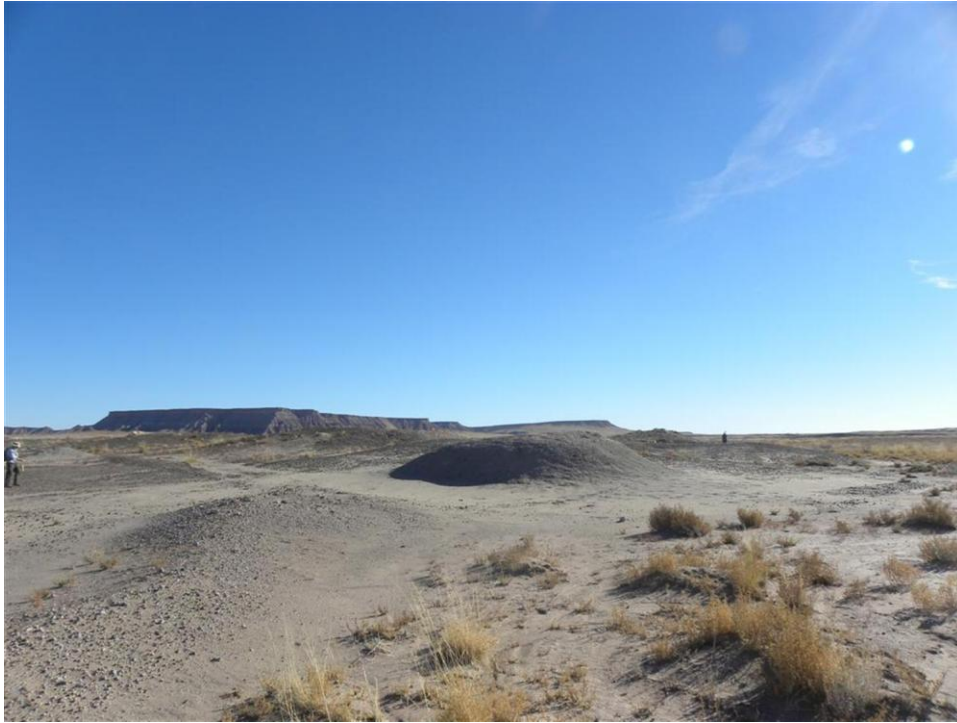
Photo 1. Ryan No. 3 mine site

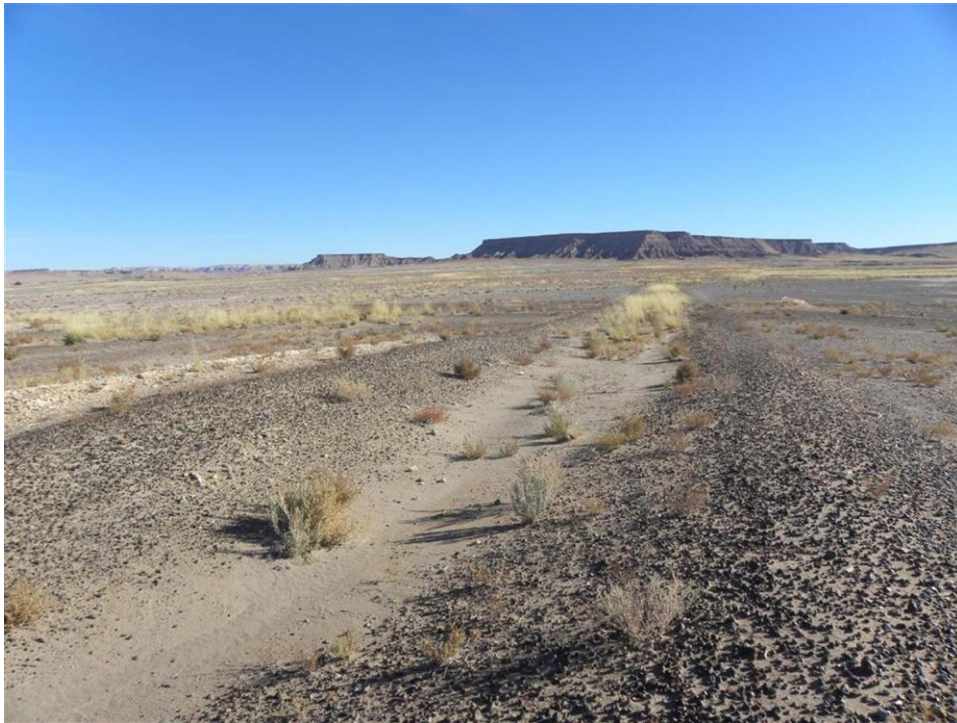
Diversion channels on eastern and central portion of site, series of small reclamation caps intermixed with mounds surrounding petrified wood piles

Photo 2. Ryan No. 3 mine site, diversion channel

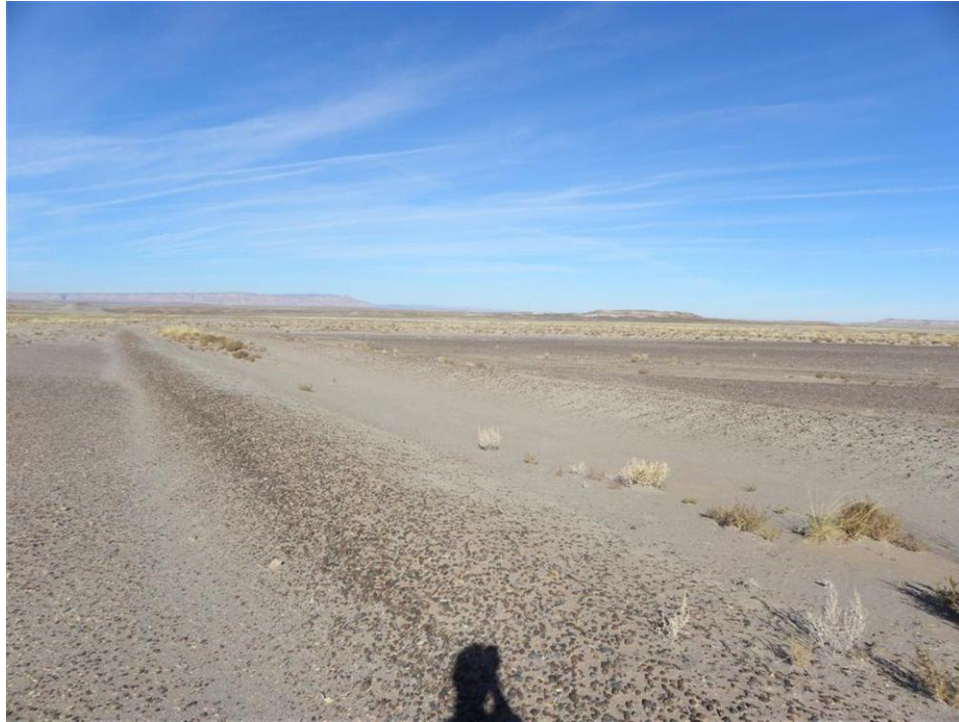
Photo 3. Ryan No. 3 mine site, diversion channel

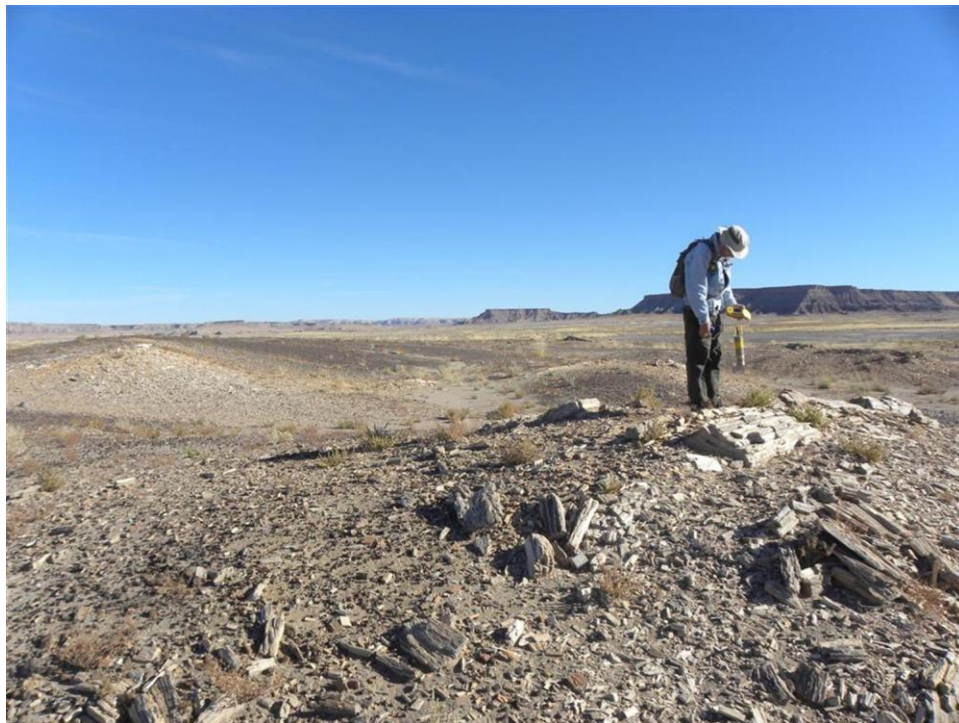
Photo 4. Ryan No. 3 mine site, reclamation caps and petrified wood piles

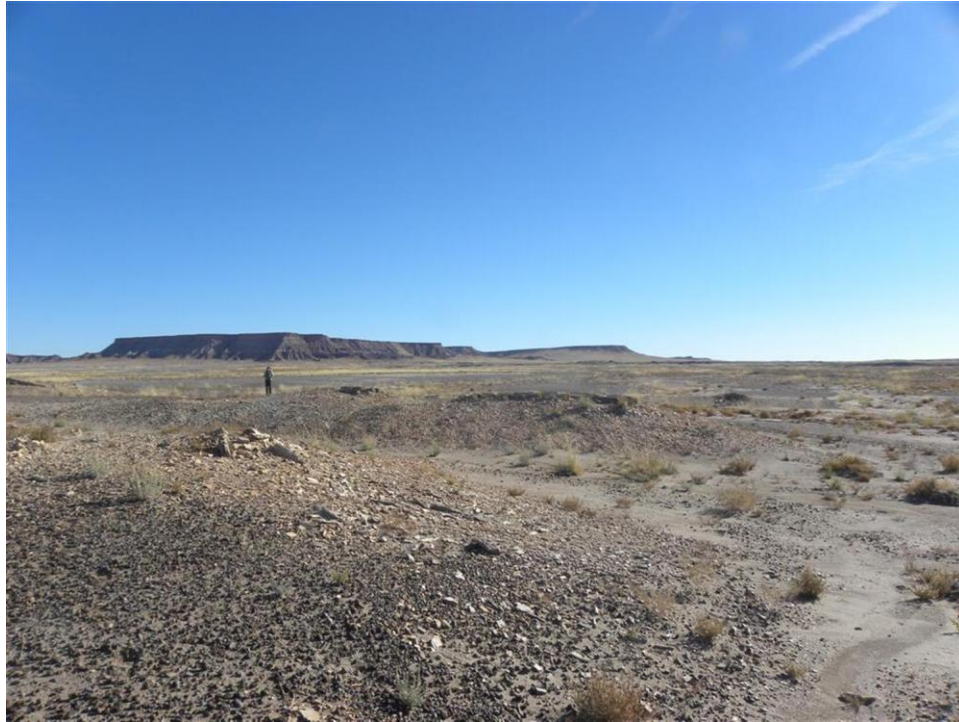
Photo 5. Ryan No. 3 mine site, reclamation caps and petrified wood piles

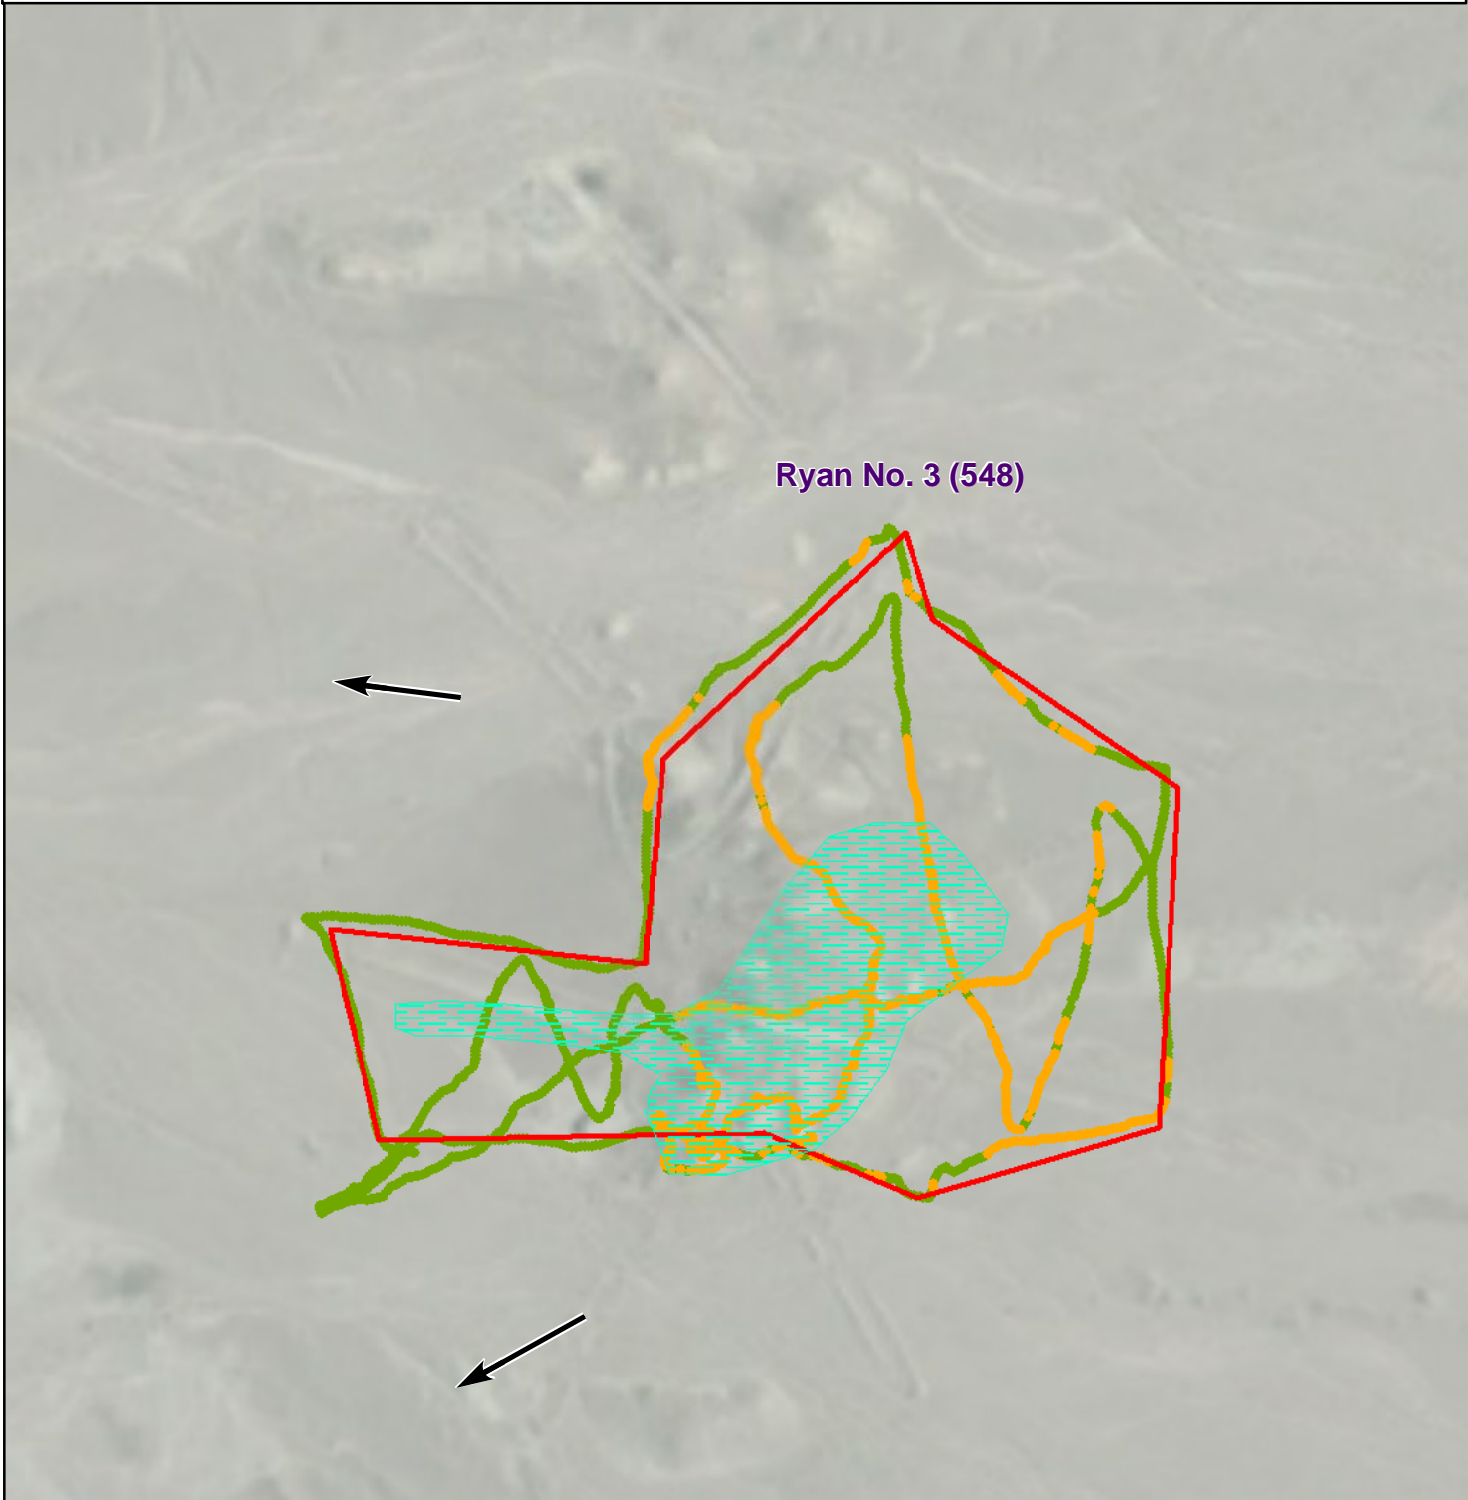
A total of 2,787 gamma radiation measurements were collected from the mine site, ranging from 10,217 cpm to 202,439 cpm. The measurements collected at the petrified wood piles were found at a maximum level of approximately 200,000 cpm. The measurements are represented in Figures 1 and 2.

**Figure 1 - Gamma Radiation Measurements, Above Two Times
Ryan No. 3 (548)
Coalmine Mesa Chapter, Navajo Nation**

Gamma survey conducted 11/2010
Measured as counts per minute (cpm)

Average background 11,885 cpm
