Navajo Abandoned Uranium Mine

Site Screen Report

Emmett Lee No. 1 AUM Site

Navajo AUM Western Region

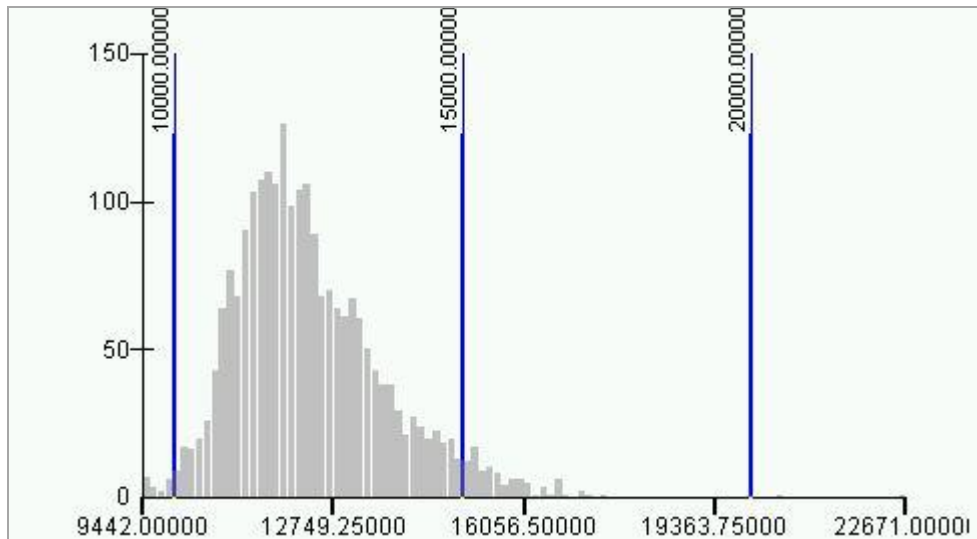
The following chart and statistics were generated by ESRI ArcGIS 9.3.1, and show the general distribution of the site gamma radiation measurements. The horizontal X axis represents the gamma radiation reading levels in cpm (lowest levels to the left). The vertical Y axis represents the frequency of each gamma radiation level.

Count:	2246
Minimum:	9442.00000
Maximum:	22671.00000
Sum:	27734513.00000
Mean:	12348.40294
Median:	12115.00000
Standard Deviation:	1312.26714

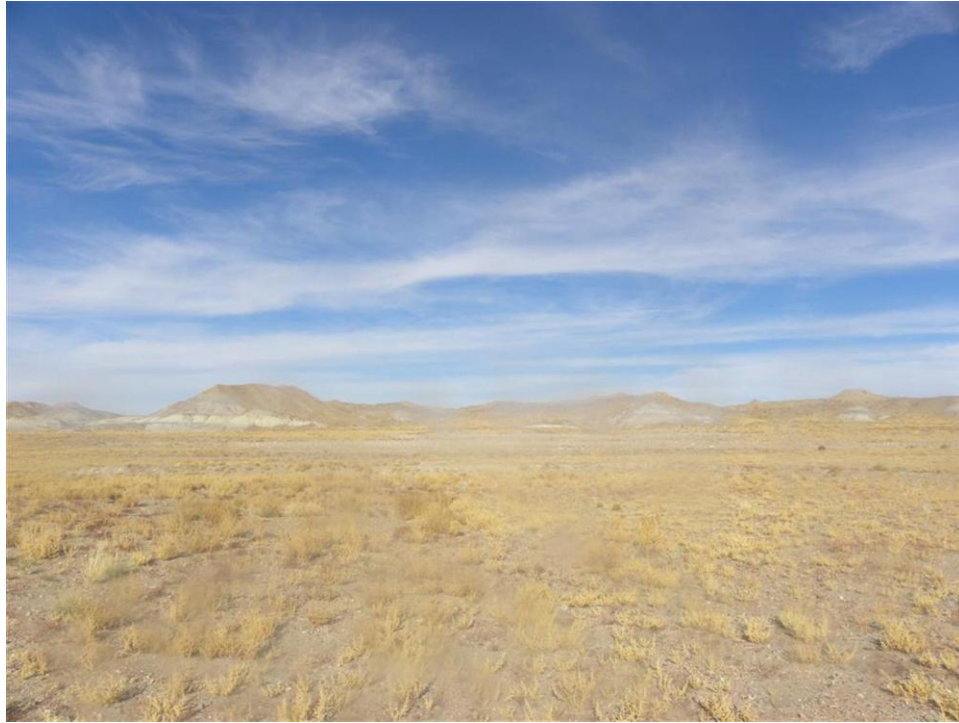
Photo 1. Emmett Lee No. 1 mine site

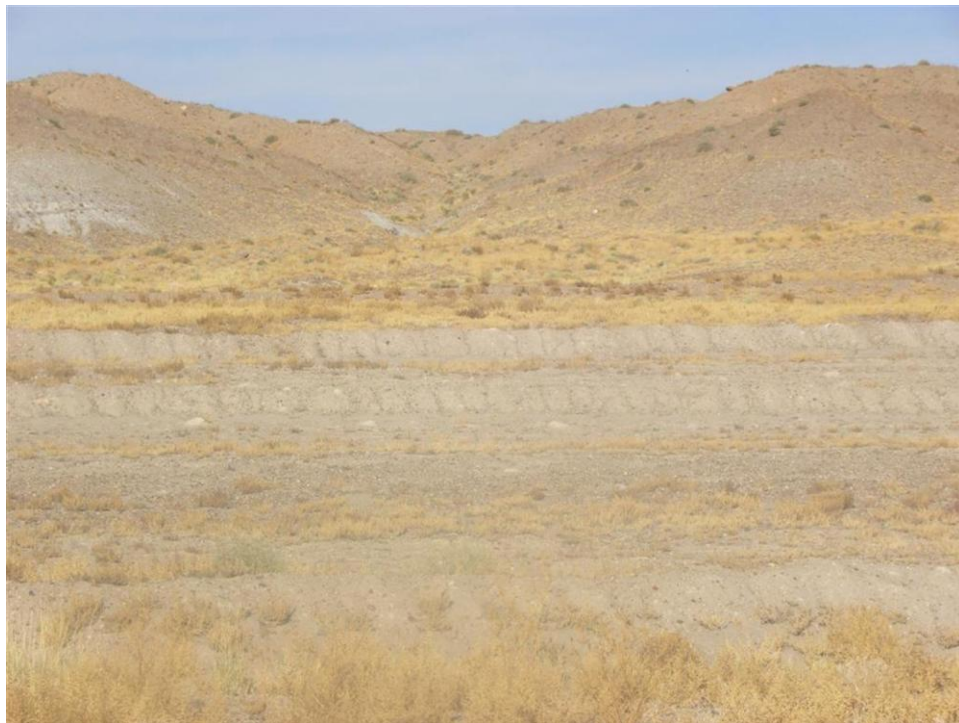
Series of reclamation berms, over area identified on old topo maps as "tailings", berms cover the corner area between sites 159, 549, 550, and 1041, breached in the southwest

Photo 2. Emmett Lee No. 1 mine site, berm area

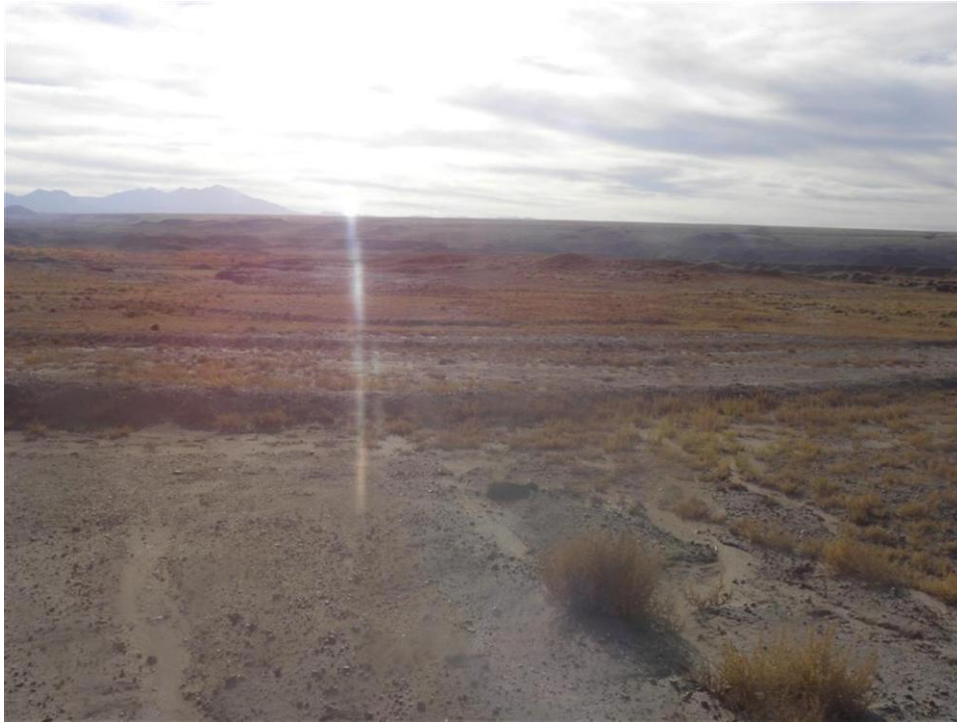
Photo 3. Emmett Lee No. 1 mine site, berm area
