# Navajo Abandoned Uranium Mine

## Site Screen Report

### Evans Huskon No. 34 AUM Site

**January 2011**

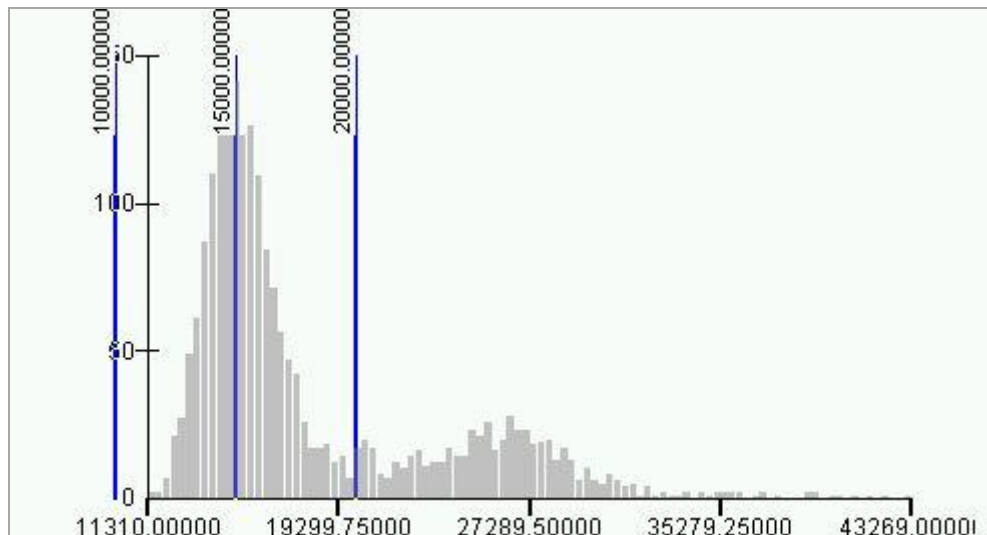
The following chart and statistics were generated by ESRI ArcGIS 9.3.1, and show the general distribution of the site gamma radiation measurements. The horizontal X axis represents the gamma radiation reading levels in cpm (lowest levels to the left). The vertical Y axis represents the frequency of each gamma radiation level.

Count:	2100
Minimum:	11310.00000
Maximum:	43269.00000
Sum:	38295272.00000
Mean:	18235.84381
Median:	15929.50000
Standard Deviation:	5385.89025

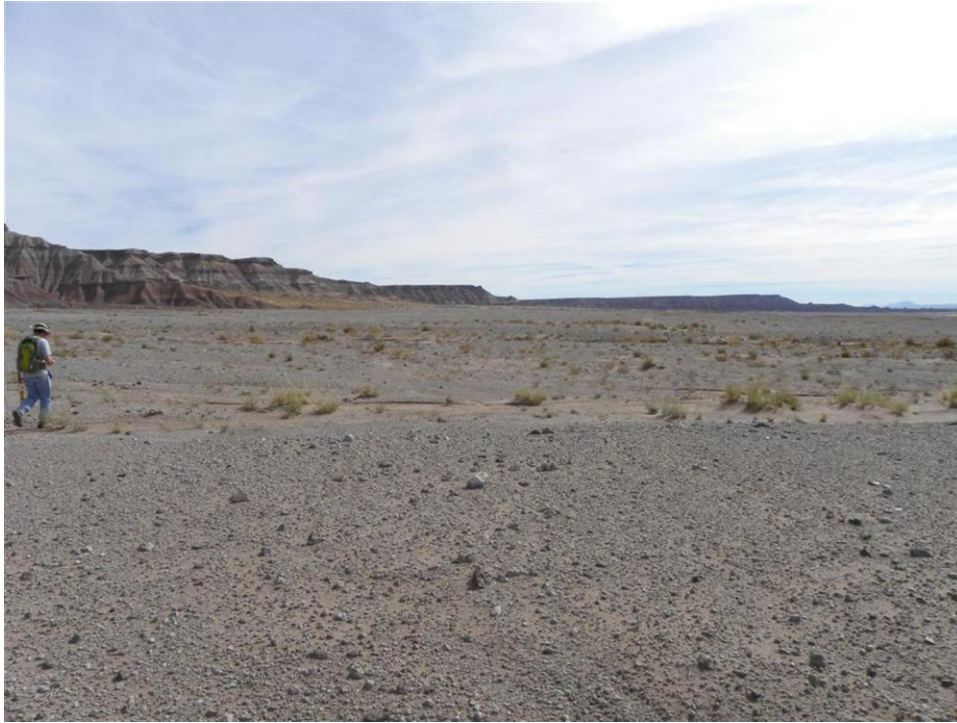
Photo 1. Evans Huskon No. 34 mine site

Large reclamation cap covering presumed open pit mine, grey granular soil with drainage/erosion cuts heading southwest through site

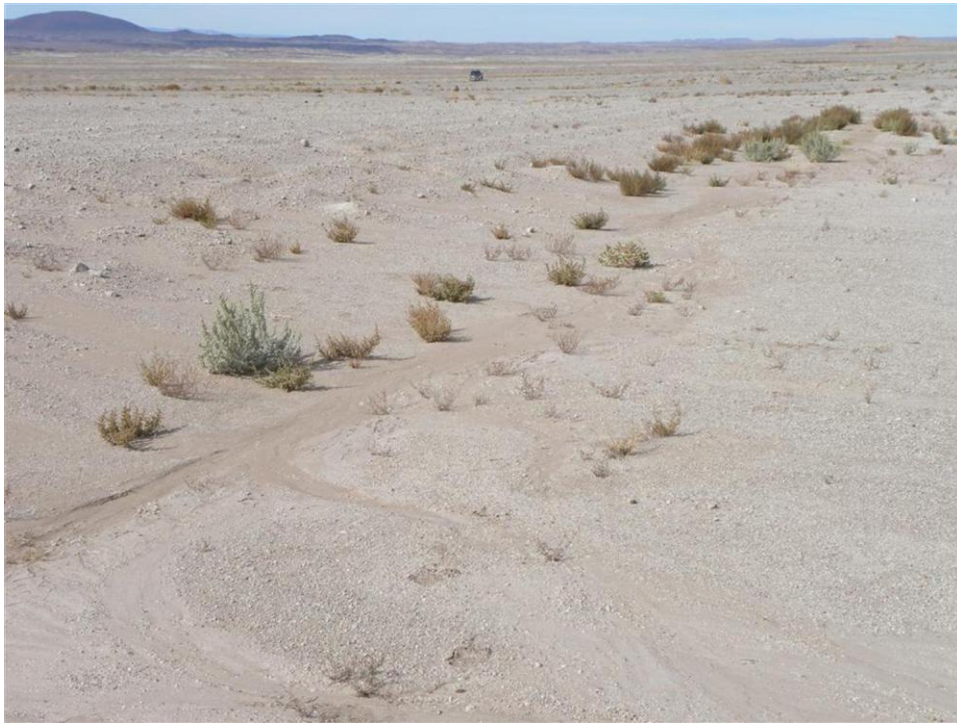
Photo 2. Evans Huskon No. 34 mine site, reclamation cap

Yes (reclamation cap)

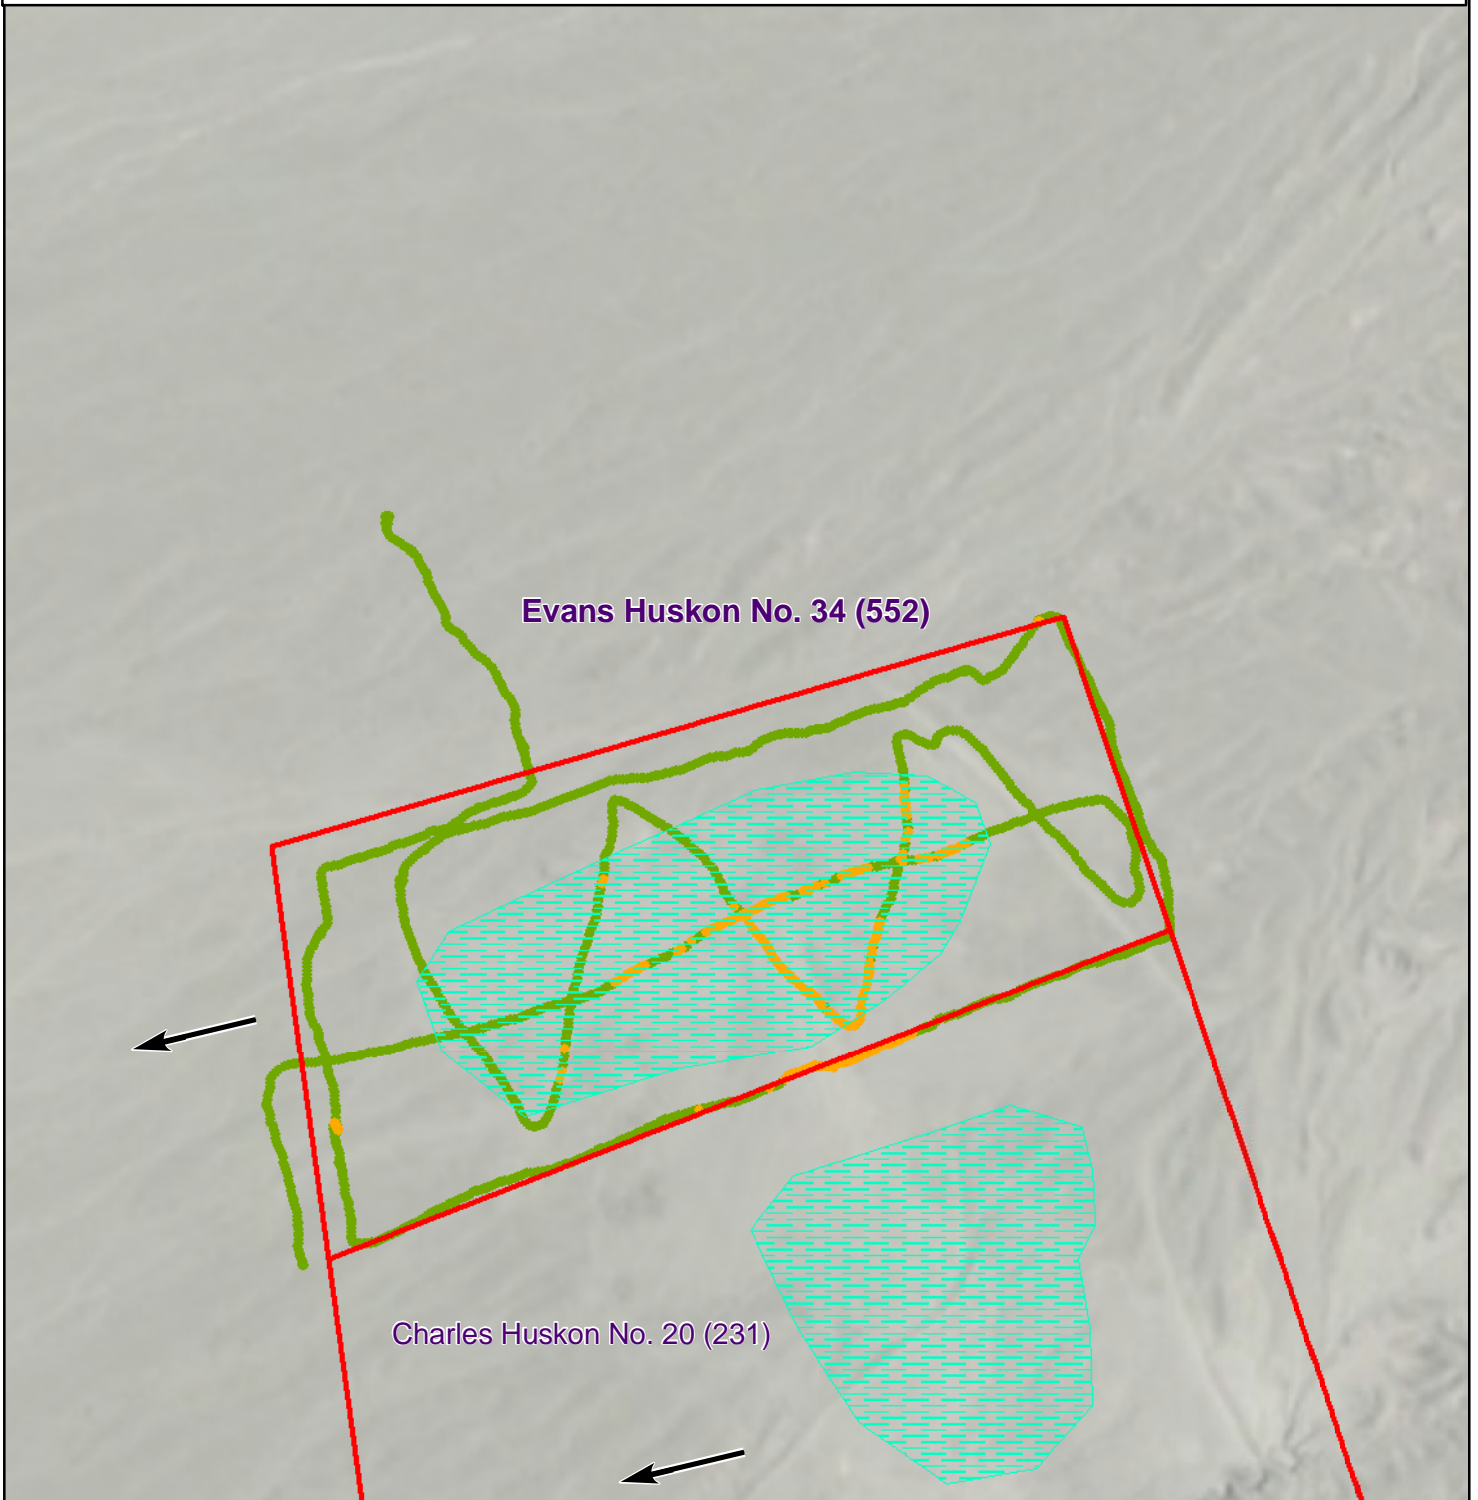
**Figure 1 - Gamma Radiation Measurements, Above Two Times Background  
 Evans Huskon No. 34 (552)  
 Coalmine Mesa Chapter, Navajo Nation**

A total of 2,100 gamma radiation measurements were collected from the mine site, ranging from 11,310 cpm to 43,269 cpm. The measurements collected at the reclamation cap were found at a maximum level of approximately 40,000 cpm. The measurements are represented in Figures 1 and 2.

Gamma survey conducted 11/2010  
 Measured as counts per minute (cpm)

Average background 12,296 cpm

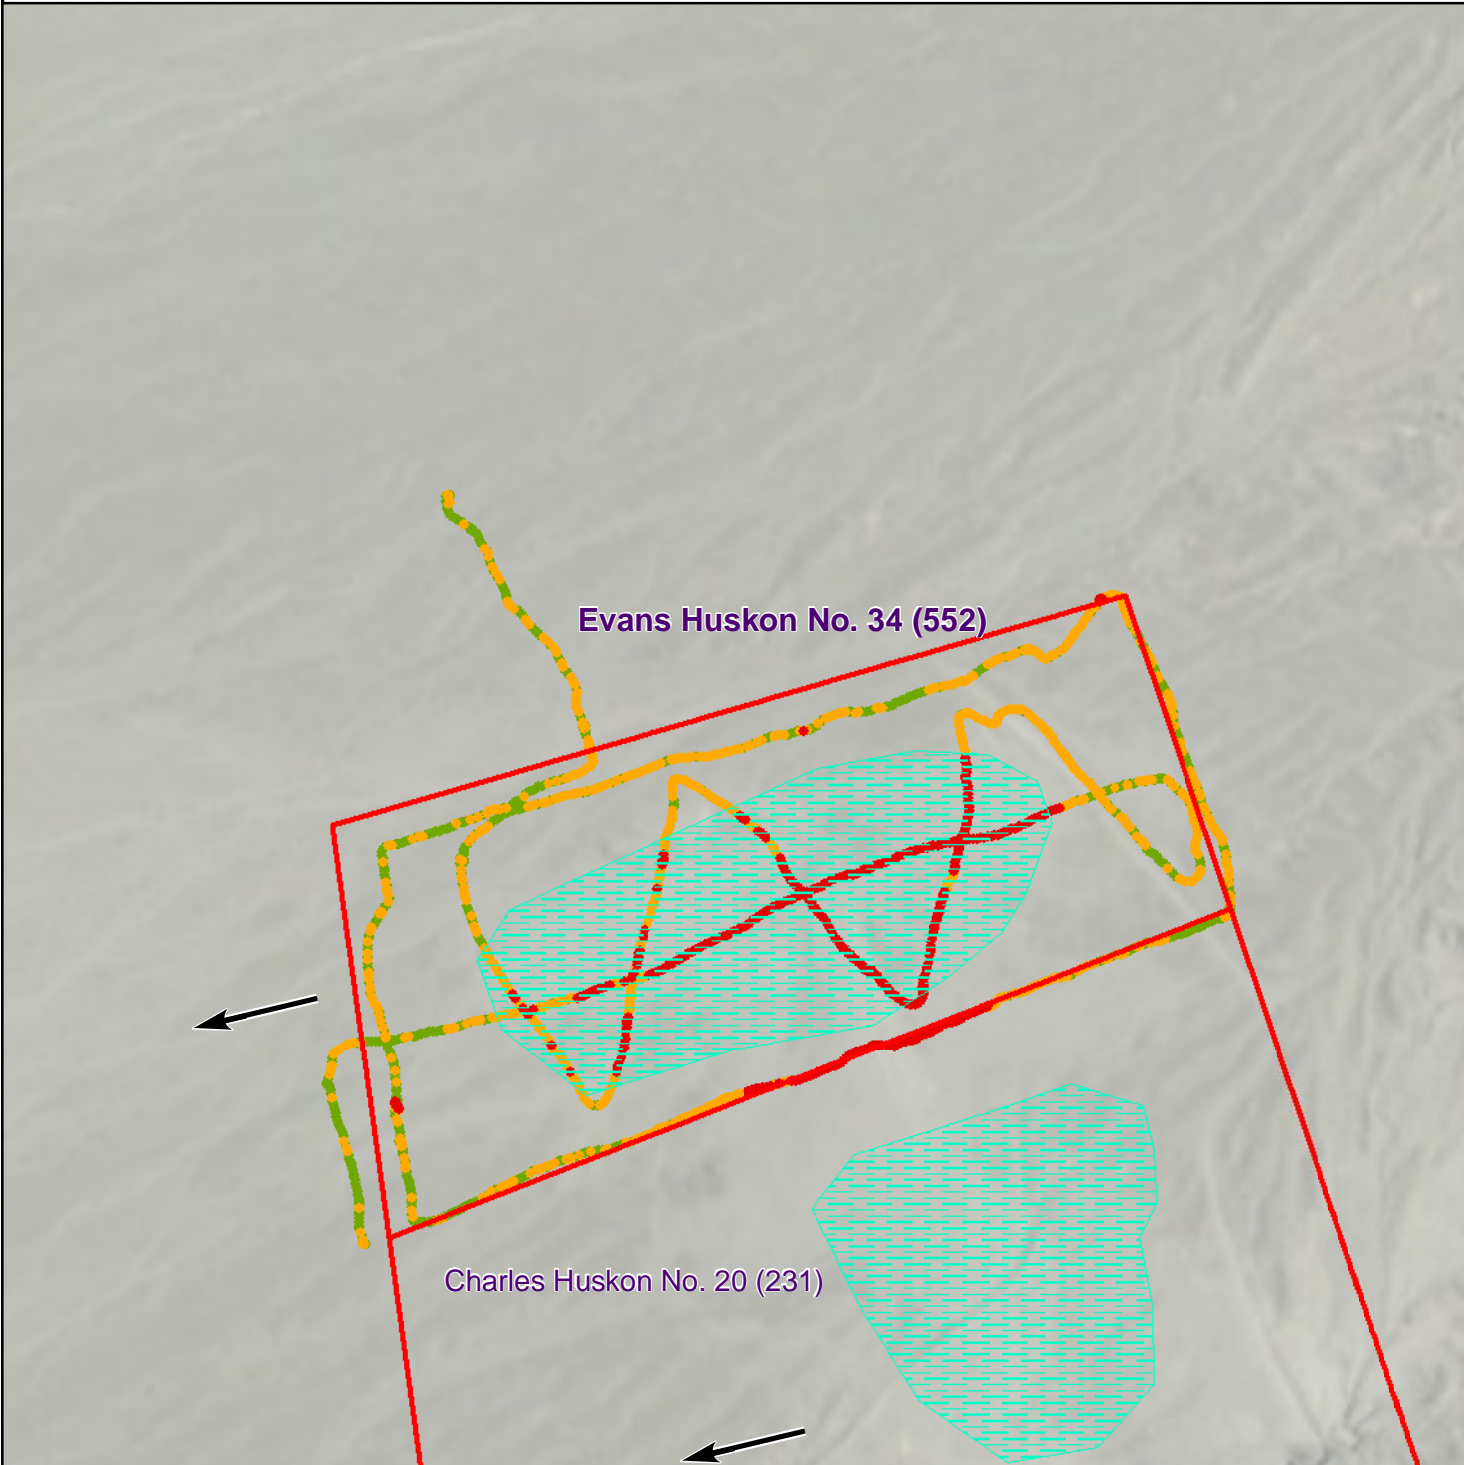
**Figure 2 - Gamma Radiation Measurements  
Evans Huskon No. 34 (552)  
Coalmine Mesa Chapter, Navajo Nation**

**Gamma survey conducted 11/2010  
Measured as counts per minute (cpm)**

**Average background 12,296 cpm**
