Navajo Abandoned Uranium Mine

Site Screen Report

North Martin AUM Site

August 2010

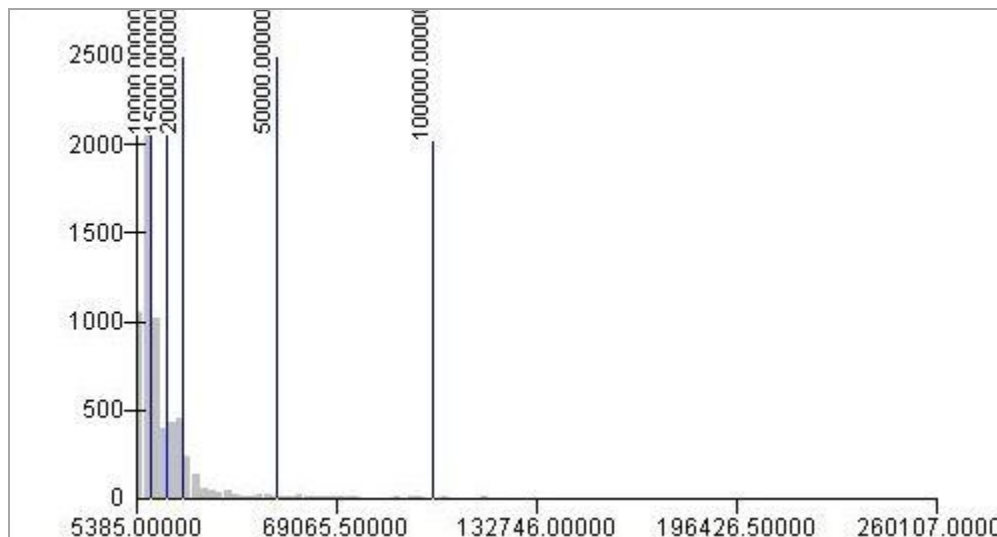
The following chart and statistics were generated by ESRI ArcGIS 9.3.1, and show the general distribution of the site gamma radiation measurements. The horizontal X axis represents the gamma radiation reading levels in cpm (lowest levels to the left). The vertical Y axis represents the frequency of each gamma radiation level.

Count:	6357
Minimum:	5385.00000
Maximum:	260107.00000
Sum:	106700750.00000
Mean:	16784.76483
Median:	10552.00000
Standard Deviation:	22890.12939

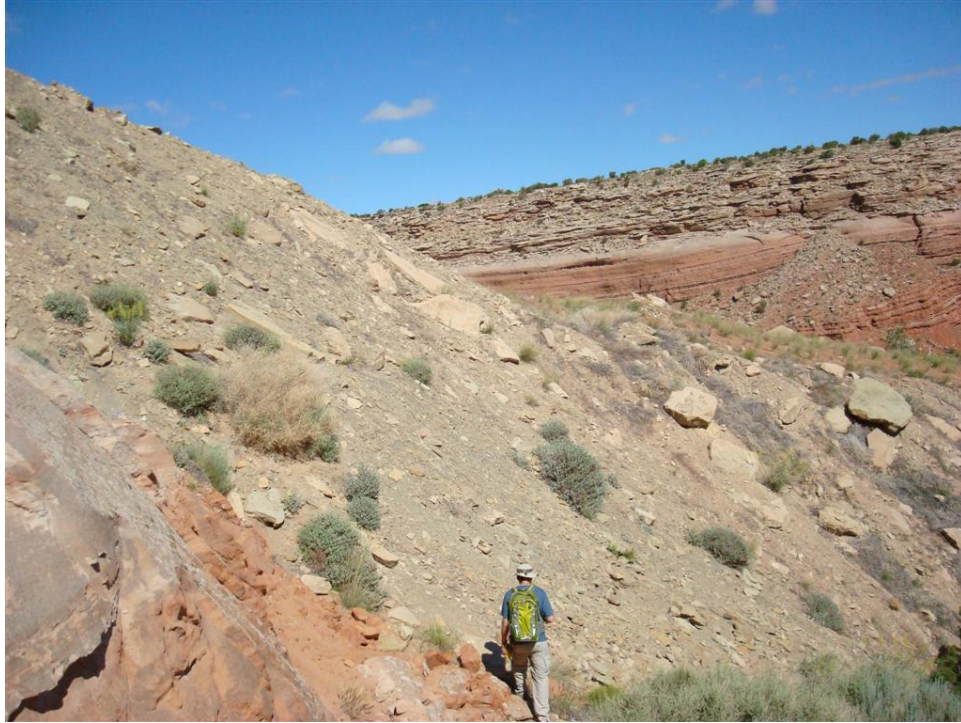
Photo 2. North Martin mine site, waste pile

Waste piles on both sides of excavation, over-steepened and failure cracks along upper edge

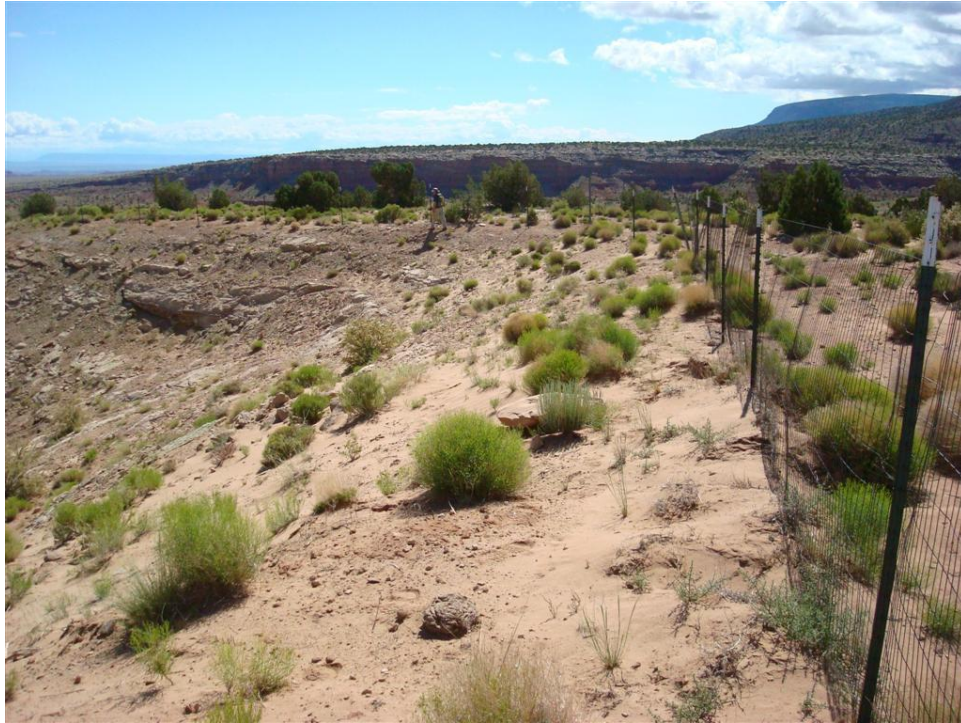
Photo 5. North Martin mine site, fence line

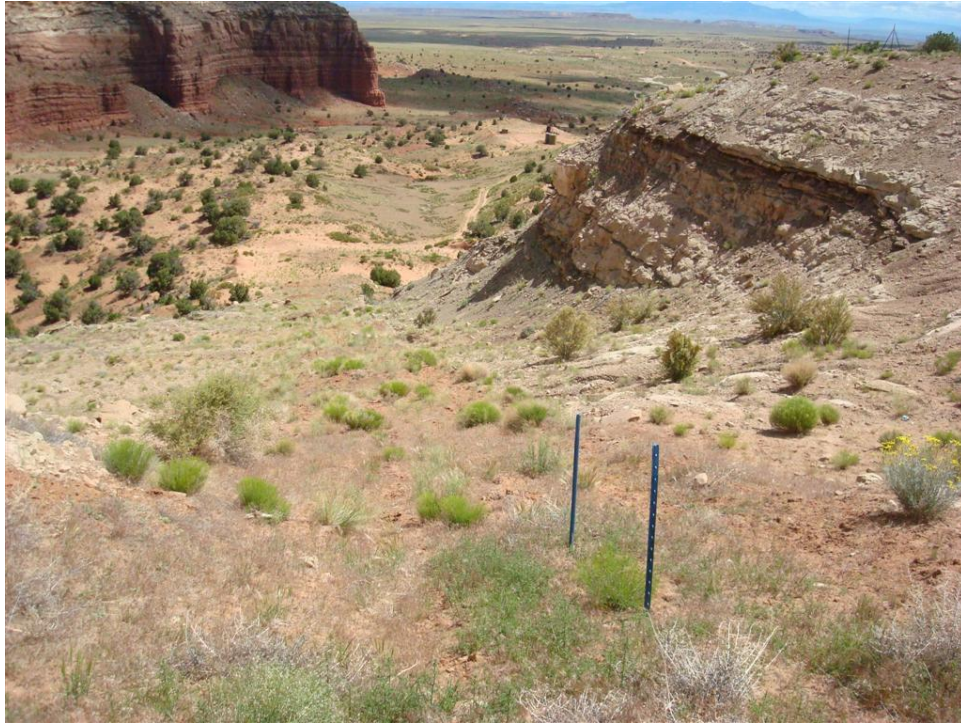
Photo 7. North Martin mine site, buried water line running through site

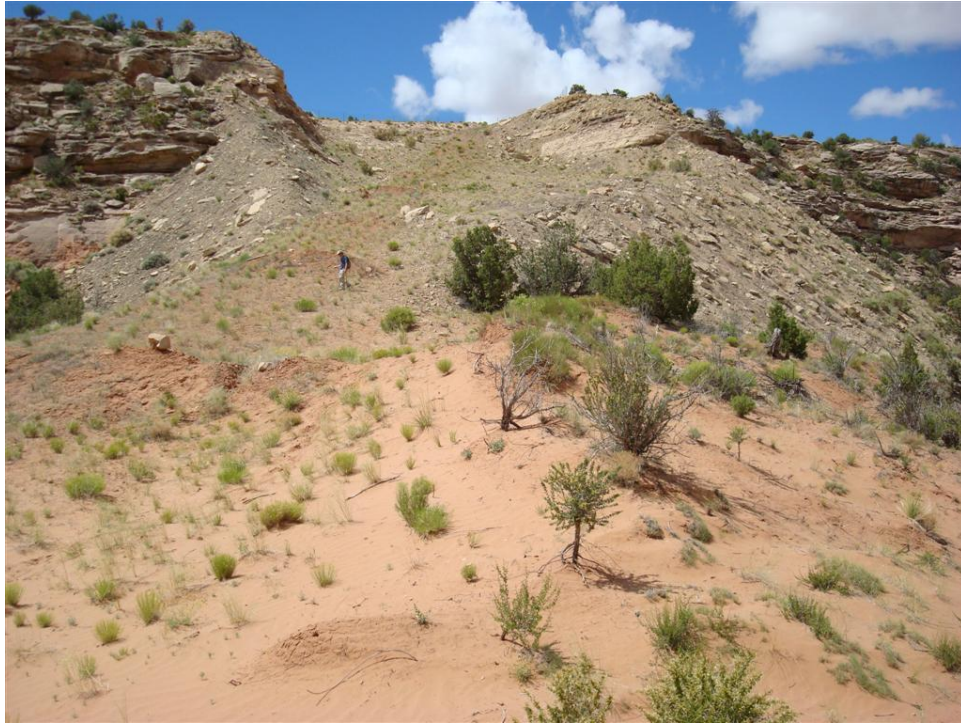
Photo 9. North Martin mine site, waste pile

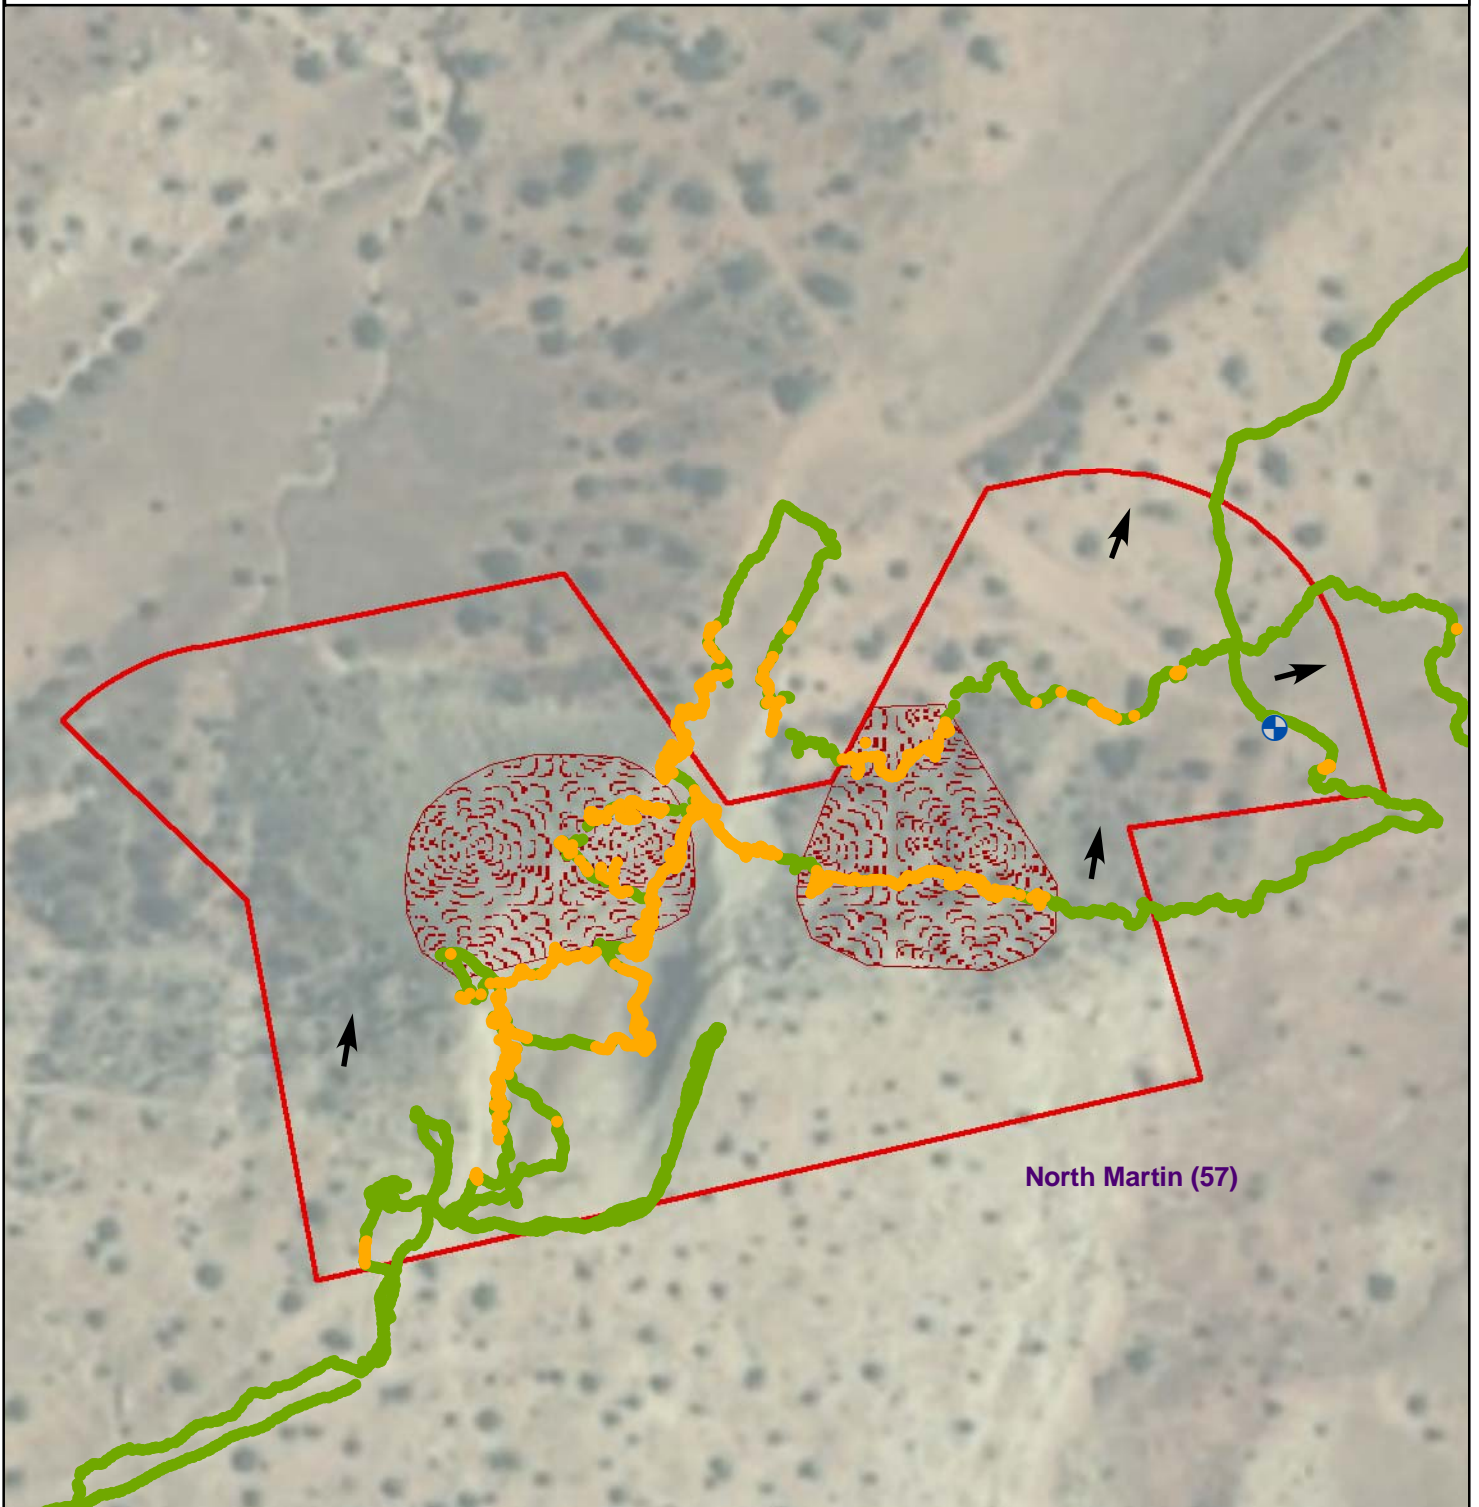
**Figure 1 - Gamma Radiation Measurements, Above Two Times Background
 North Martin (57)
 Sweetwater / Teec Nos Pos Chapter, Navajo Nation**

A total of 6,357 gamma radiation measurements were collected from the mine site, ranging from 5,385 cpm to 260,107 cpm. Measurements collected in the vicinity of the waste debris were found at levels up to approximately 250,000 cpm, and in the excavation pit at levels up to approximately 10,000 cpm. The measurements are represented in Figures 1 and 2.

Gamma survey conducted 06/2010
 Measured as counts per minute (cpm)

Average background = 8,374 cpm

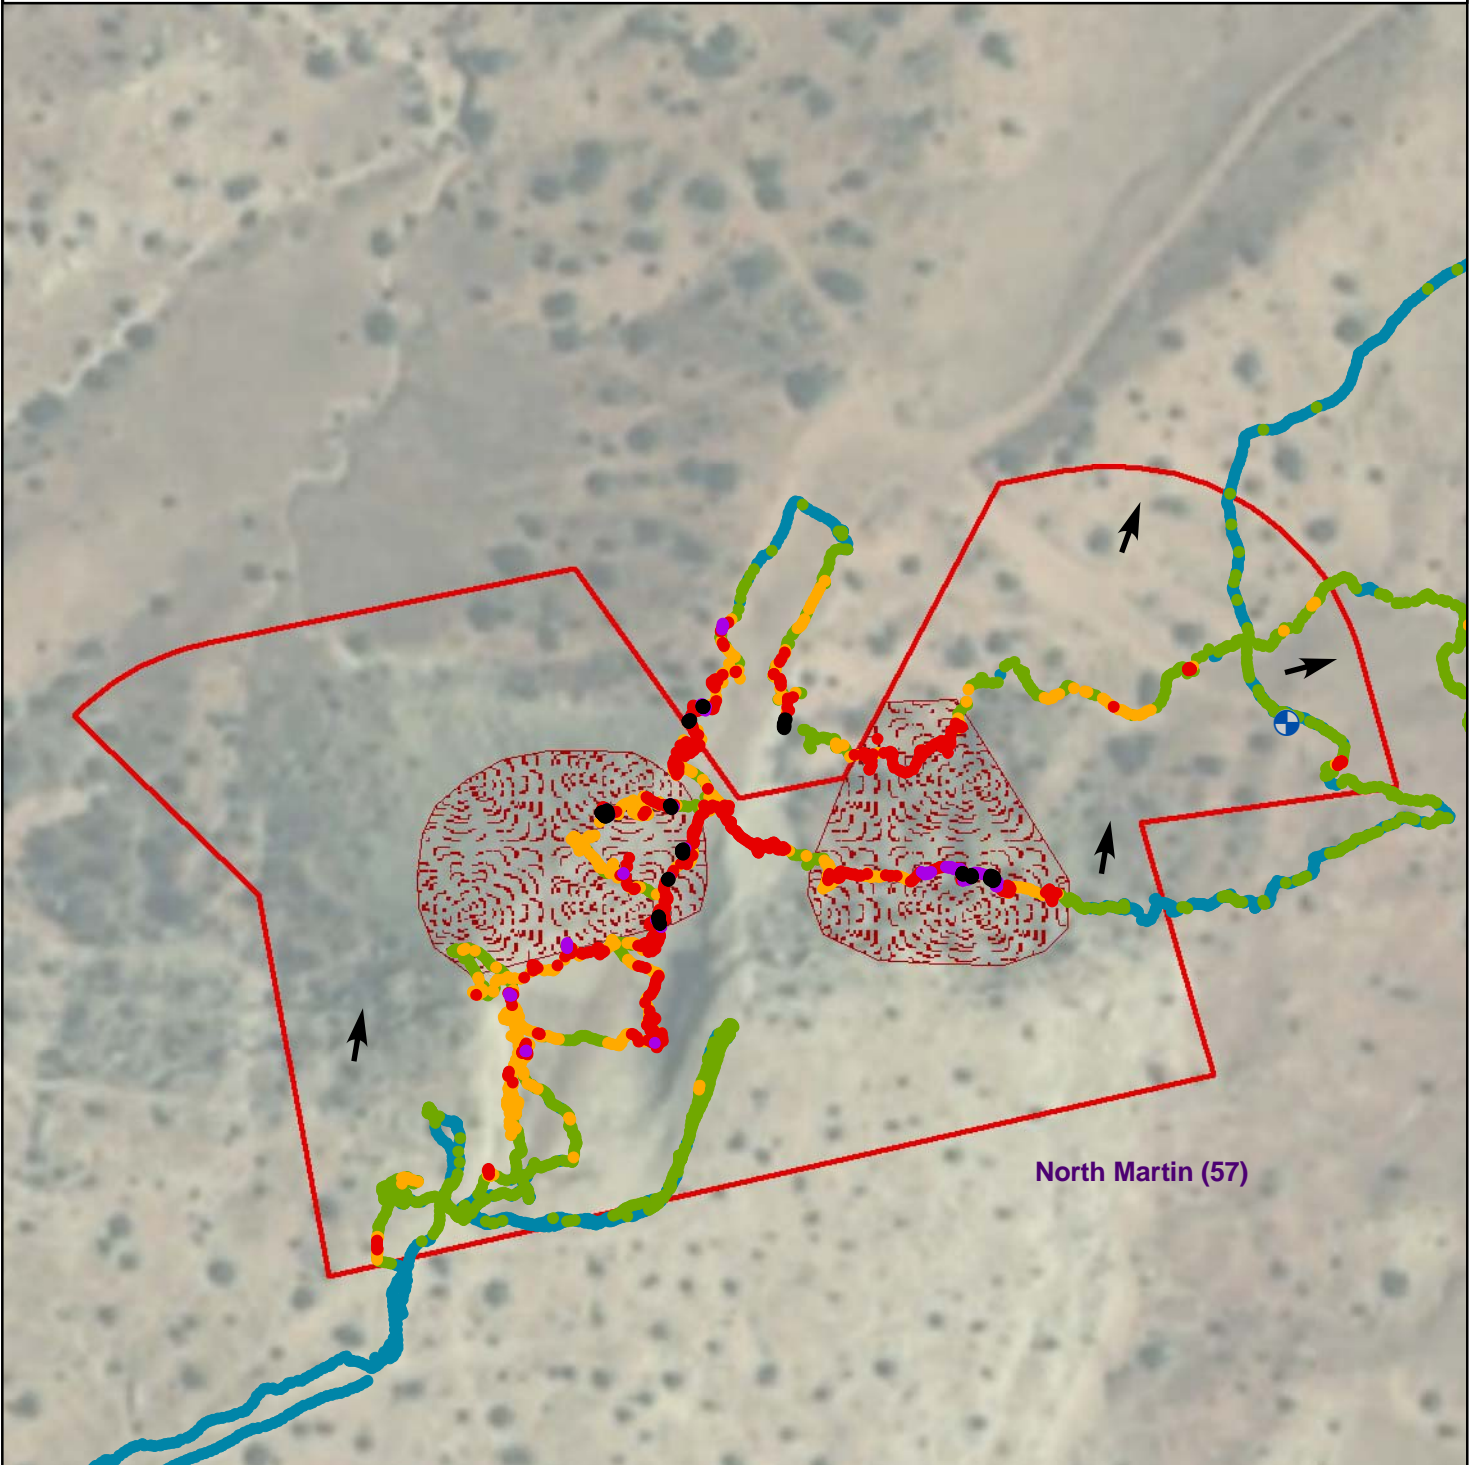
**Figure 2 - Gamma Radiation Measurements
North Martin (57)
Sweetwater / Teec Nos Pos Chapter, Navajo Nation**

Gamma survey conducted 06/2010
Measured as counts per minute (cpm)

Average background 8,374 cpm
