# Navajo Abandoned Uranium Mine

## Site Screen Report

### McKenzie 3 AUM Site

**August 2010**

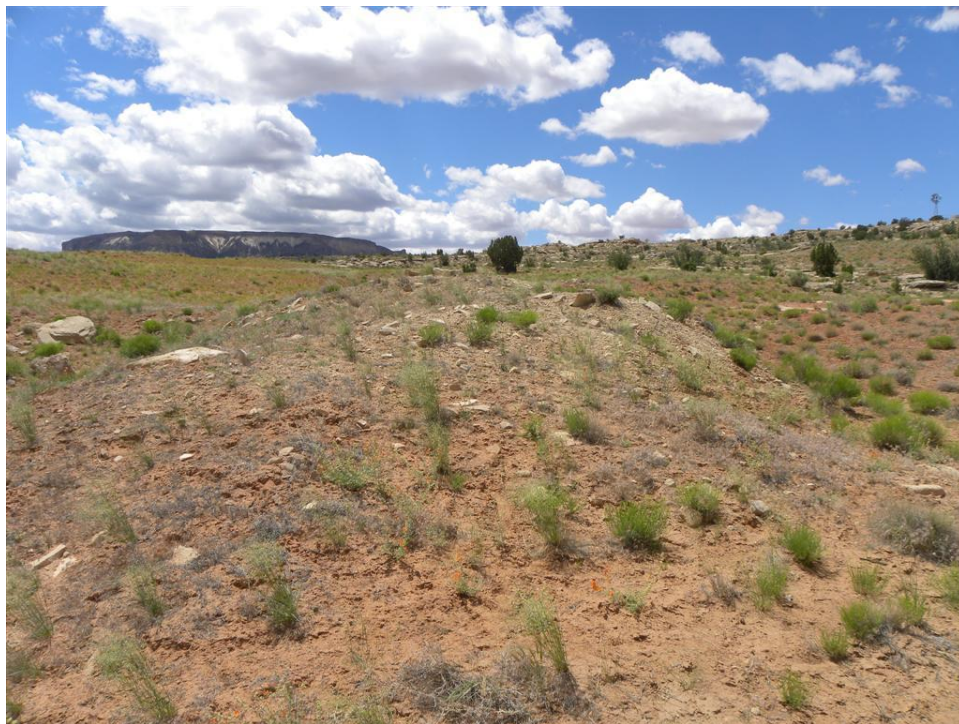
Photo 2. McKenzie 3 site, reclaimed area

3 reclamation caps in center of site, totaling 150' x 150' x 3': SE cap 125' x 50' x 3'; SW cap 25' x 35' x 2'; 2 caps at W boundary: 25' x 15' x 2'; 50' x 20' x 3'

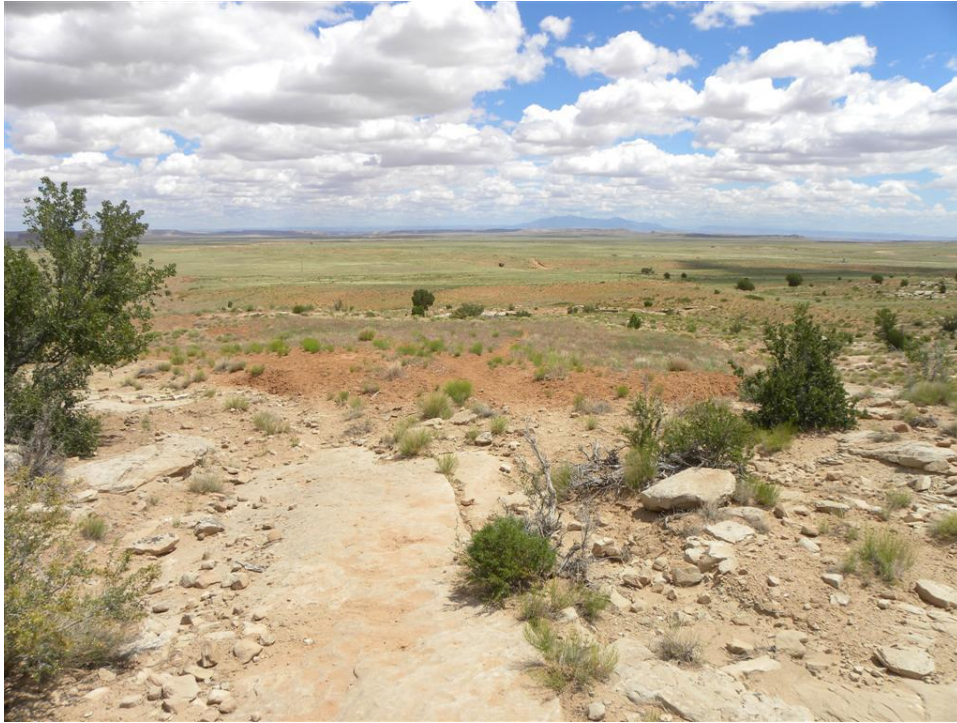
Photo 3. McKenzie 3 site, reclaimed area and unreclaimed waste

Waste pile at NW part of site, 25' x 20' x 6', drainage running adjacent to pile to S

Reclamation caps; unreclaimed waste rock

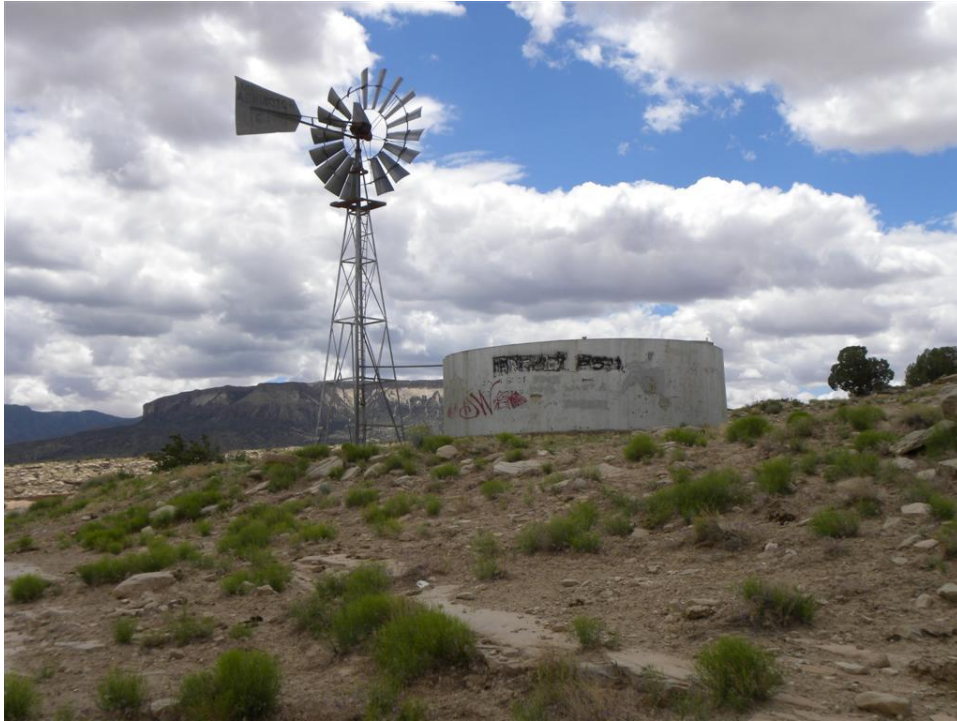
Photo 7. McKenzie 3 site, windmill well S of site

**0 to 0.25 miles:** Windmill well immediately S of site
