# Navajo Abandoned Uranium Mine

## Site Screen Report

## Last Chance AUM Site

**August 2010**

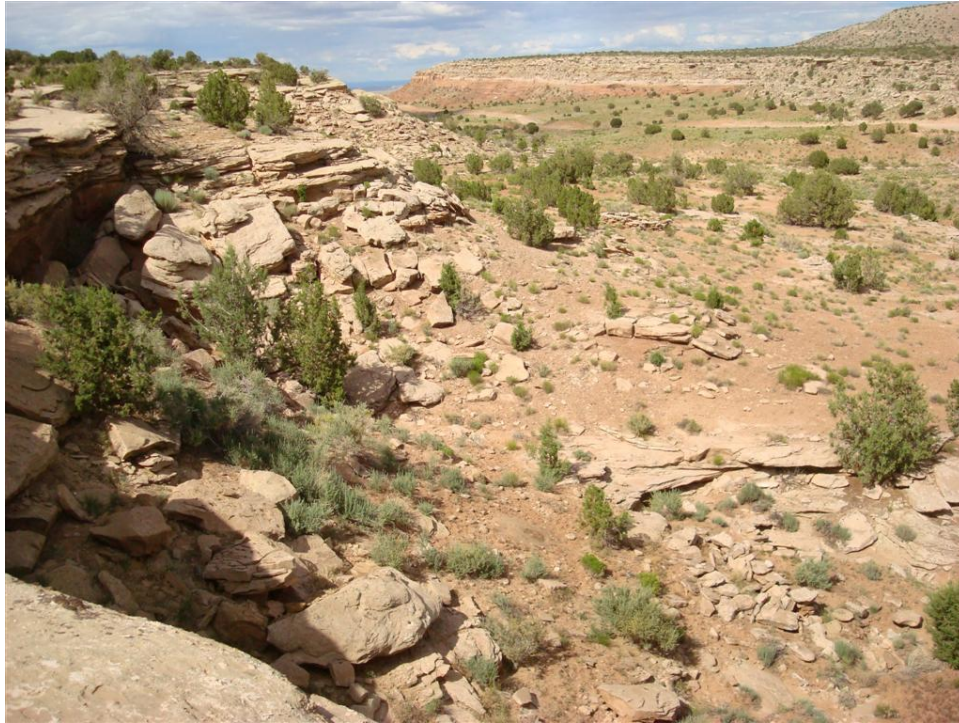
Photo 1. Last Chance site

Waste pile 60ft east of site 25' x 25' x 5'

Unreclaimed waste rock

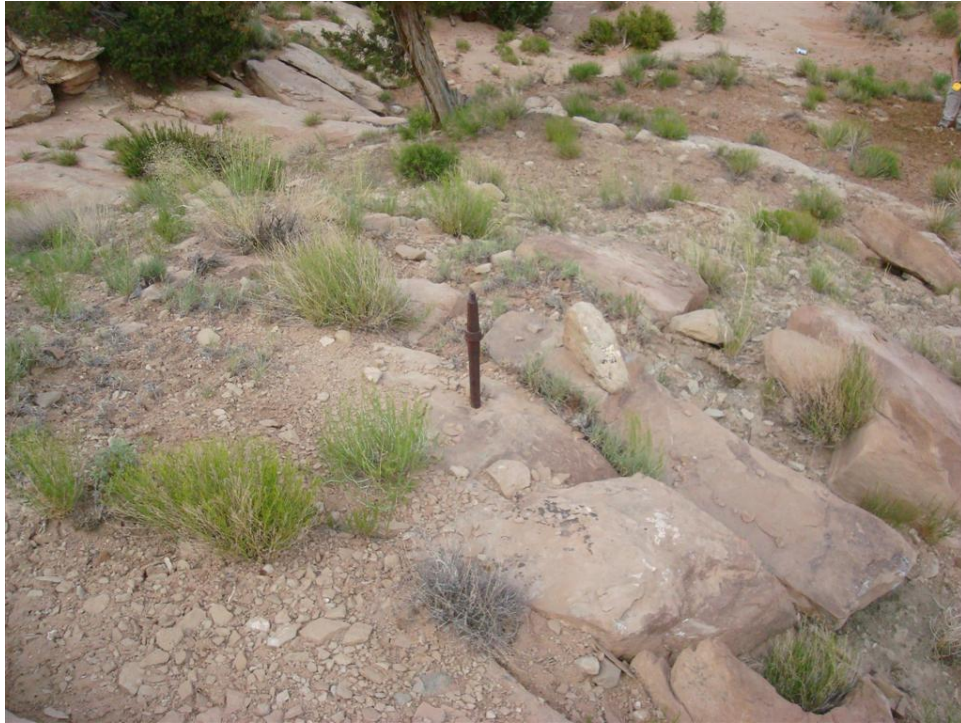
Drill bit in rock

Photo 3. Last Chance site, drill bit
