Navajo Abandoned Uranium Mine

Site Screen Report

Plot 8 AUM Site

Weston Solutions, Inc.

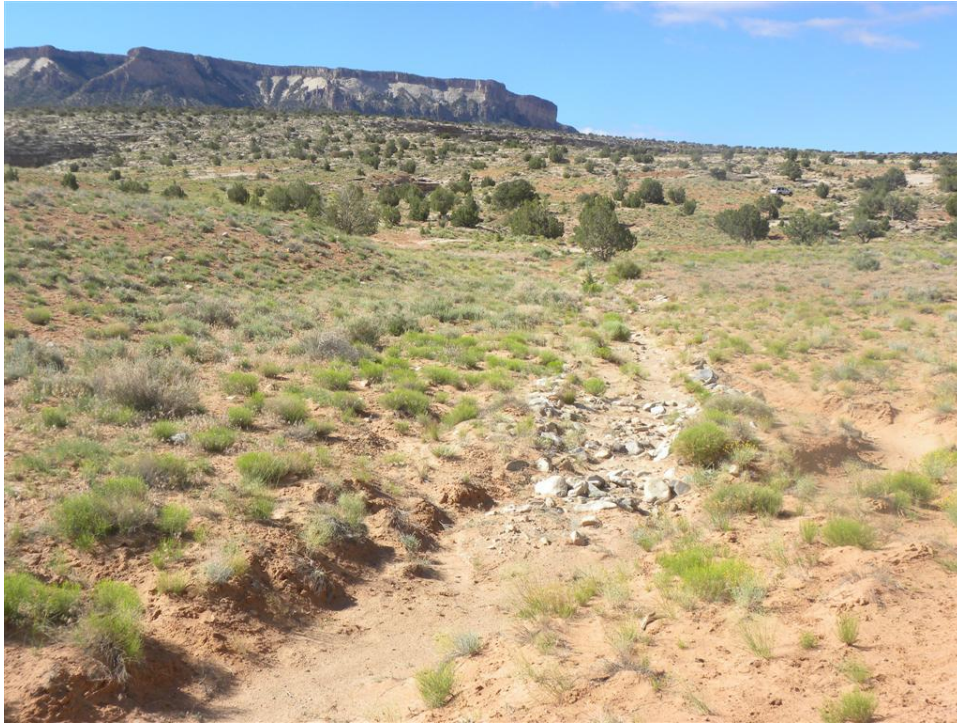
Photo 1. Plot 6 site

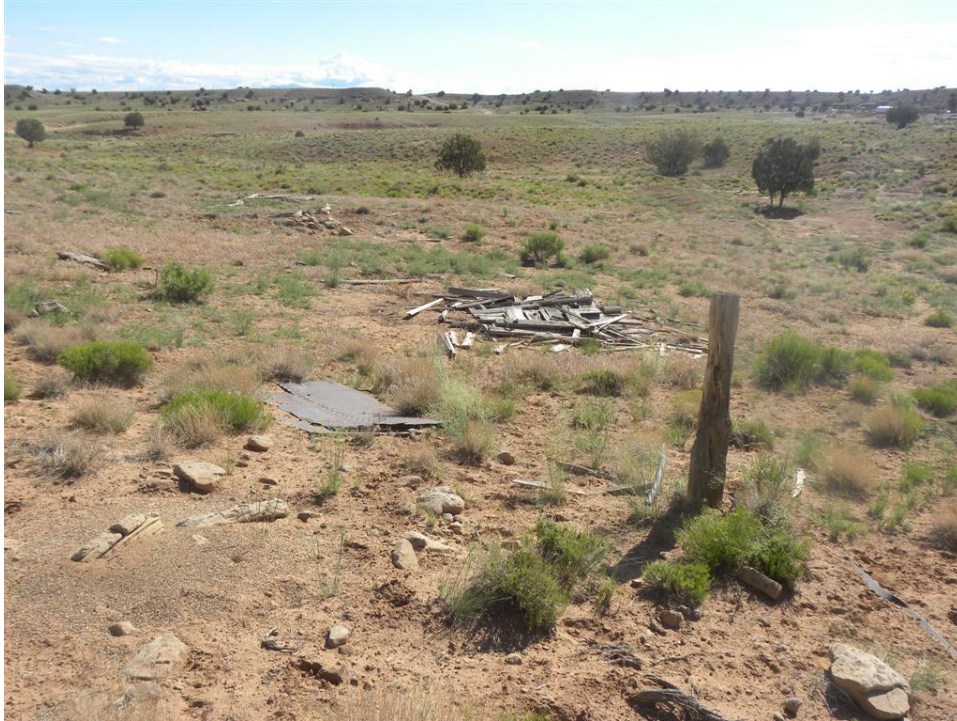
Various wood mining debris throughout site; 2' diameter hole with corrugated metal sleeve, approximately 15' deep; reclamation diversion channel along entire S edge of site

Photo 2. Plot 6 site, mining debris

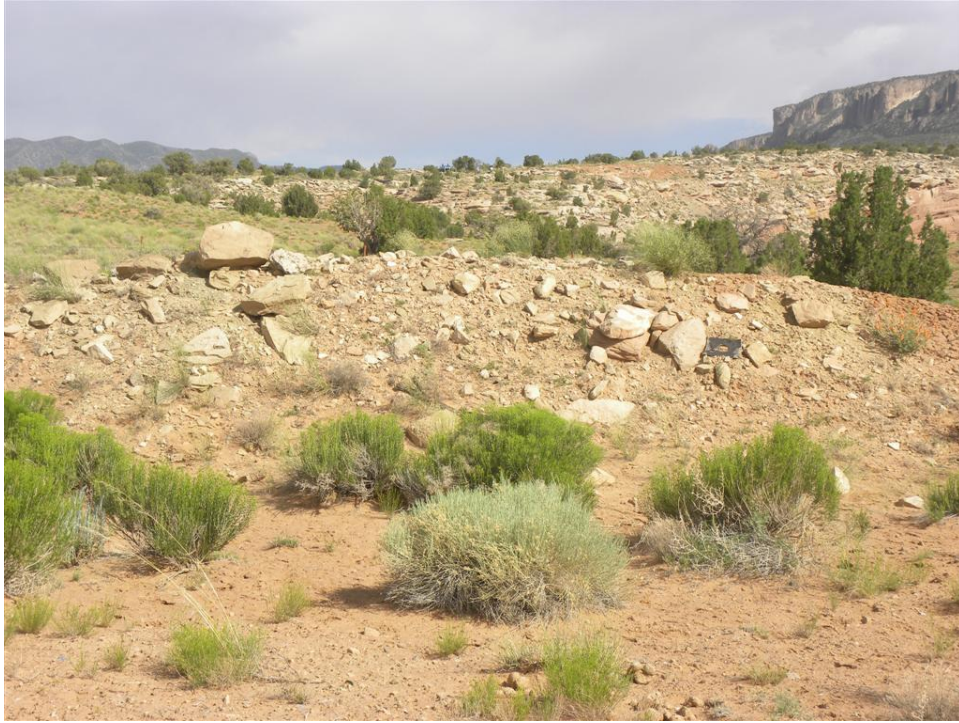
15'x45'x6' waste rock pile with mining debris

Is there an unreclaimed waste pile at the site? Yes

Photo 3. Plot 6 site, waste pile

Sealed adit; reclamation channel; unreclaimed waste

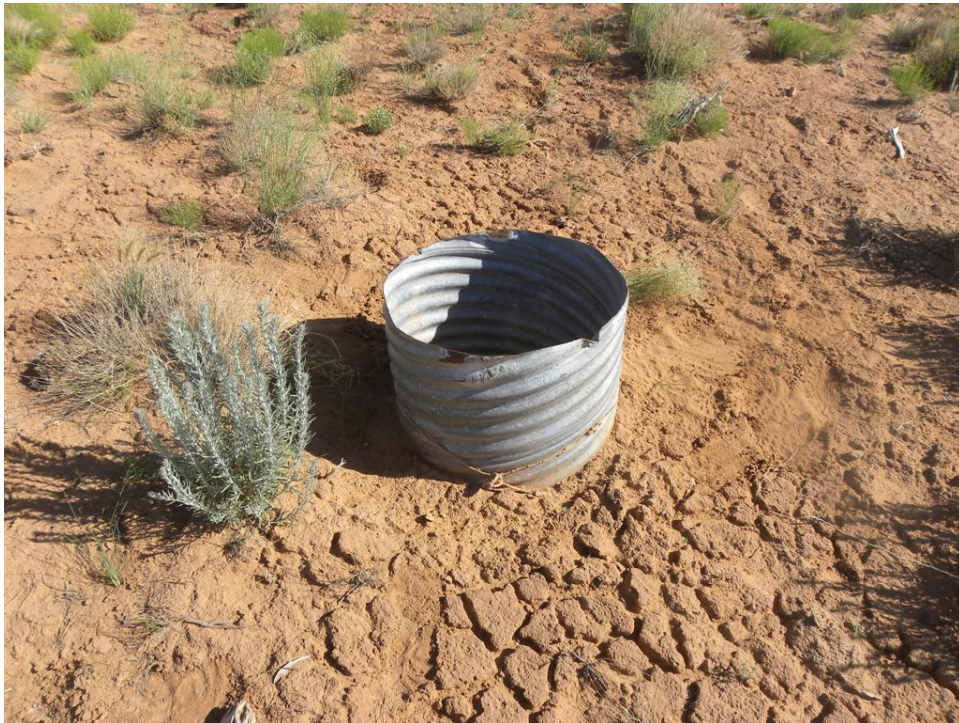
Photo 4. Plot 6 site, lined hole
