# Navajo Abandoned Uranium Mine

## Site Screen Report

### NA-0928 AUM Site

**August 2010**

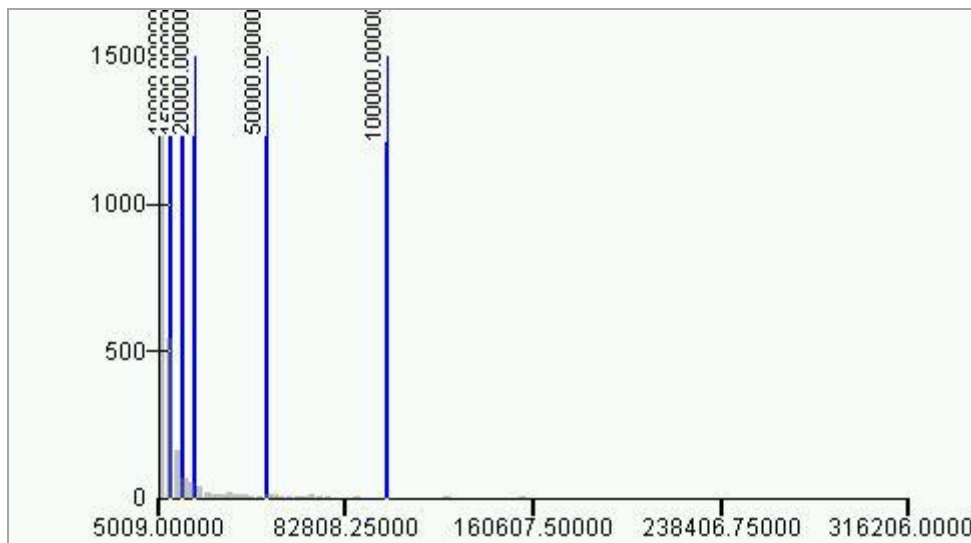
The following chart and statistics were generated by ESRI ArcGIS 9.3.1, and show the general distribution of the site gamma radiation measurements. The horizontal X axis represents the gamma radiation reading levels in cpm (lowest levels to the left). The vertical Y axis represents the frequency of each gamma radiation level.

Count:	2572
Minimum:	5009.00000
Maximum:	316206.00000
Sum:	38906335.00000
Mean:	15126.87986
Median:	7871.00000
Standard Deviation:	26232.91907

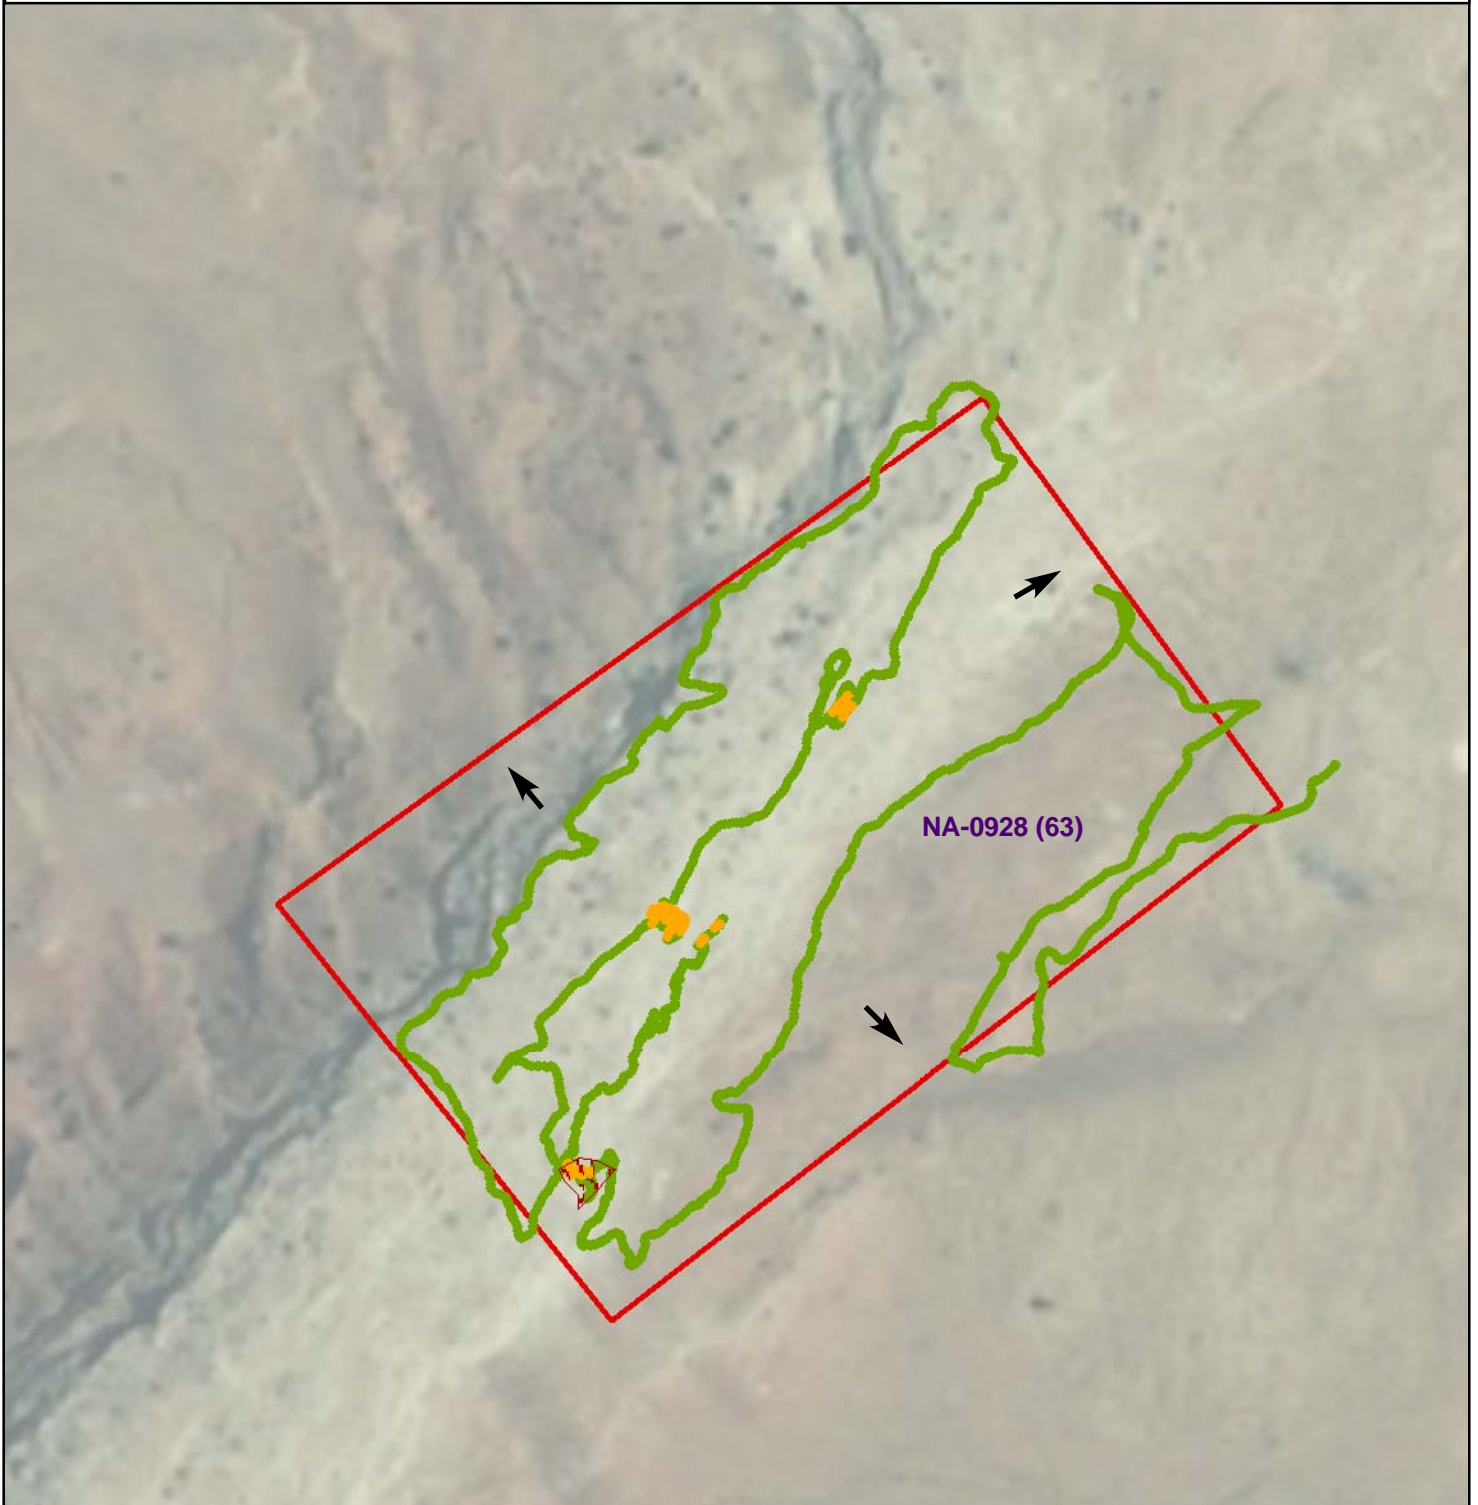
**Figure 1 - Gamma Radiation Measurements, Above Two Times Background  
NA-0928 (63)  
Teec Nos Pos Chapter, Navajo Nation**

A total of 2,572 gamma radiation measurements were collected from the mine site, ranging from 5,009 cpm to 316,206 cpm. Measurements collected in the vicinity of the waste debris were found at levels up to approximately 22,000 cpm in the grey dirt area, 75,000 cpm above the pile, and in one spot on the southeast side down-slope of the mesa at levels up to approximately 300,000 cpm. The measurements are represented in Figures 1 and 2.

Gamma survey conducted 06/2010  
Measured as counts per minute (cpm)

Average background = 8,688 cpm

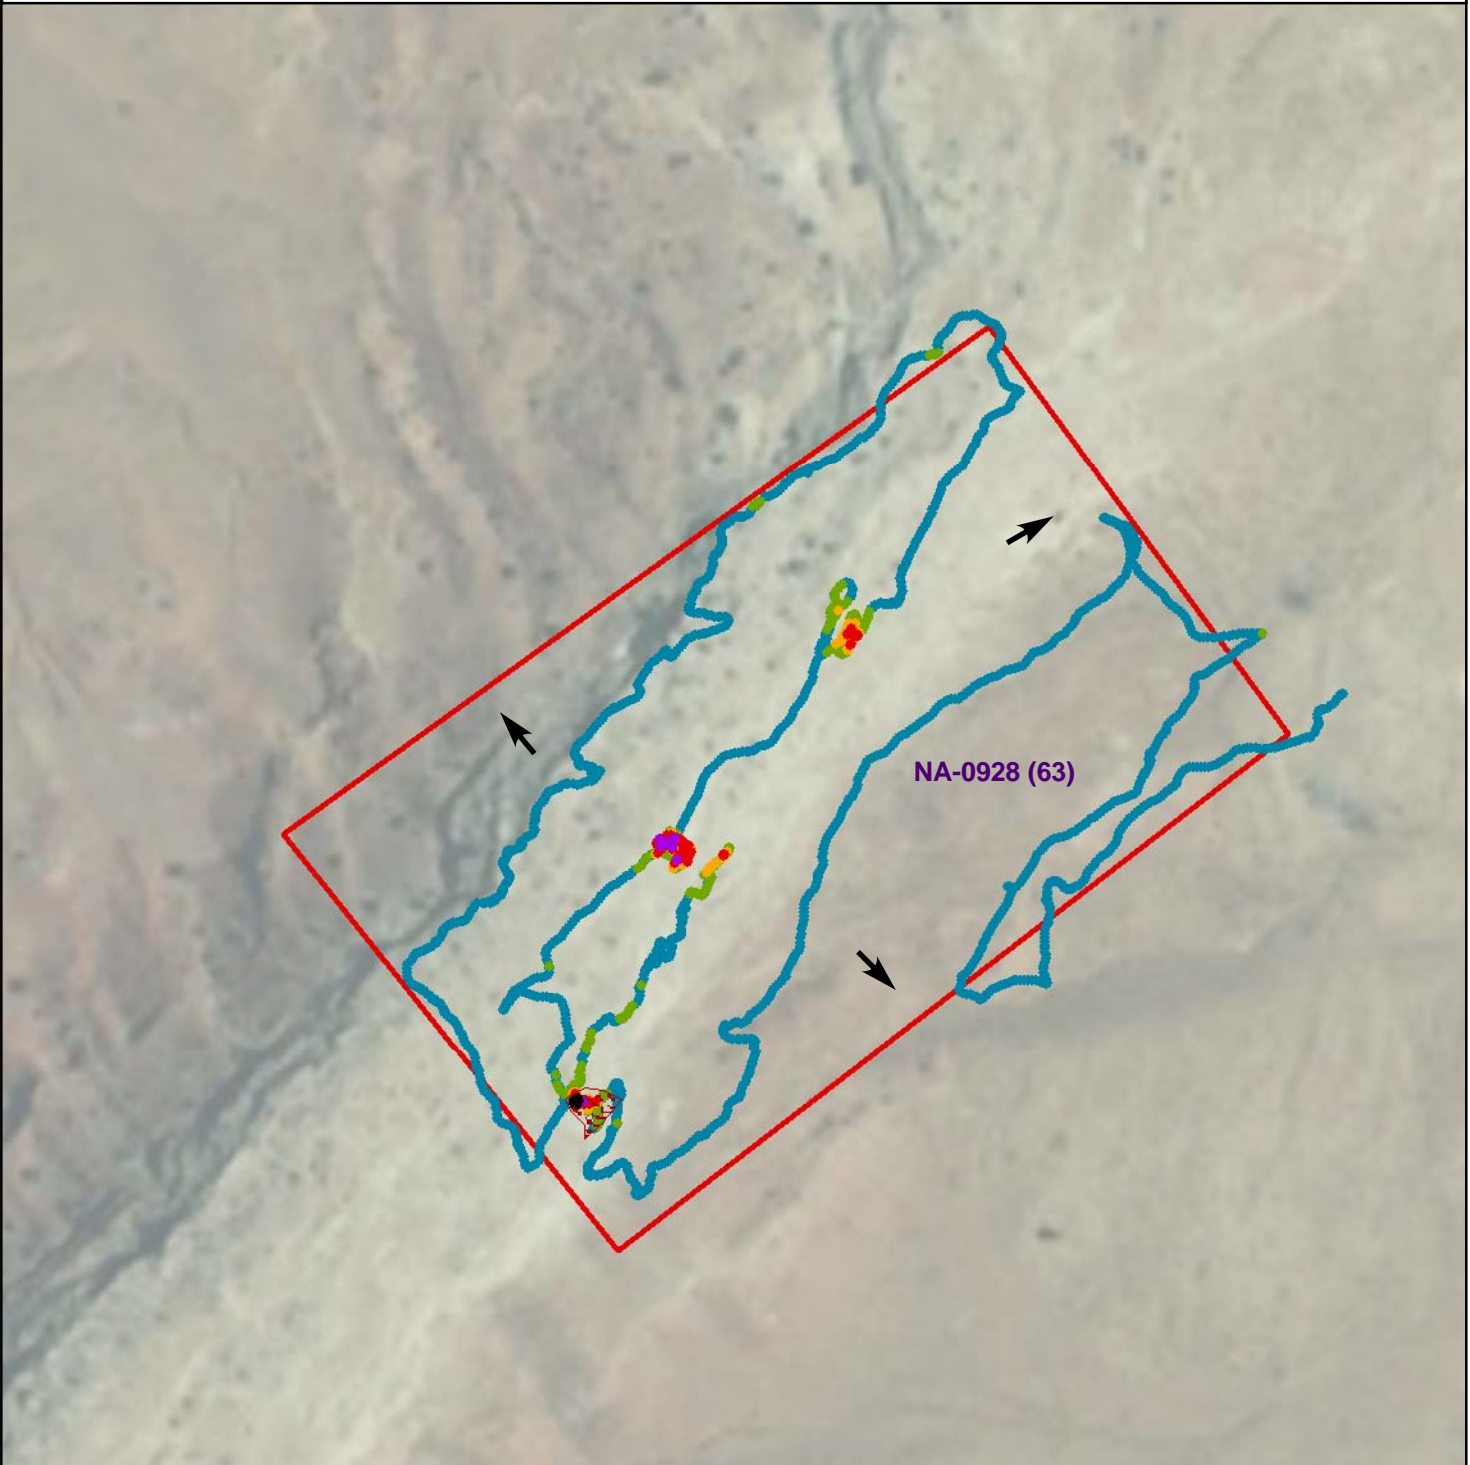
**Figure 2 - Gamma Radiation Measurements  
NA-0928 (63)  
Teec Nos Pos Chapter, Navajo Nation**

**Gamma survey conducted 06/2010  
Measured as counts per minute (cpm)**

**Average background 8,688 cpm**
