Navajo Abandoned Uranium Mine

Site Screen Report

NA-0410 AUM Site

March 2010

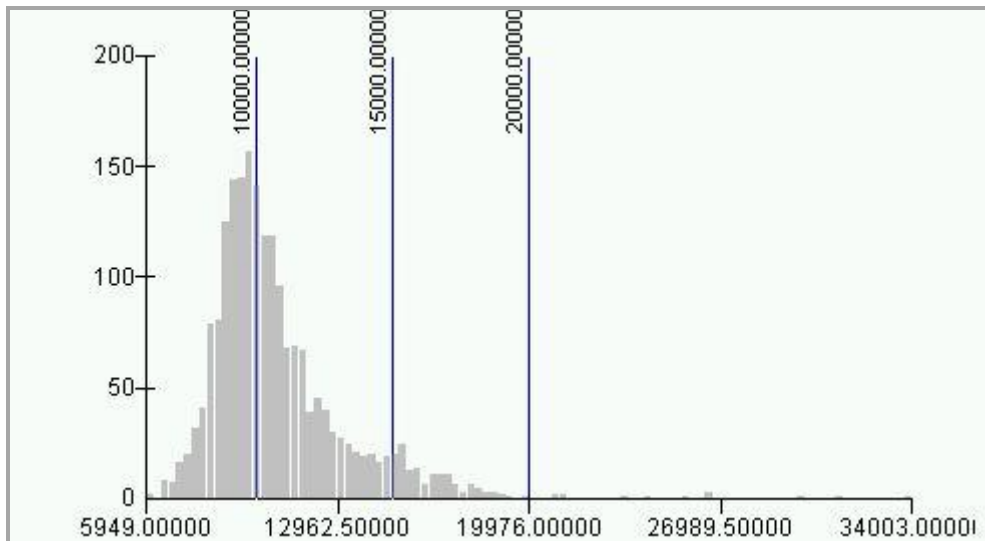
The following chart and statistics were generated by ESRI ArcGIS 9.3.1, and show the general distribution of the site gamma radiation measurements. The horizontal X axis represents the gamma radiation reading levels in cpm (lowest levels to the left). The vertical Y axis represents the frequency of each gamma radiation level.

Count:	1984
Minimum:	5949.00000
Maximum:	34003.00000
Sum:	21421146.00000
Mean:	10796.94859
Median:	10151.00000
Standard Deviation:	2555.12836

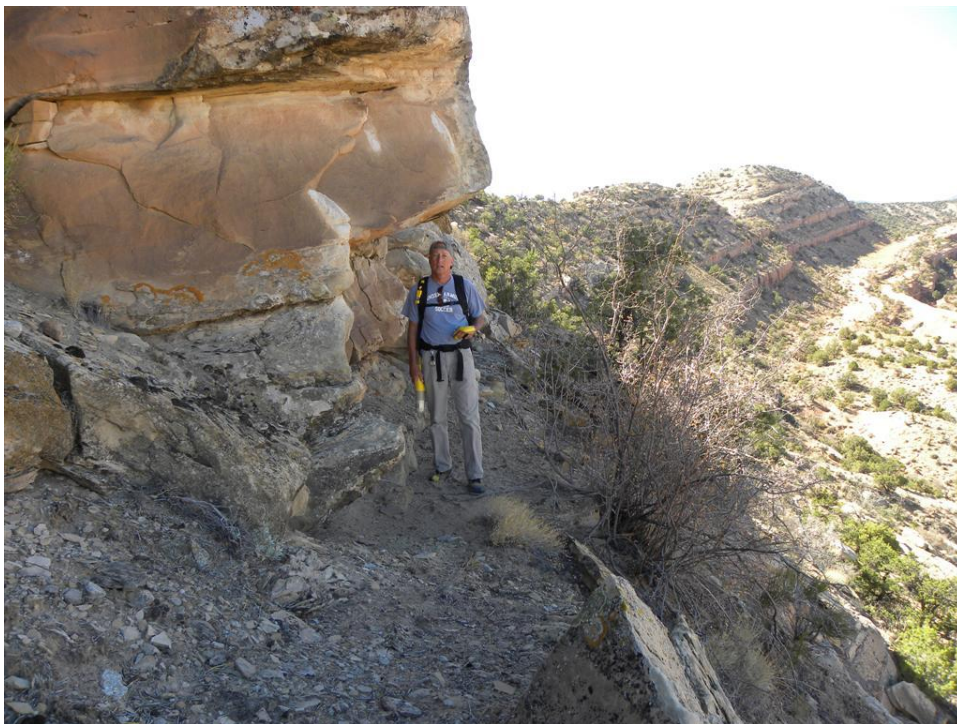
Photo 4. Mine site cliff overhang
