Navajo Abandoned Uranium Mine

Site Screen Report

Leroy AUM Site

March 2010

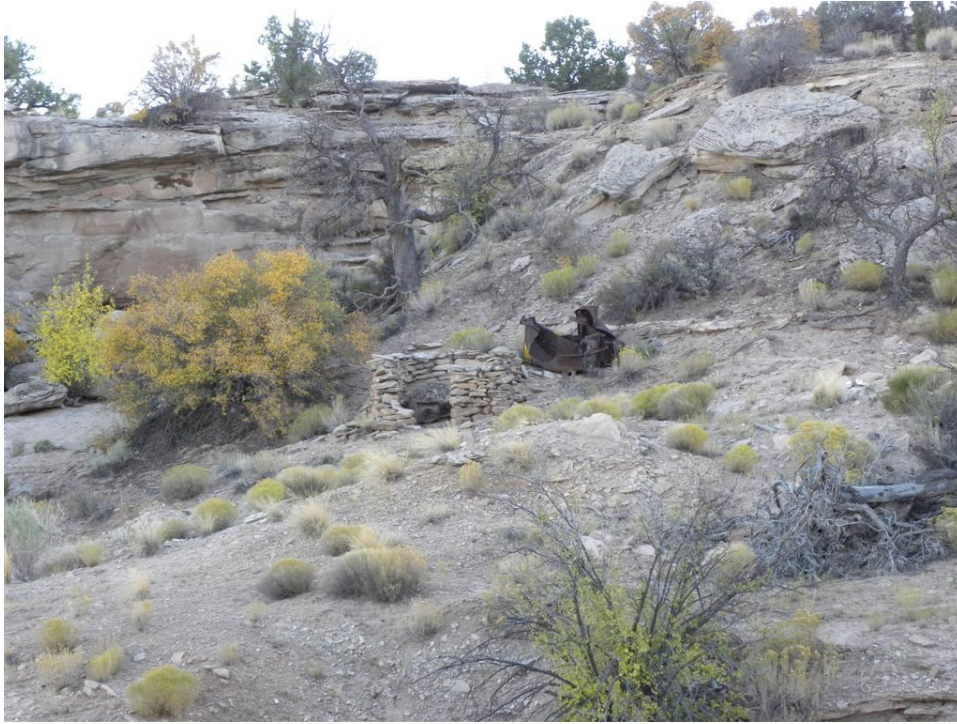
Some stacked rocks and metal debris

Photo 5. Stacked rock and metal debris

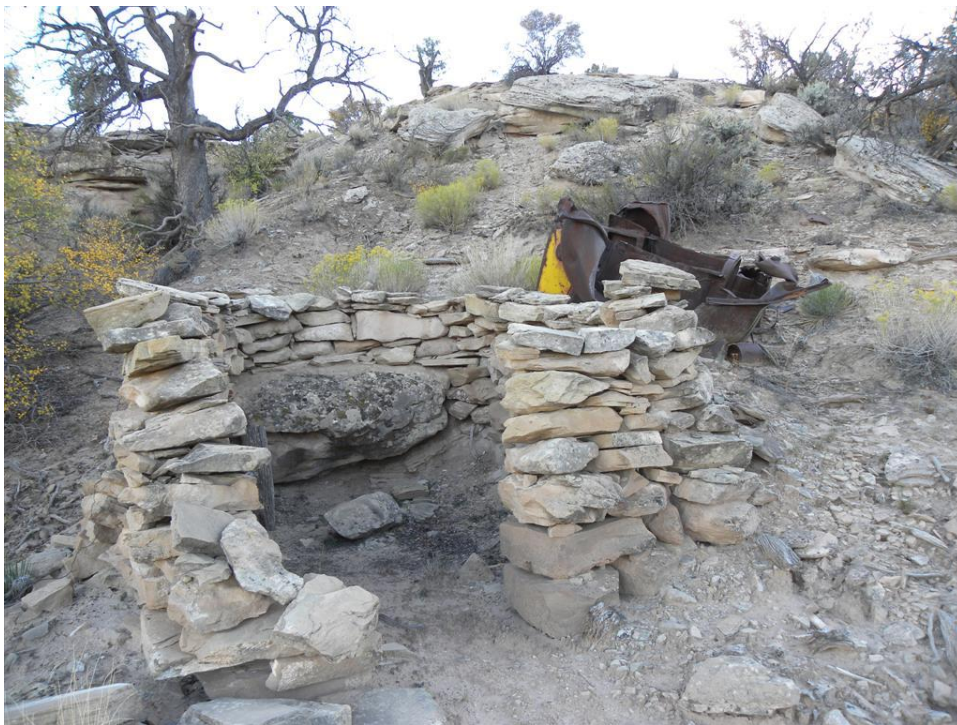
Photo 6. Stacked rock and metal debris
