Navajo Abandoned Uranium Mine

Site Screen Report

Plot 3 AUM Site

Weston Solutions, Inc.

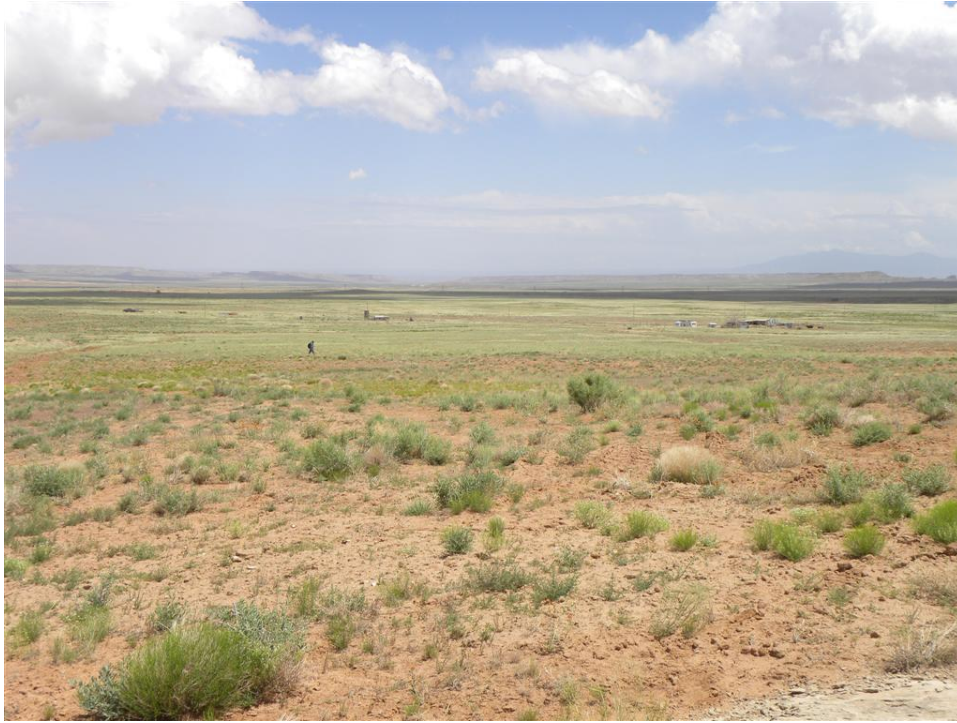
Photo 1. Plot 3 site

Fill material at S boundary continuing down slope along rock edge to the NW; basin & potential burrow area
