# **Navajo Abandoned Uranium Mine**

## **Site Screen Report**

## **Climax Transfer Station AUM Site**

**August 2010**

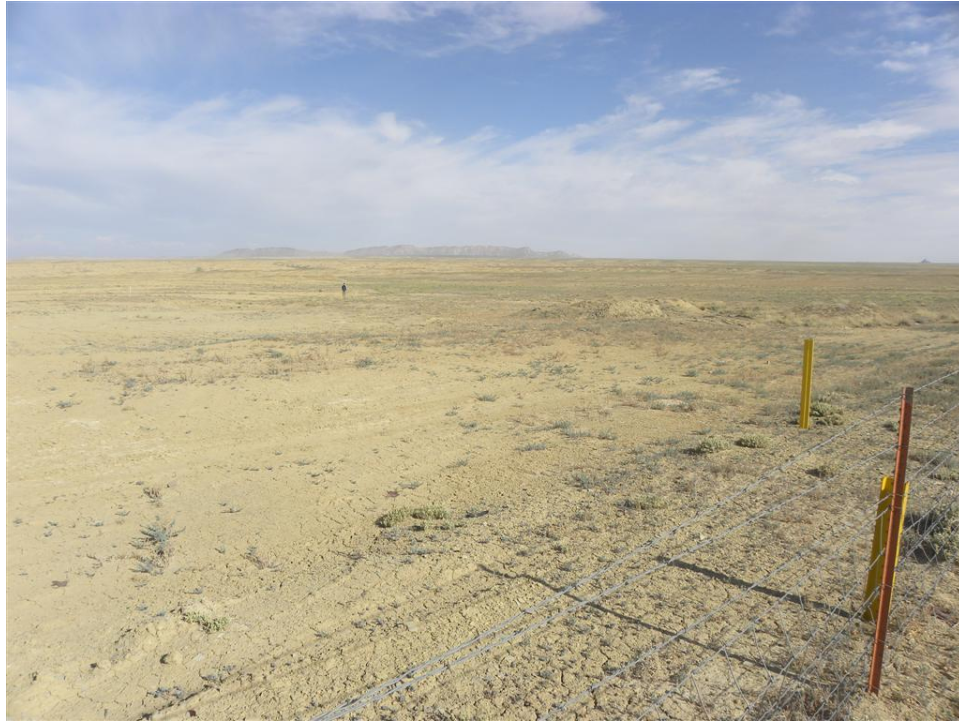
Photo 1. Climax Transfer Station site

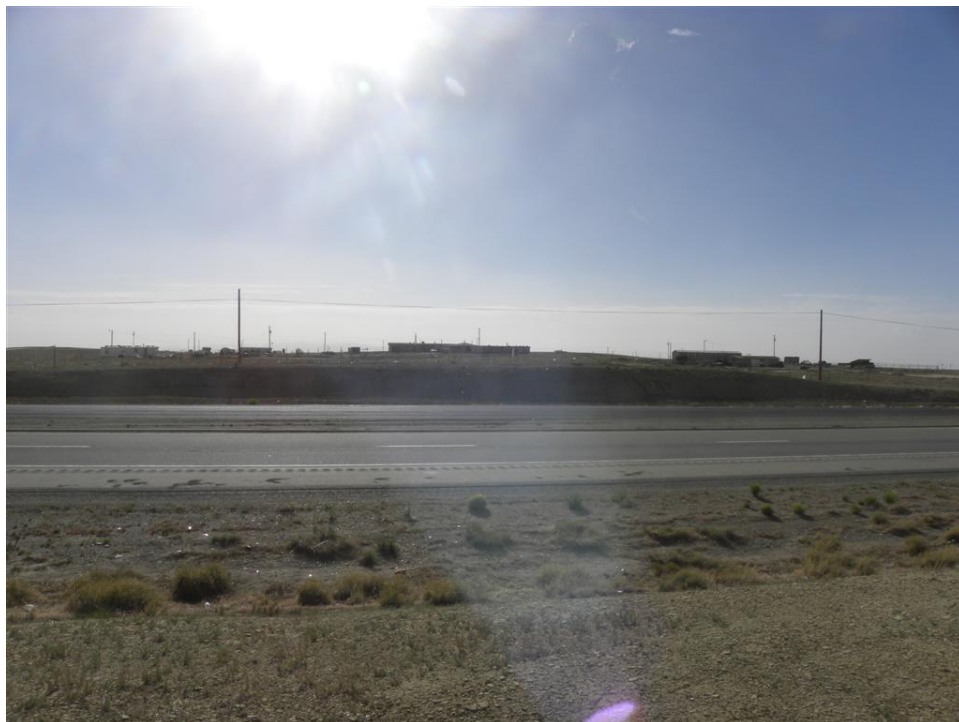
Photo 2. Housing compound across Hwy 491, W of site

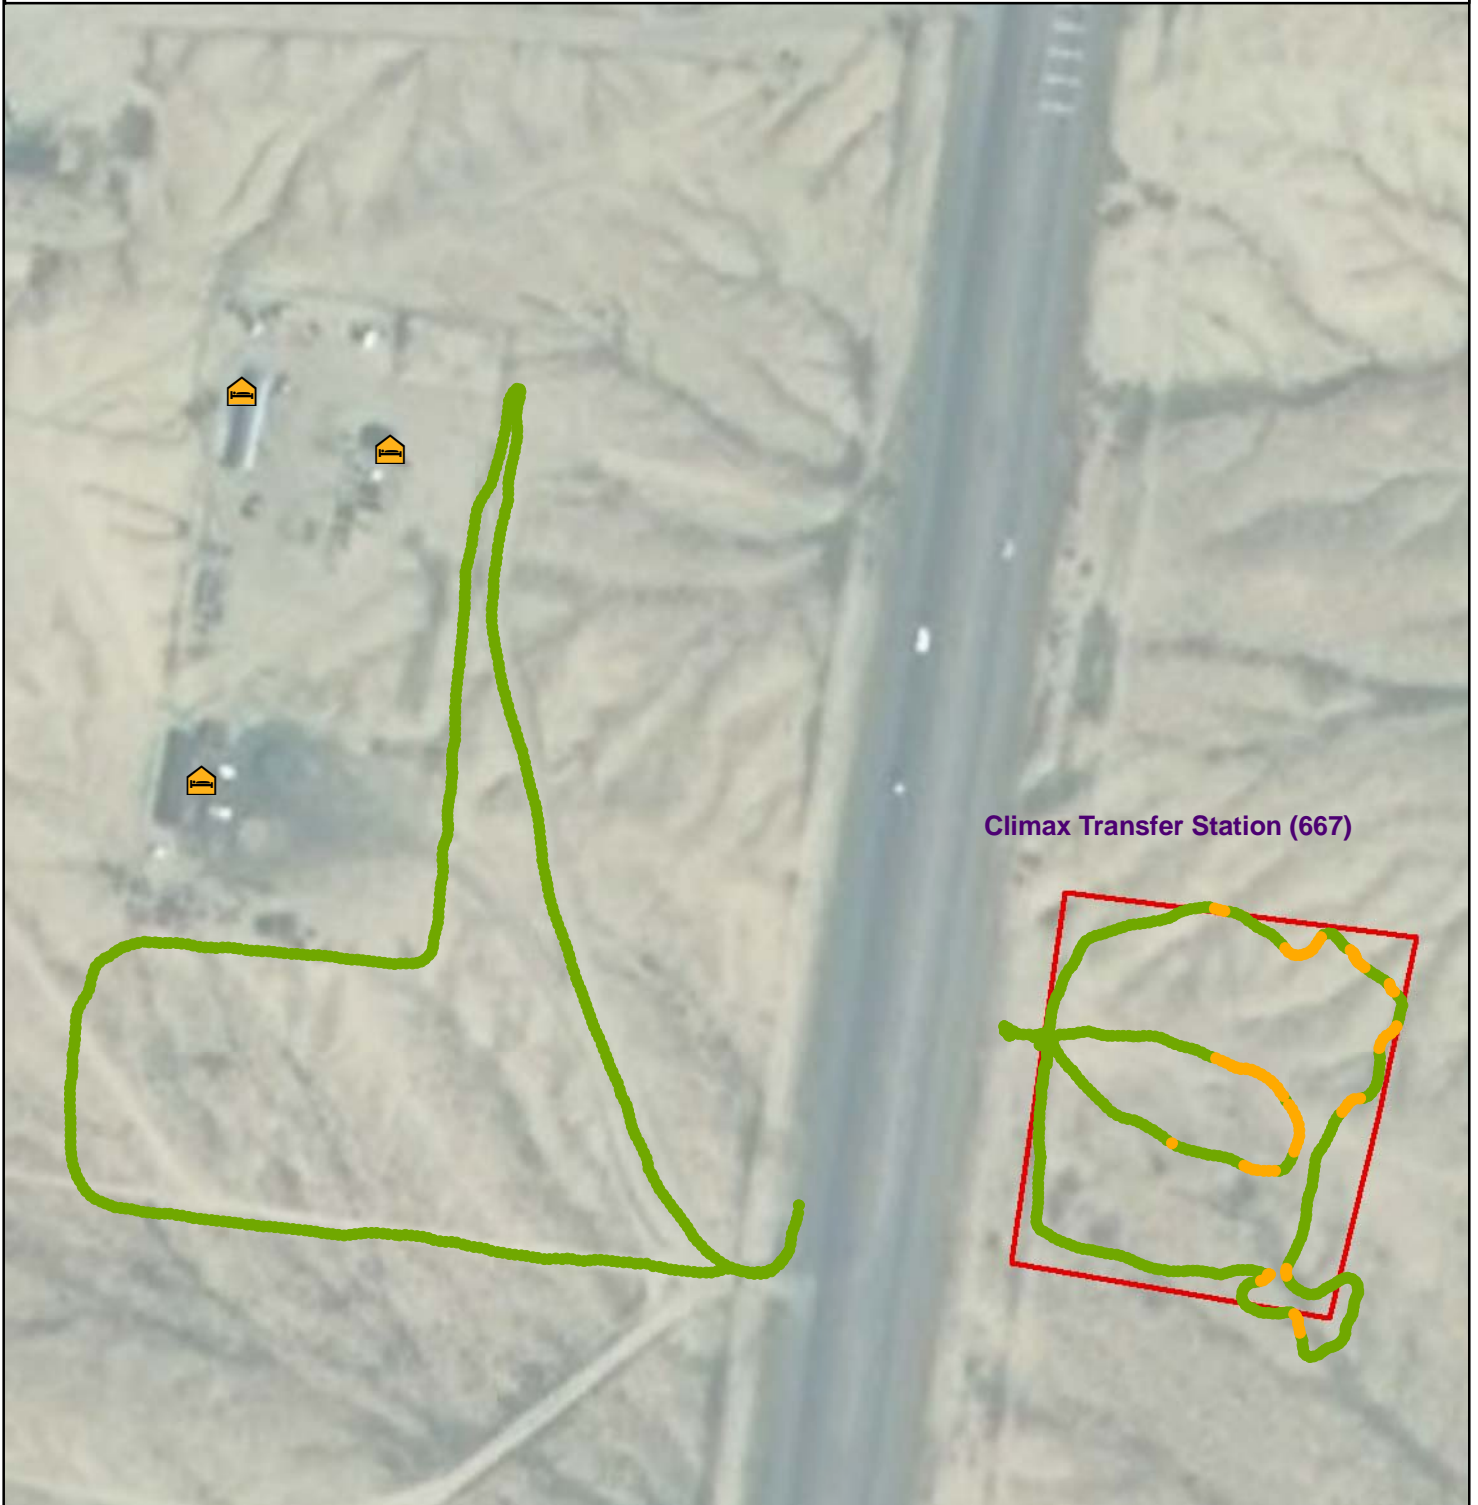
**Figure 1 - Gamma Radiation Measurements, Above Two Times Background  
Climax Transfer Station (667)  
Shiprock Chapter, Navajo Nation**

Gamma survey conducted 06/2010  
Measured as counts per minute (cpm)

Average background = 10,278 cpm

A total of 611 gamma radiation measurements were collected from the mine site, ranging from 10,470 cpm to 29,170 cpm. Measurements collected from some low-lying areas were found at levels up to approximately 30,000 cpm. The measurements are represented in Figures 1 and 2.

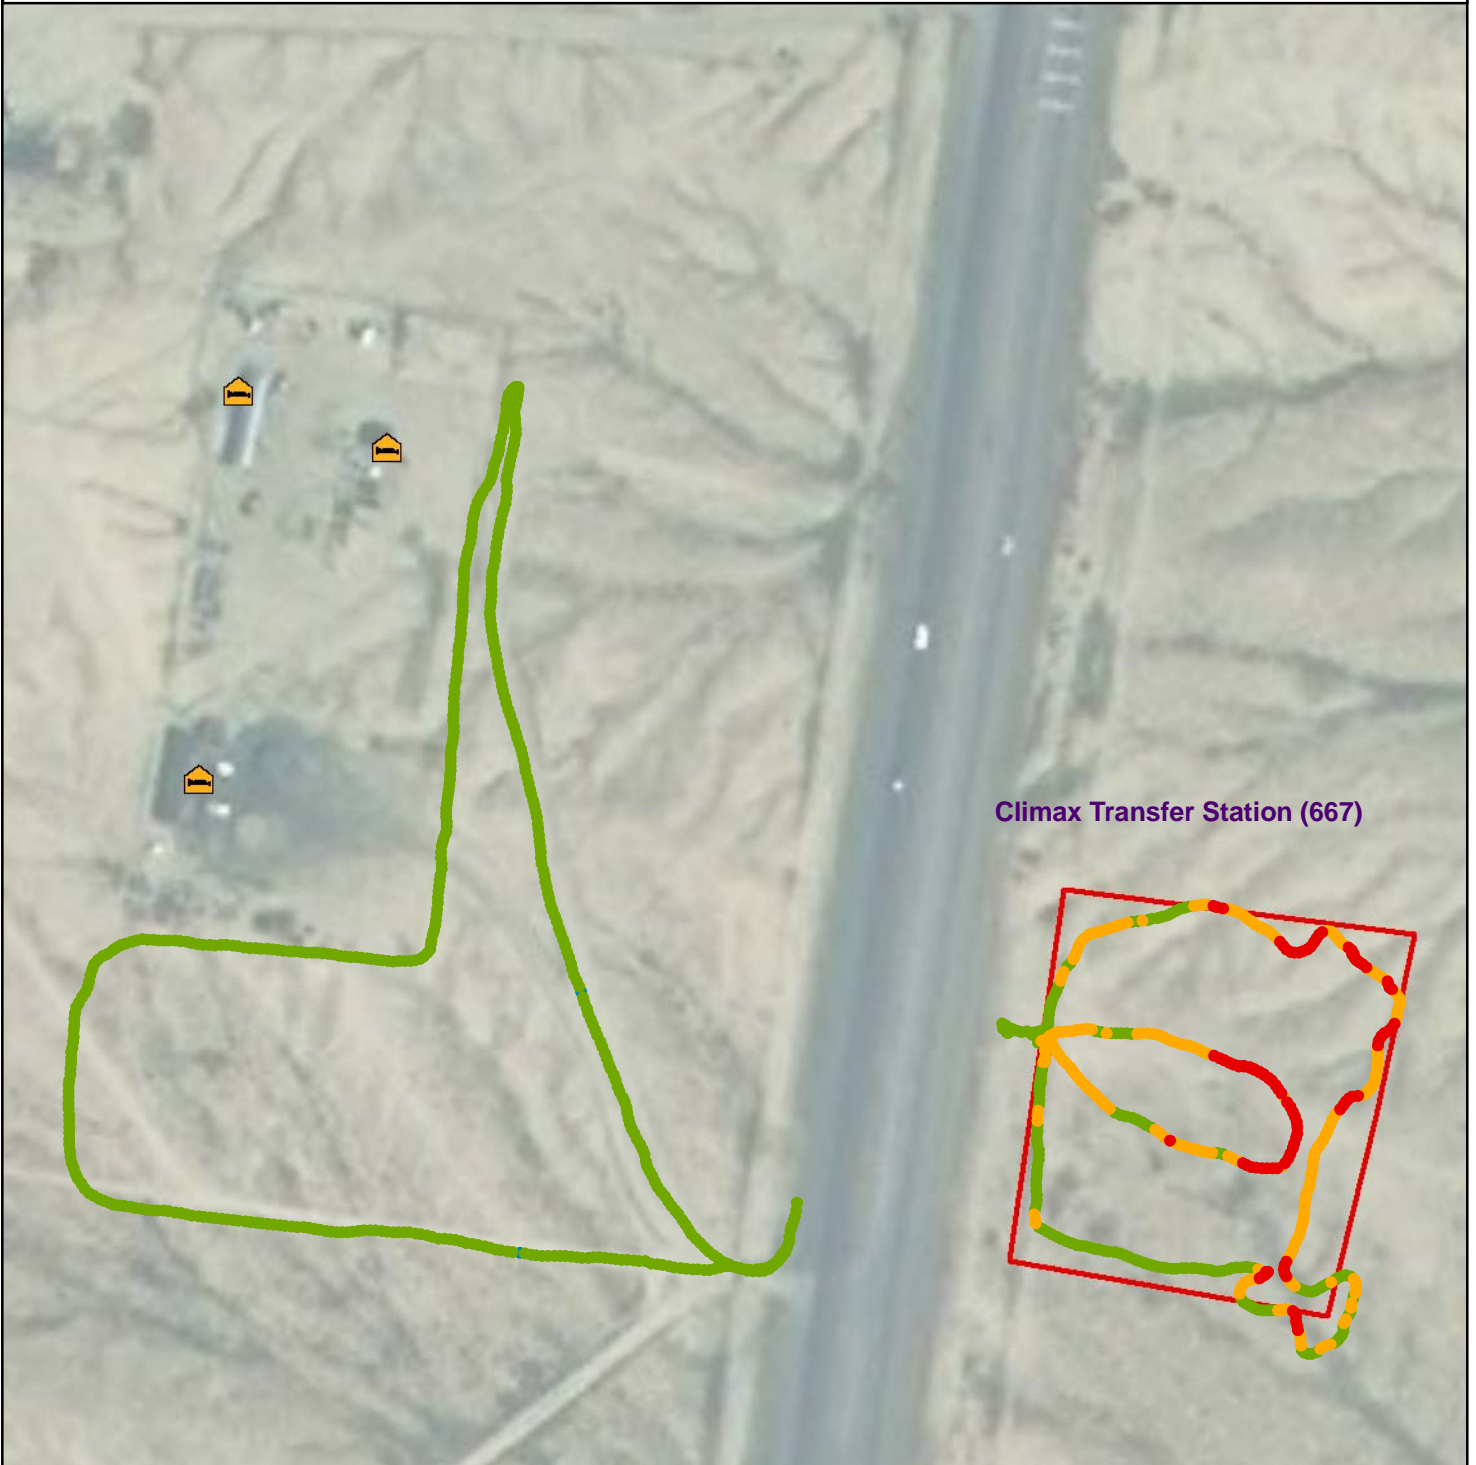
**Figure 2 - Gamma Radiation Measurements  
Climax Transfer Station (667)  
Shiprock Chapter, Navajo Nation**

Gamma survey conducted 06/2010  
Measured as counts per minute (cpm)

Average background 10,278 cpm
