# Navajo Abandoned Uranium Mine

## Site Screen Report

### **NA-0924 AUM Site**

**August 2010**

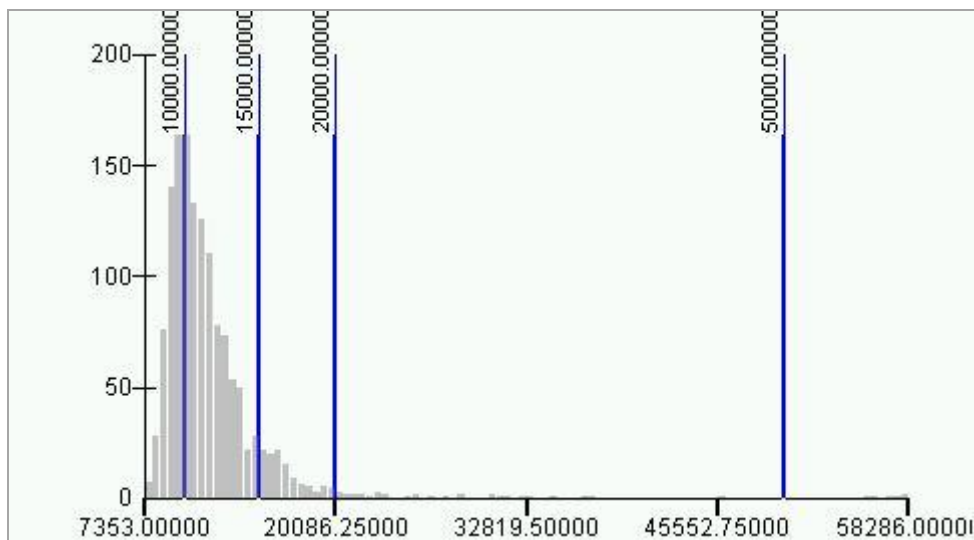
The following chart and statistics were generated by ESRI ArcGIS 9.3.1, and show the general distribution of the site gamma radiation measurements. The horizontal X axis represents the gamma radiation reading levels in cpm (lowest levels to the left). The vertical Y axis represents the frequency of each gamma radiation level.

Count:	1405
Minimum:	7353.00000
Maximum:	58286.00000
Sum:	16658264.00000
Mean:	11856.41566
Median:	10848.00000
Standard Deviation:	4447.94475

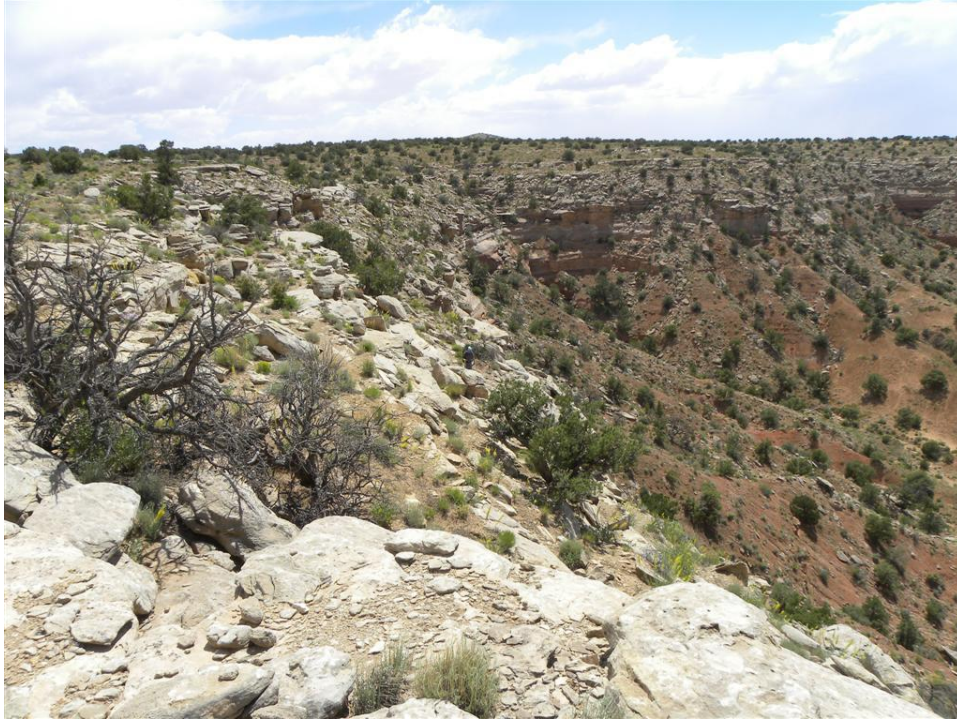
Photo 1. NA-0924 site

NA-0924 mine consists of an area of 16,902.44 m<sup>2</sup>. The mine was not identified as ever being operational. No other historical information or any additional ownership / lease information was identified in the EPA/AUM database.

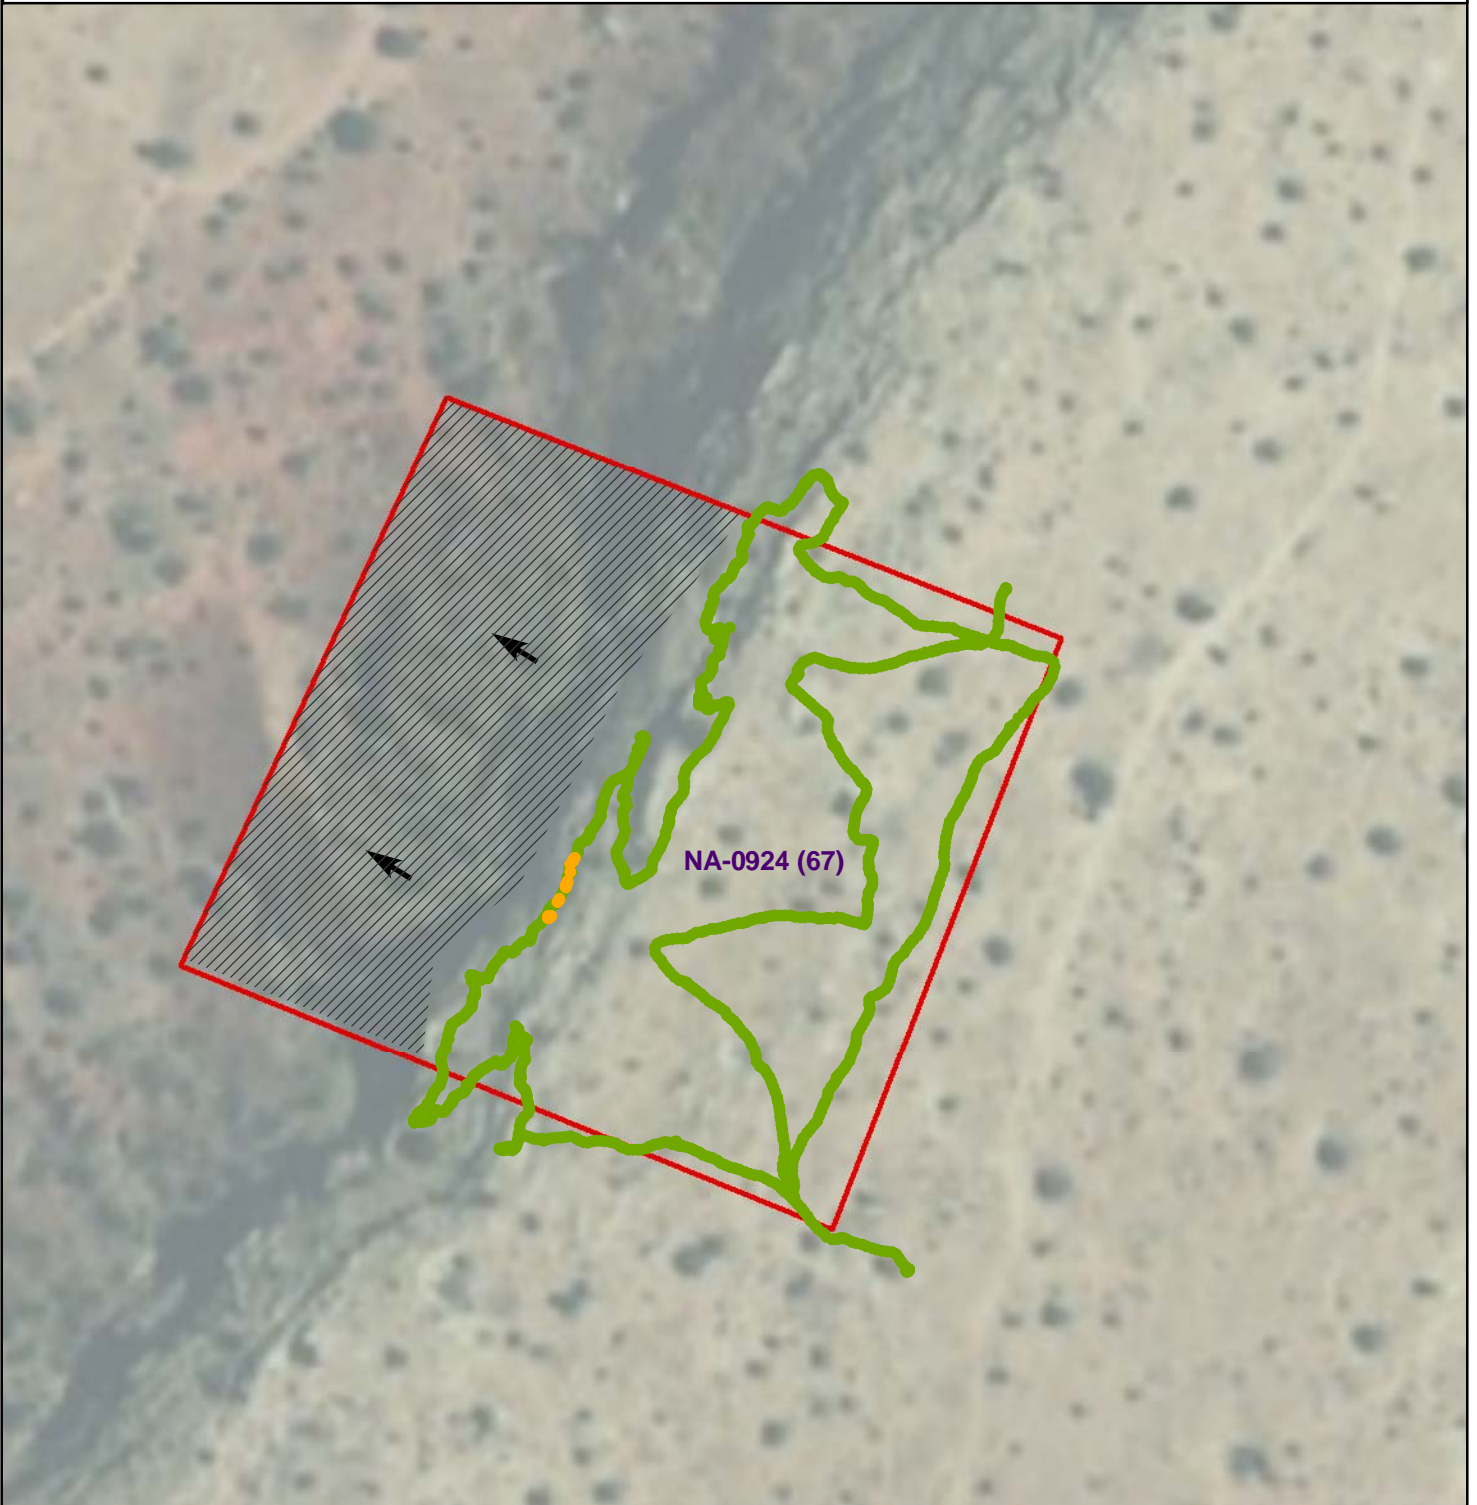
**Figure 1 - Gamma Radiation Measurements, Above Two Times Background  
 NA-0924 (67)  
 Sweetwater / Teec Nos Pos Chapter, Navajo Nation**

A total of 1,405 gamma radiation measurements were collected from the mine site, ranging from 7,353 cpm to 58,286 cpm. The measurements are represented in Figures 1 and 2.

**Gamma survey conducted 06/2010  
 Measured as counts per minute (cpm)**

**Average background = 10,130 cpm**

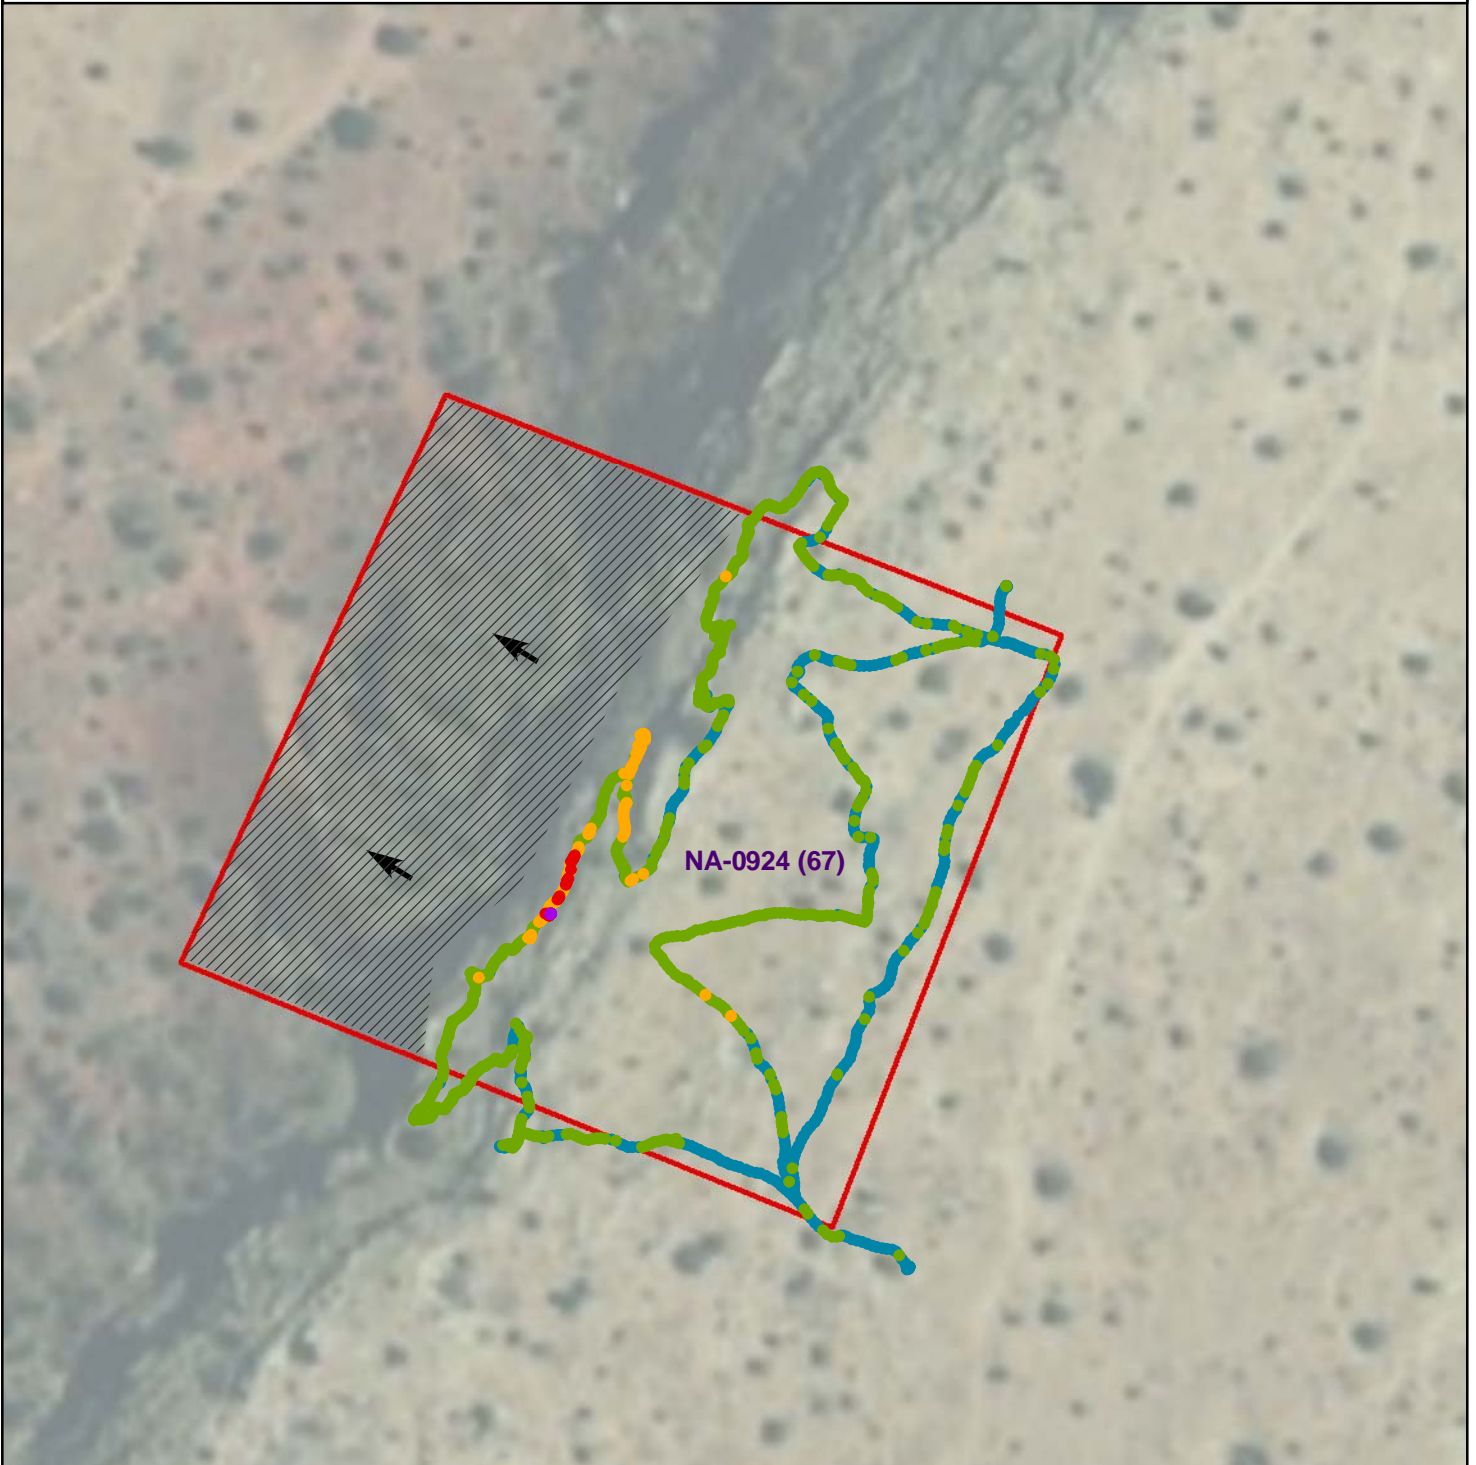
**Figure 2 - Gamma Radiation Measurements  
NA-0924 (67)  
Sweetwater / Teec Nos Pos Chapter, Navajo Nation**

**Gamma survey conducted 06/2010  
Measured as counts per minute (cpm)**

**Average background 10,130 cpm**
