# Navajo Abandoned Uranium Mine

## Site Screen Report

**Mine Name: Starlight**  
**Mine ID: 701**

**April 2012**

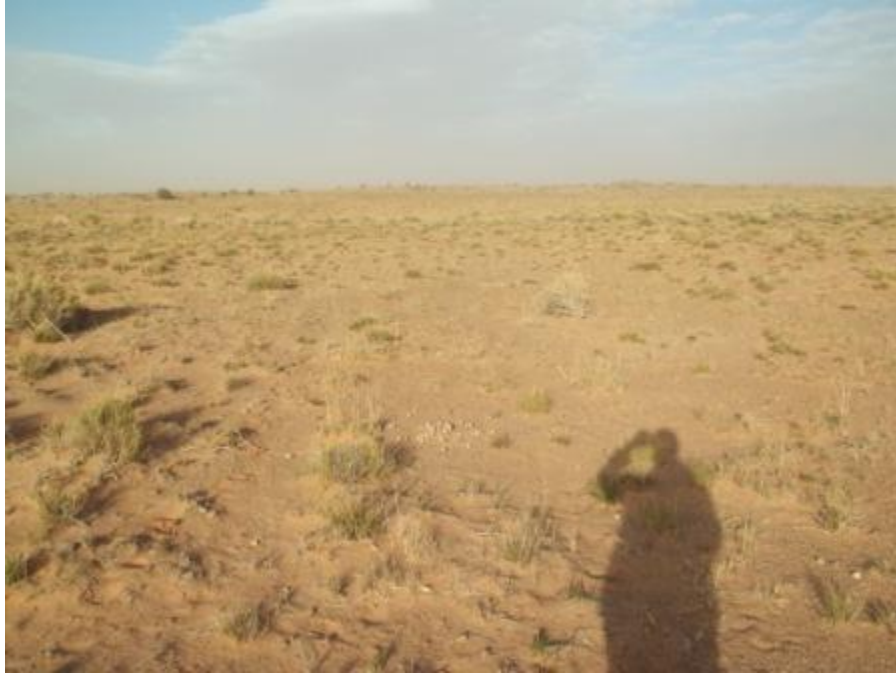
**Photo 1**

Mine Site #701

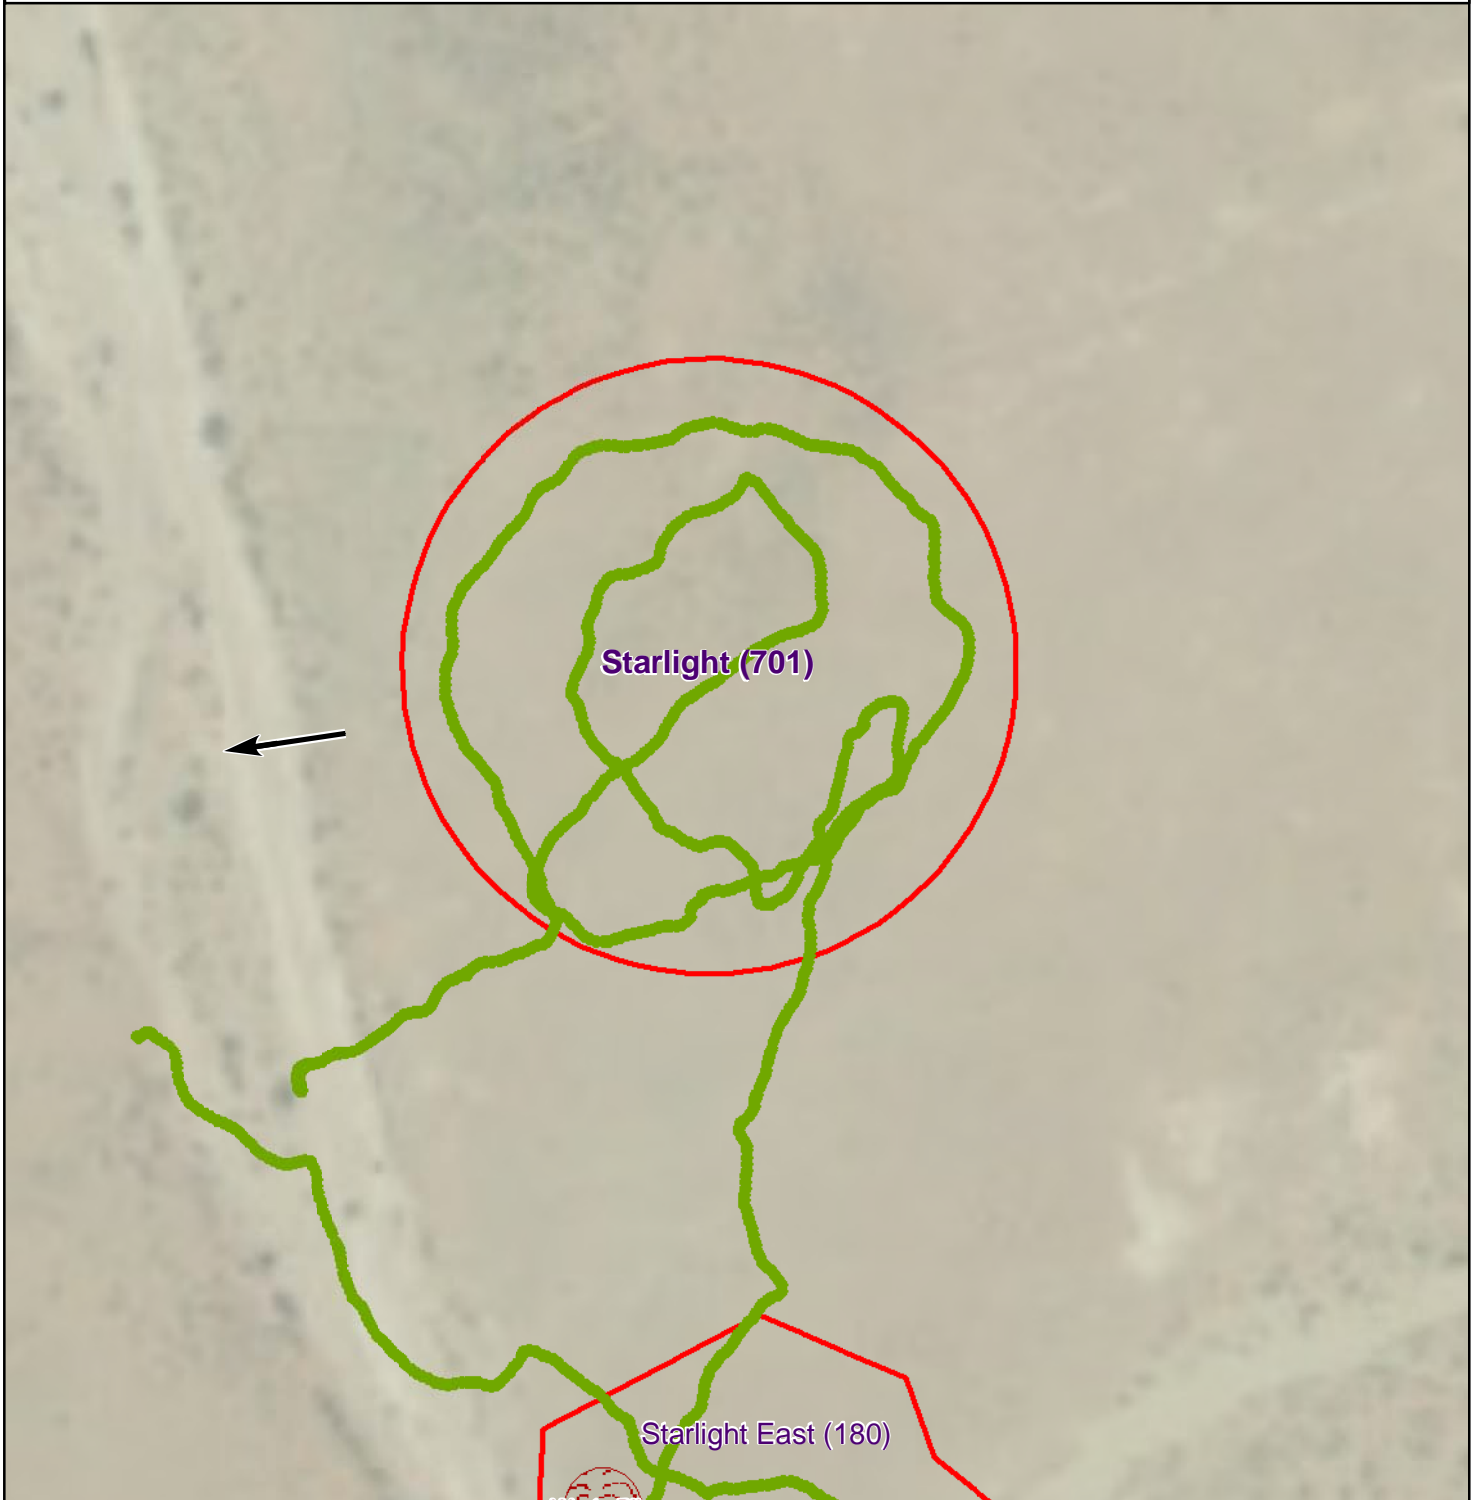
**Figure 1 - Gamma Radiation Measurements, Above Two Times Background  
Starlight (701)  
Oljato Chapter, Navajo Nation**

A total of 823 gamma radiation measurements were collected from the mine site, ranging from 5,669 cpm to 12,672 cpm. The measurements are represented in Figures 1 and 2.

Measured as counts per minute (cpm)

Average background 6,522 cpm

**Were any gamma radiation measurements collected at the mine greater than two times the site-specific background levels?**

No
