Navajo Abandoned Uranium Mine

Site Screen Report

Mine Name: Mitten No. 2
Mine ID: 704

April 2012

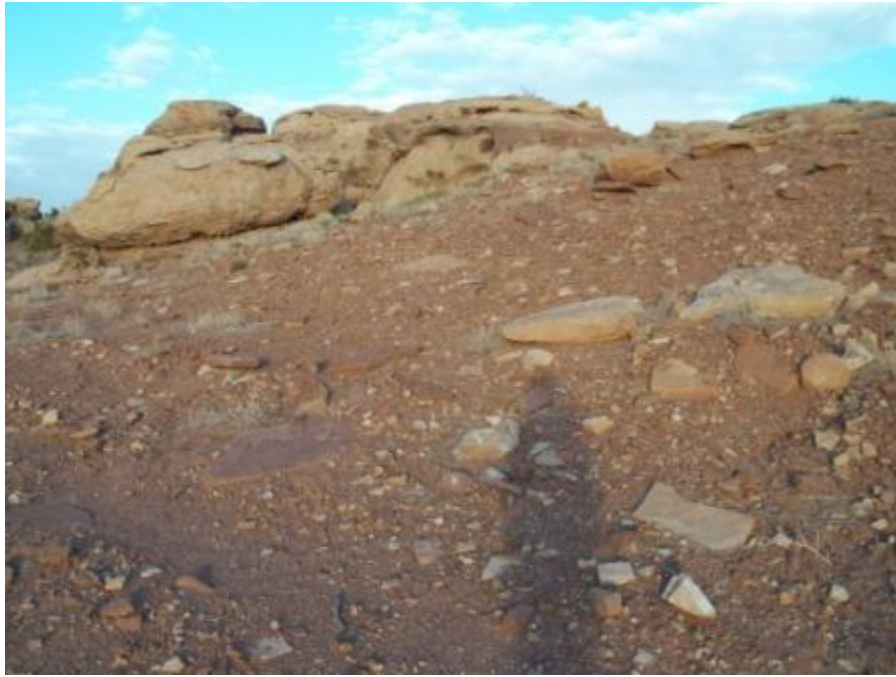
Photo 1

Capped and bermed area shared with site #247; dump area 50 ft north of the site

Mine Site #704

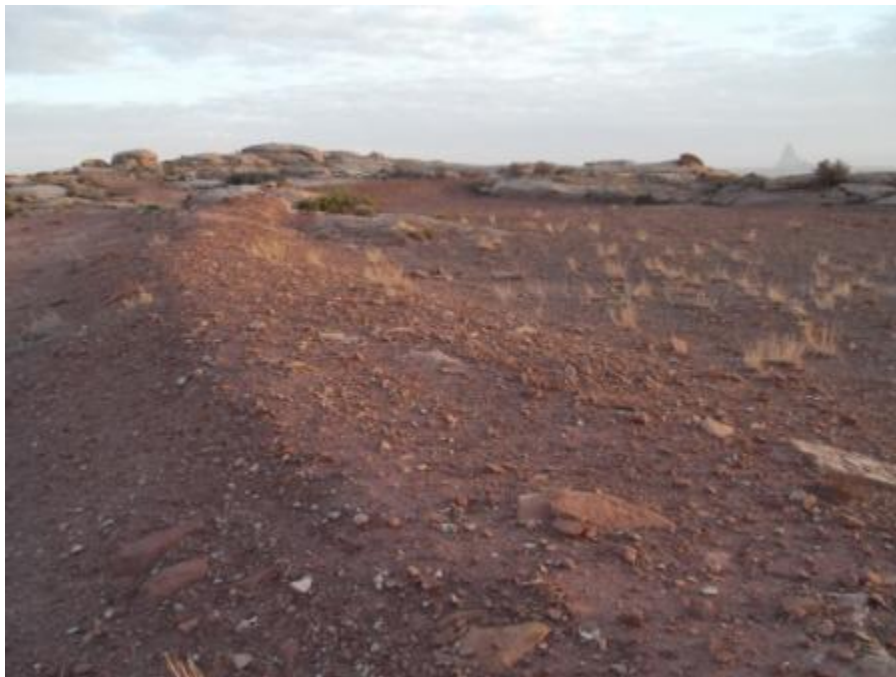
Photo 2

Mine Site #704 – Berm area
