Navajo Abandoned Uranium Mine

Site Screen Report

Mine Name: Claim 3 / Claim 4
Mine ID: 805

Weston Solutions, Inc.

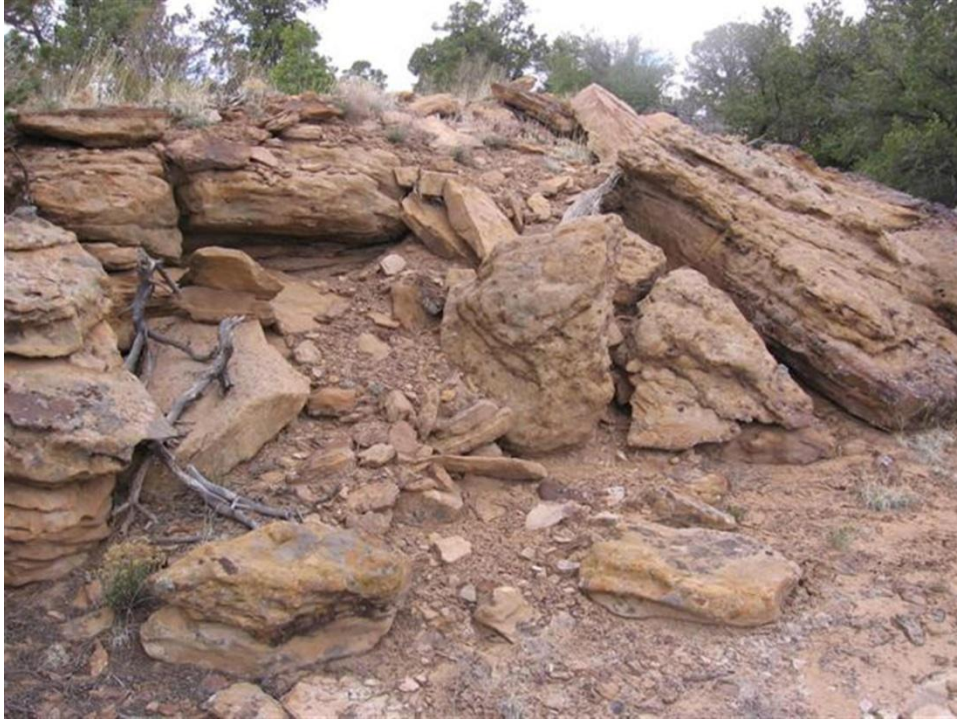
Photo 1: Mine Site #805; Elevated readings

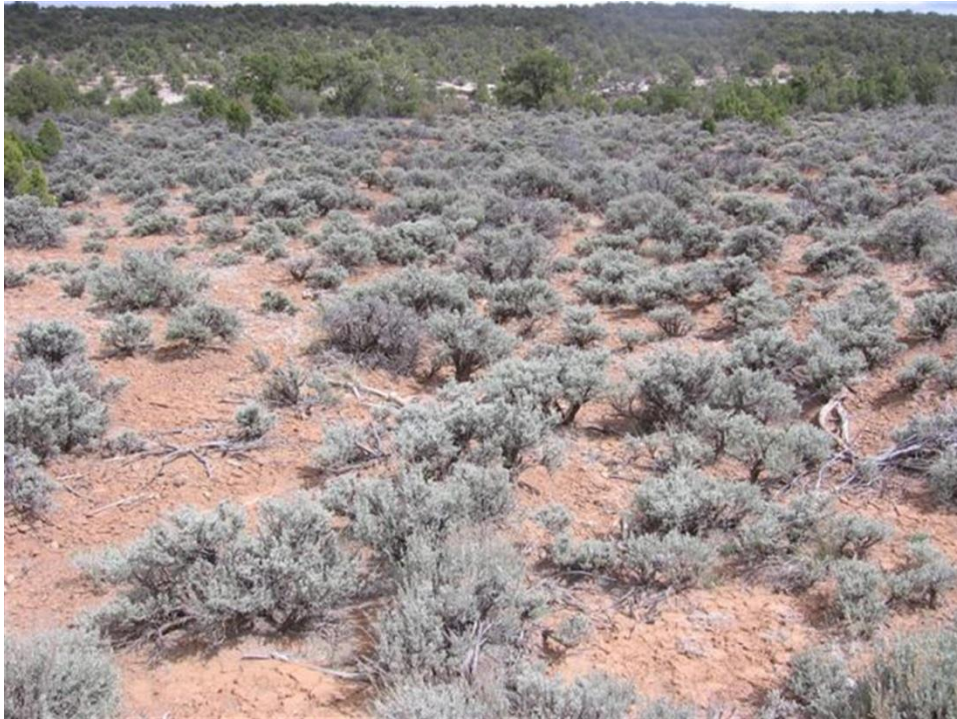
Reclamation cap, 300' diameter, fine red-brown soil

Photo 3: Mine Site #805; Reclamation area
