Navajo Abandoned Uranium Mine

Site Screen Report

Mine Name: Claim 16

Mine ID: 806

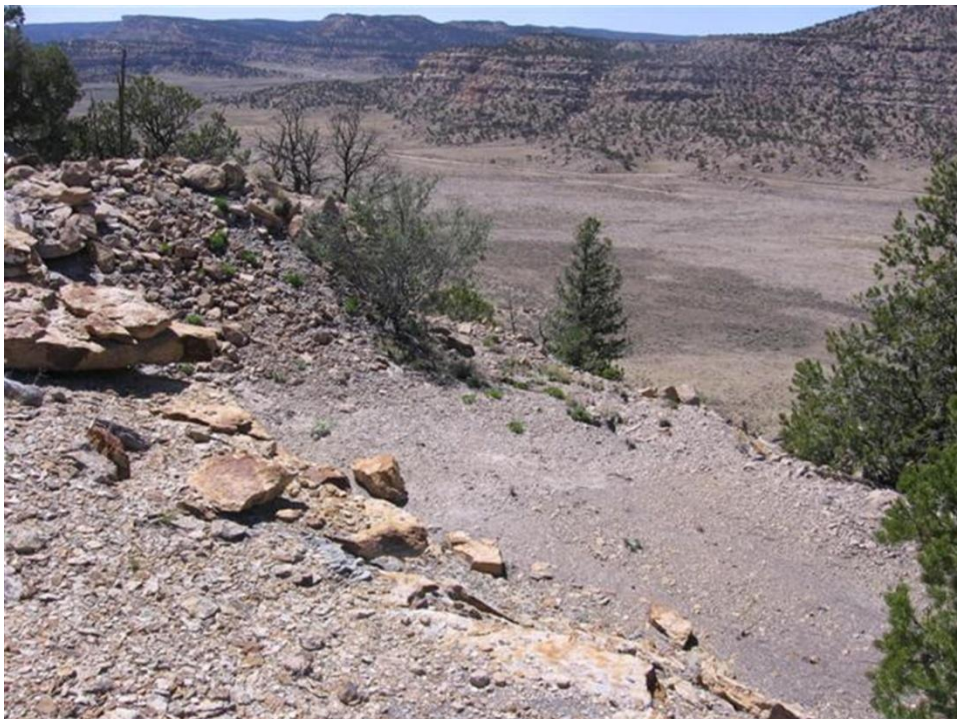
Photo 4: Mine Site #806; Small pit / workings

Small depression/pit, 20'x10' oval, gray shale soil, berm surrounding pit
