Navajo Abandoned Uranium Mine

Site Screen Report

Mine Name: Mail Box Claim
Mine ID: 853

April 2012

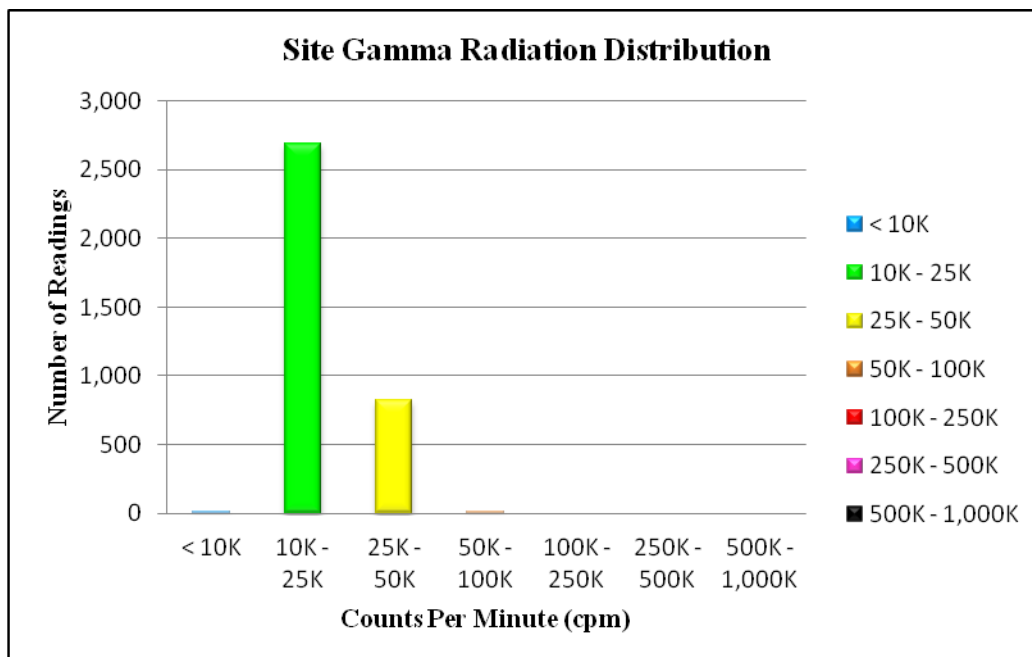
Distribution Chart and Statistics:

Site Gamma Radiation Statistics	
Number of Readings	3,527
Minimum (cpm)	9,101
Maximum (cpm)	56,433
Mean (cpm)	21,649
Median (cpm)	19,116
Standard Deviation	7,248

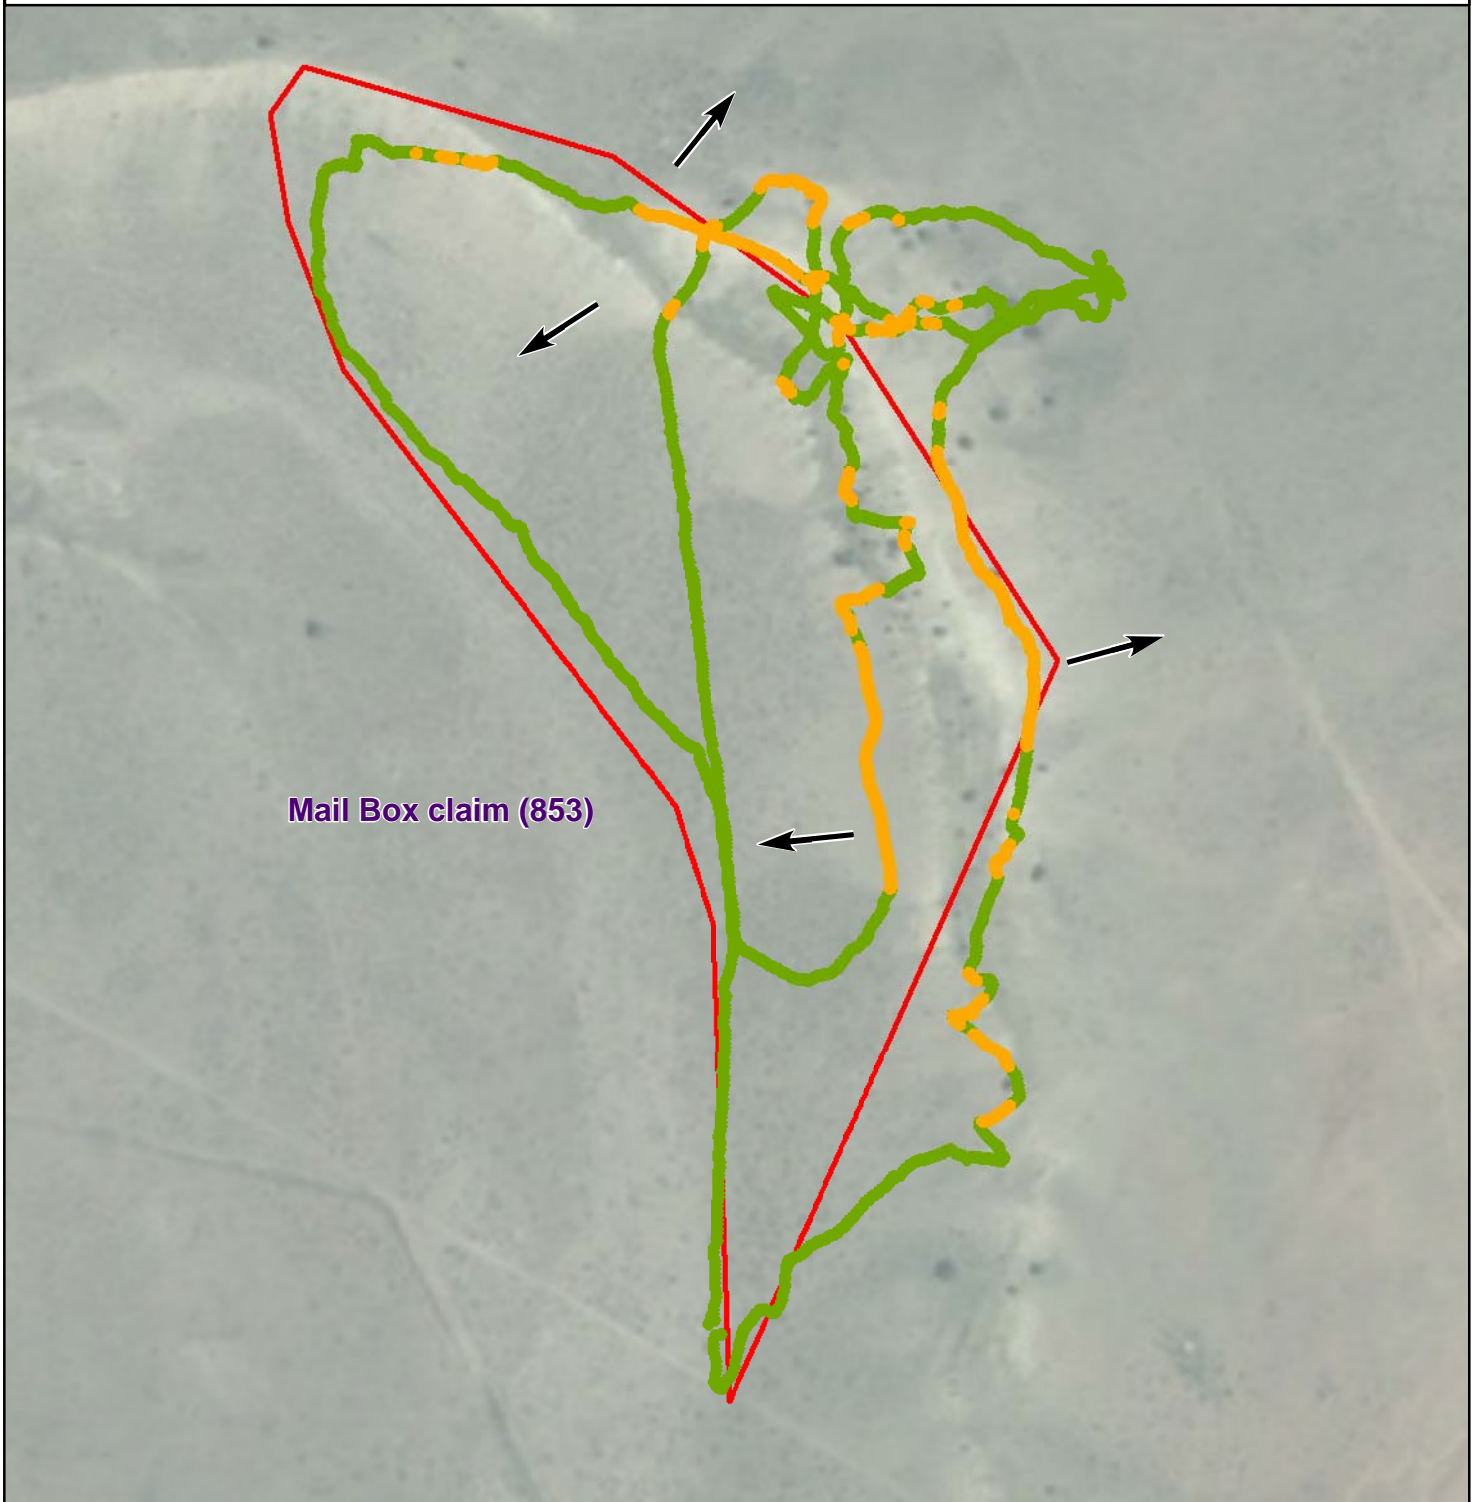
**Figure 1 - Gamma Radiation Measurements, Above Two Times Background
Mail Box claim (853)
Indian Wells Chapter, Navajo Nation**

Gamma Radiation Measurements

Measured as counts per minute (cpm)

Average background 13,908 cpm

A total of 3,527 gamma radiation measurements were collected from the mine site, ranging from 9,101 cpm to 56,433 cpm. The measurements are represented in Figures 1 and 2.

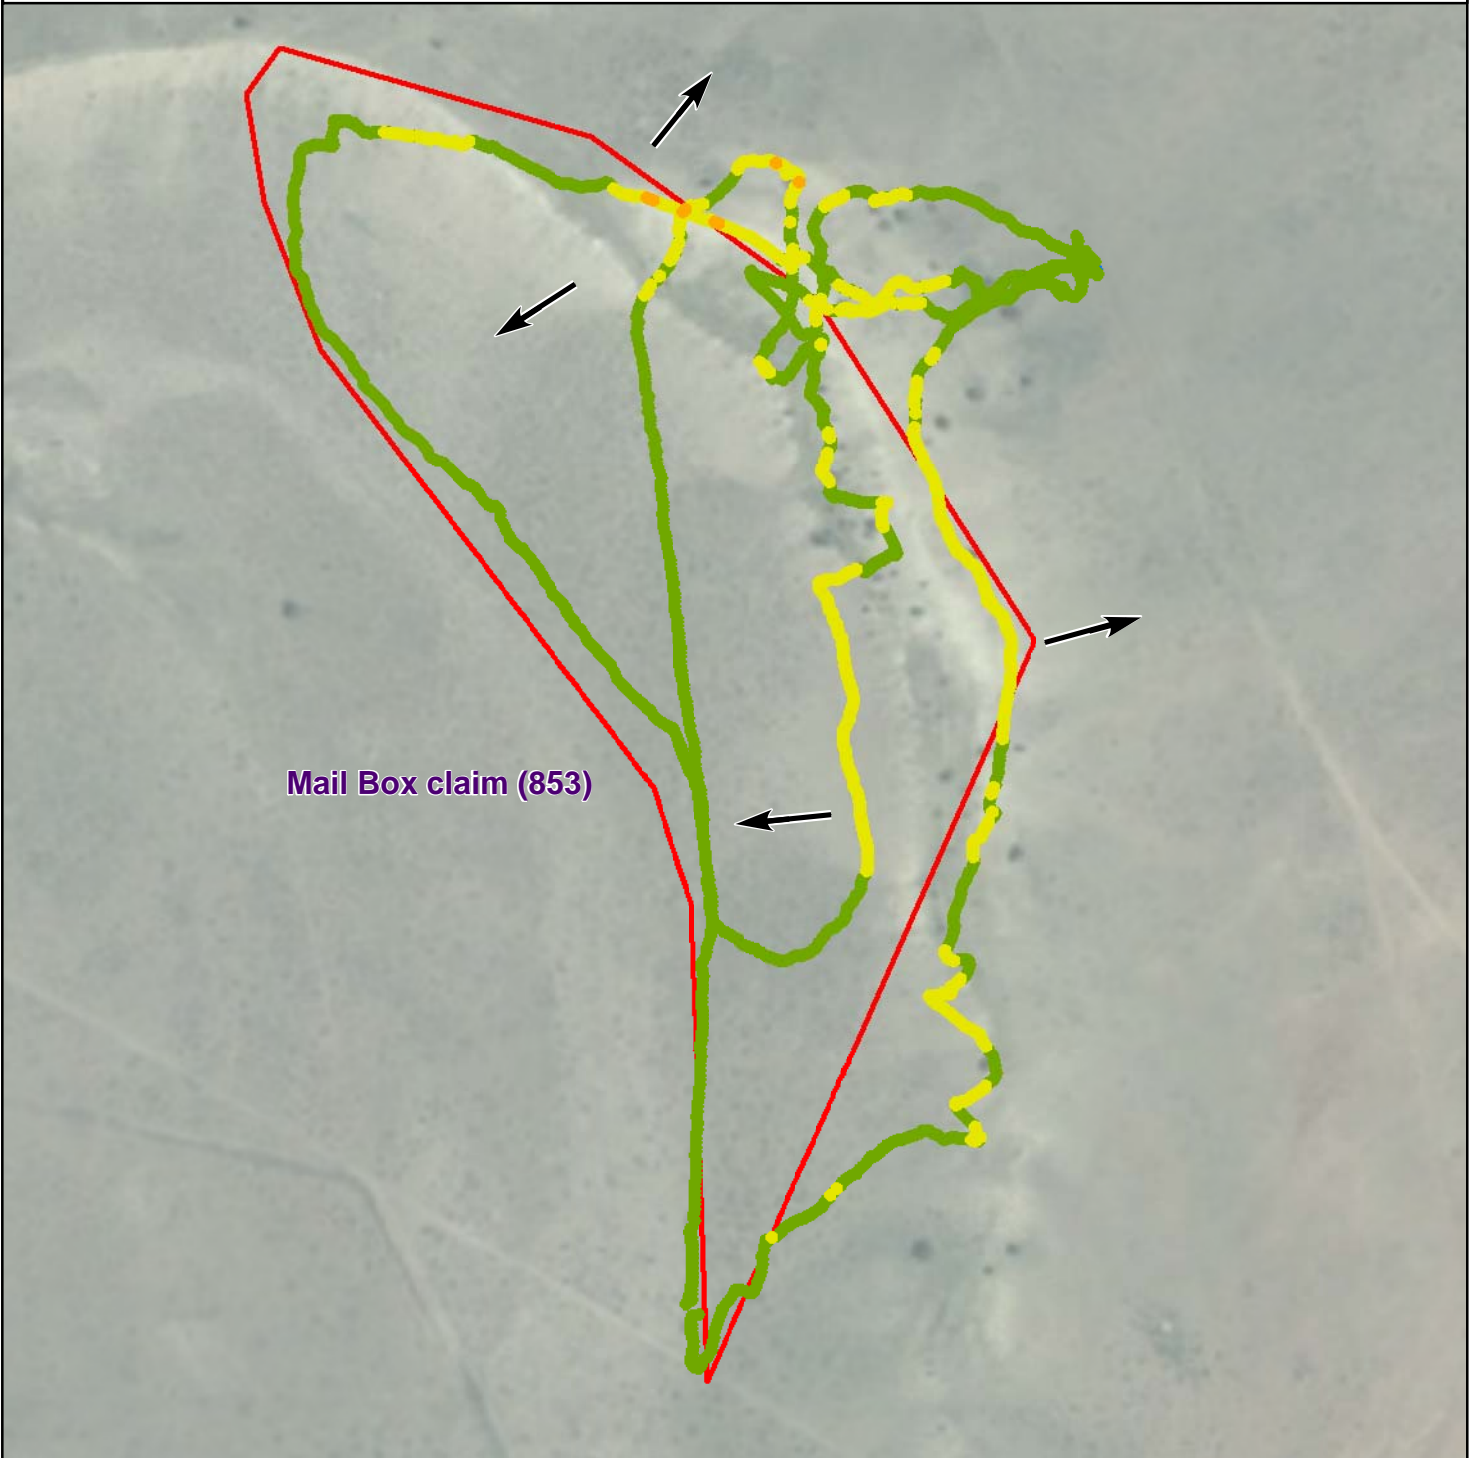
**Figure 2 - Gamma Radiation Measurements
Mail Box claim (853)
Indian Wells Chapter, Navajo Nation**

Gamma Radiation Measurements

Average background 13,908 cpm Measured as counts per minute (cpm)
