# Navajo Abandoned Uranium Mine

## Site Screen Report

**Mine Name: Sam Charley No. 1**  
**Mine ID: 86**

**August 2011**

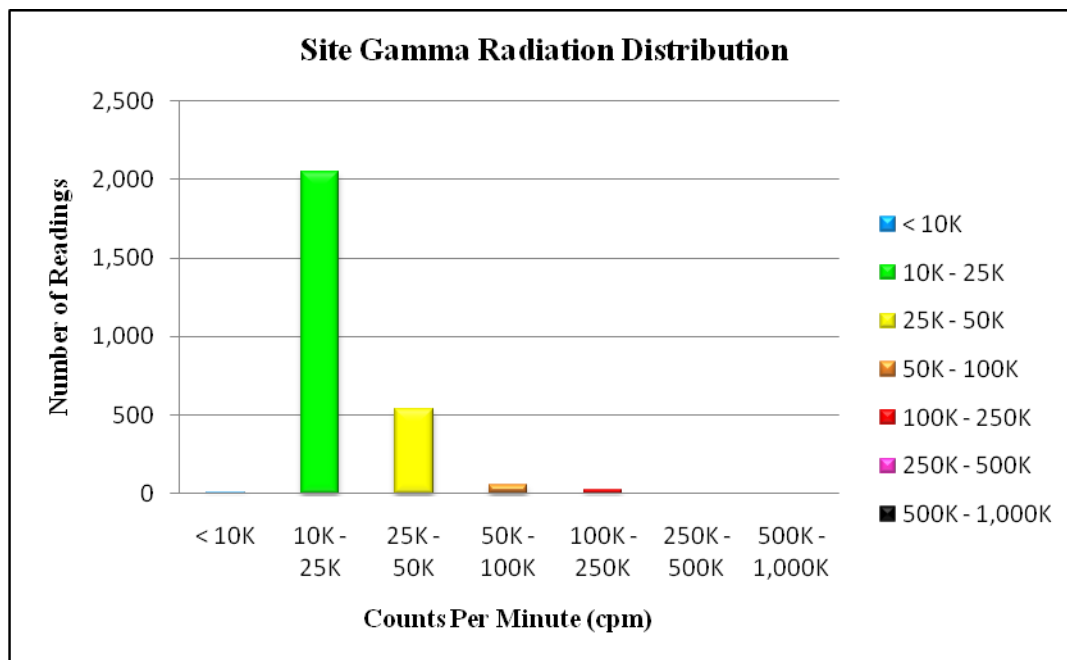
**Distribution Chart and Statistics:**

A total of 2,667 gamma radiation measurements were collected from the mine site, ranging from 9,448 cpm to 217,602 cpm. Measurements collected in the vicinity of the reclamation area were found at a maximum level of approximately 215,000 cpm. The measurements are represented in Figures 1 and 2.

<b>Site Gamma Radiation Statistics</b>	
Number of Readings	2,667
Minimum (cpm)	9,448
Maximum (cpm)	217,602
Mean (cpm)	22,700
Median (cpm)	18,149
Standard Deviation	16,830

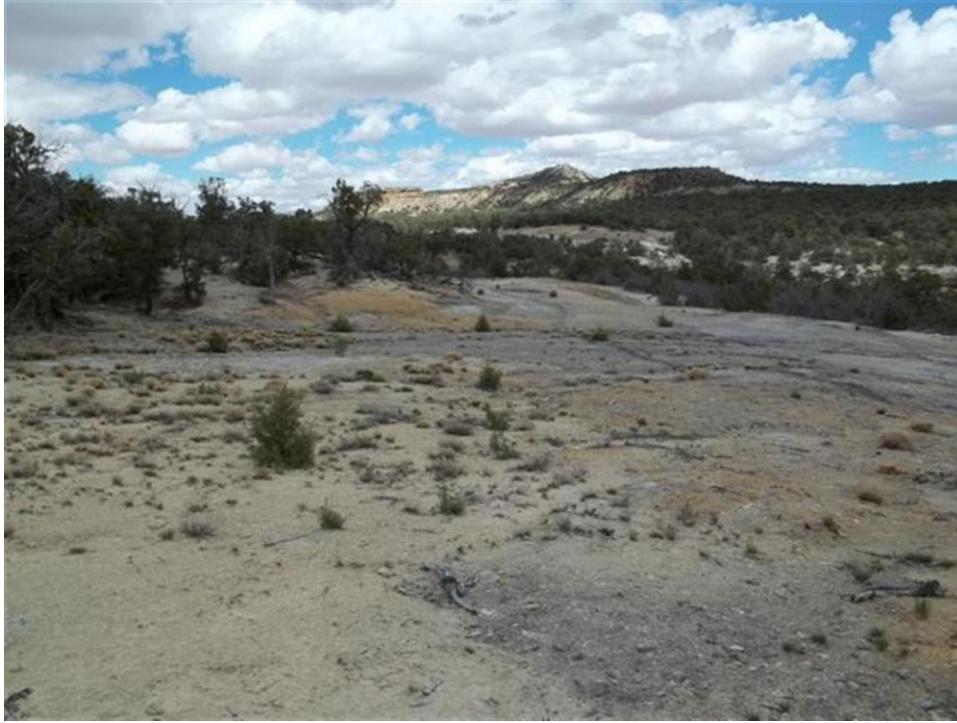
**Photo 1:** Mine Site #86

Gray soil cap over mine surface area, eroded to bedrock in southern portion of site

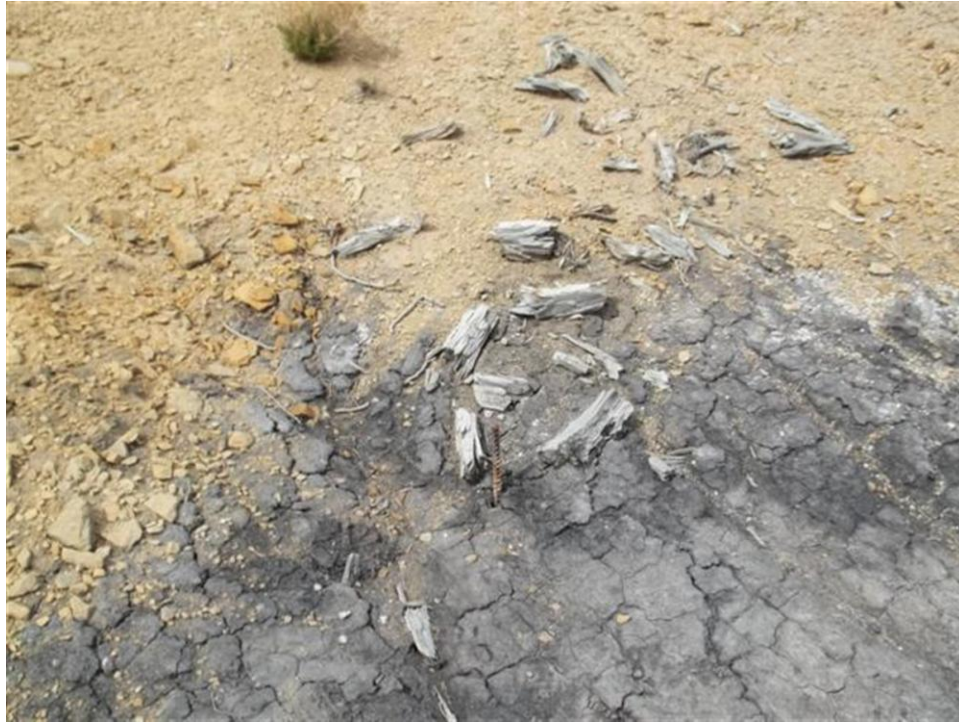
**Photo 3:** Mine Site #86; Rebar

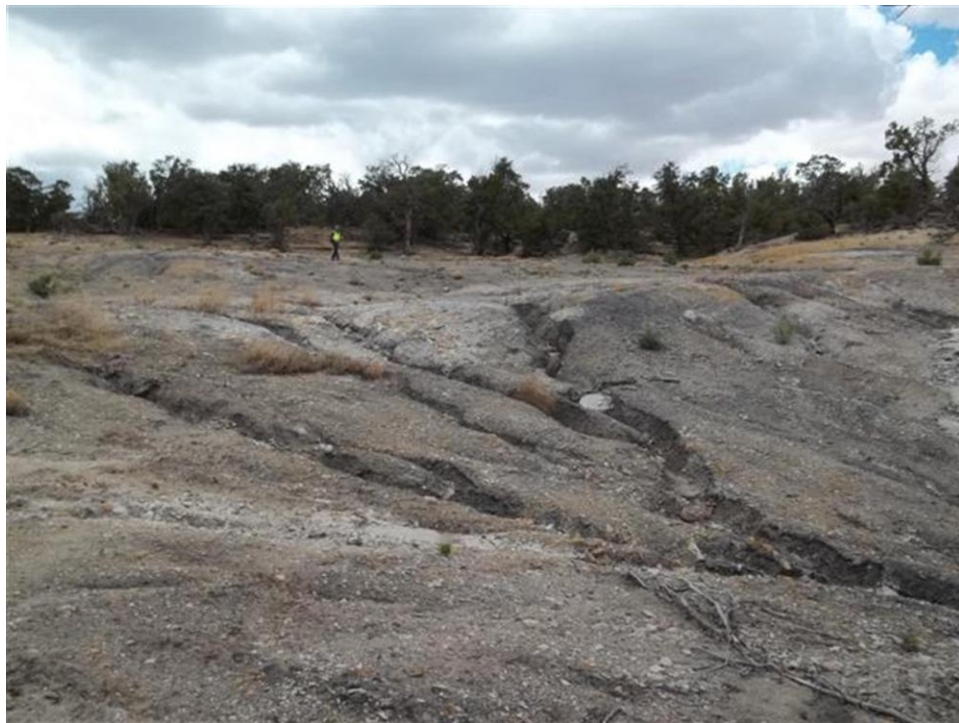
**Photo 4:** Mine Site #86; Erosion trenches

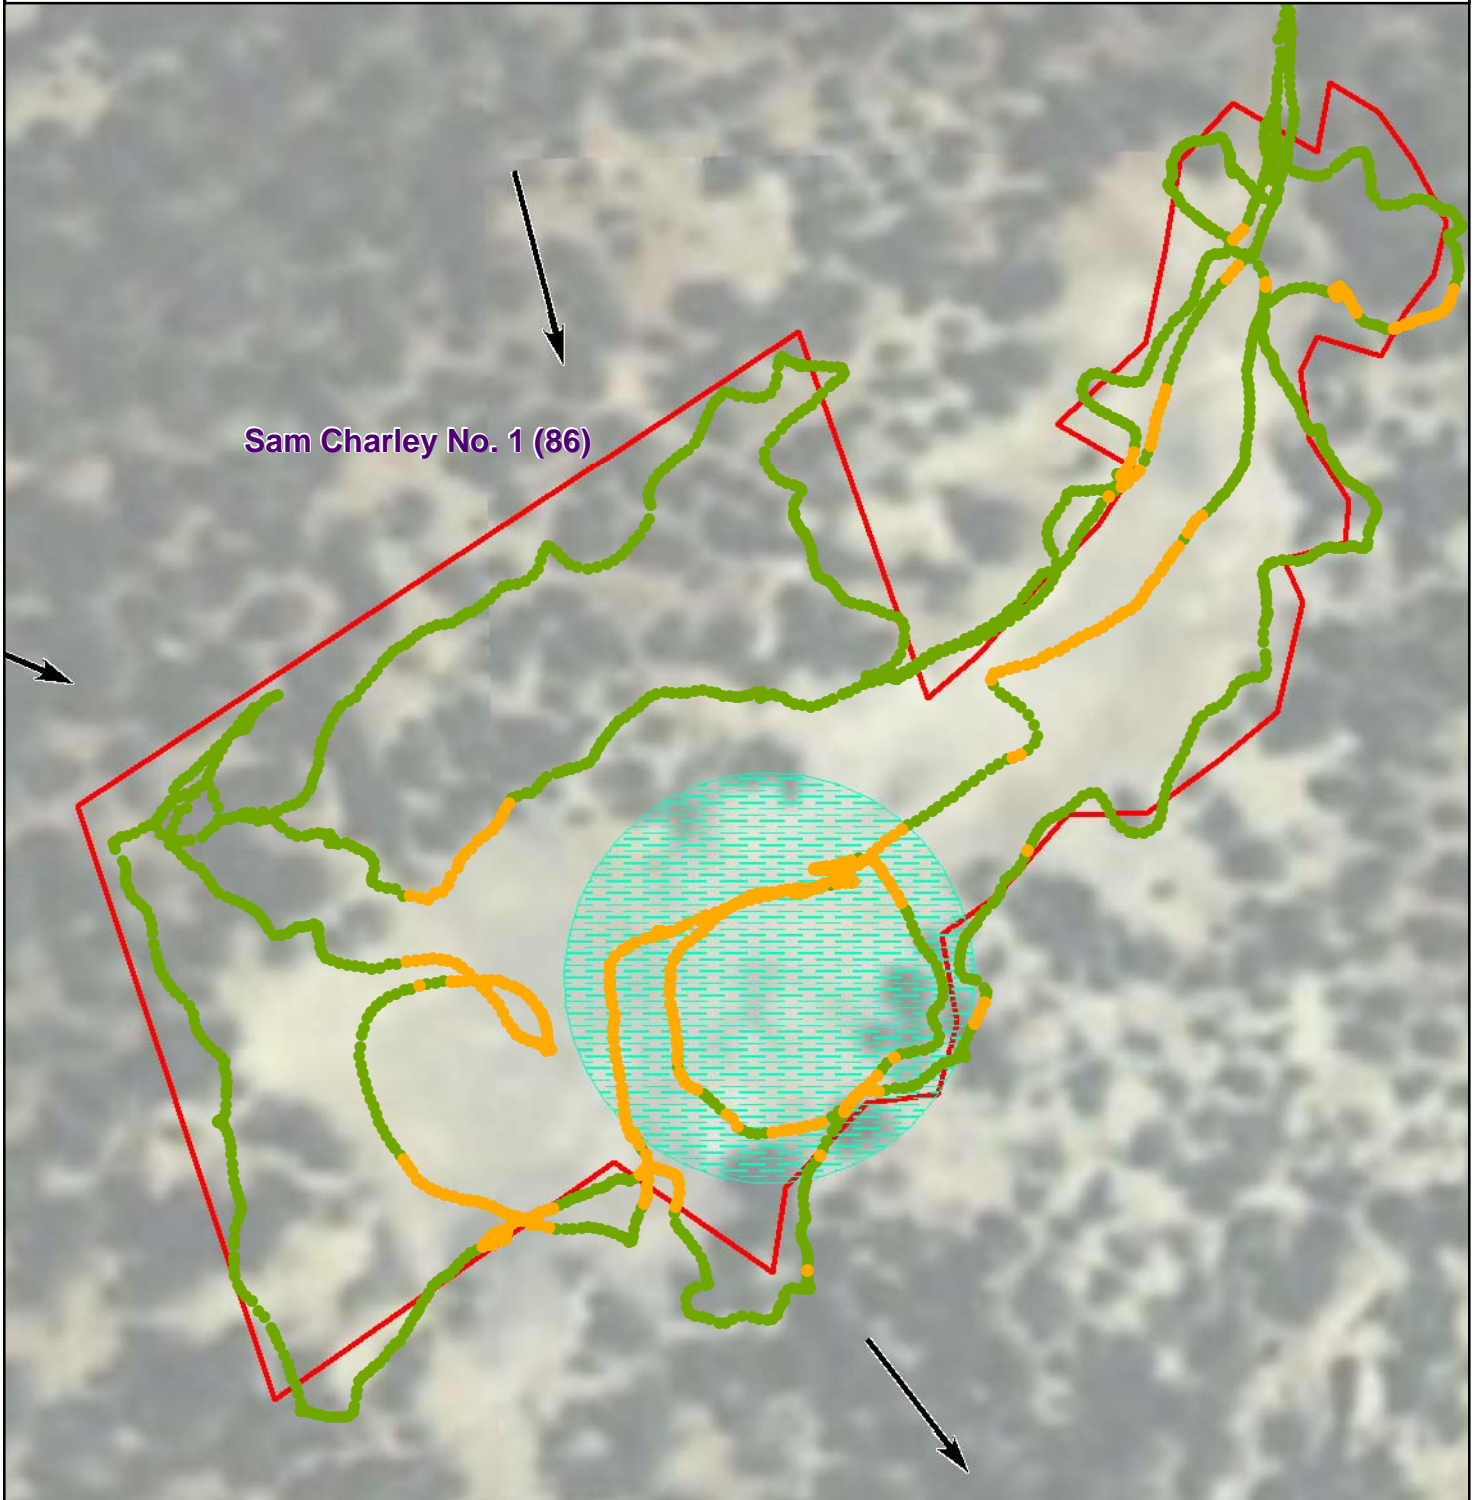
**Figure 1 - Gamma Radiation Measurements, Above Two Times Background  
 Sam Charley No. 1 (86)  
 Black Mesa Chapter, Navajo Nation**

Average background 13,502 cpm

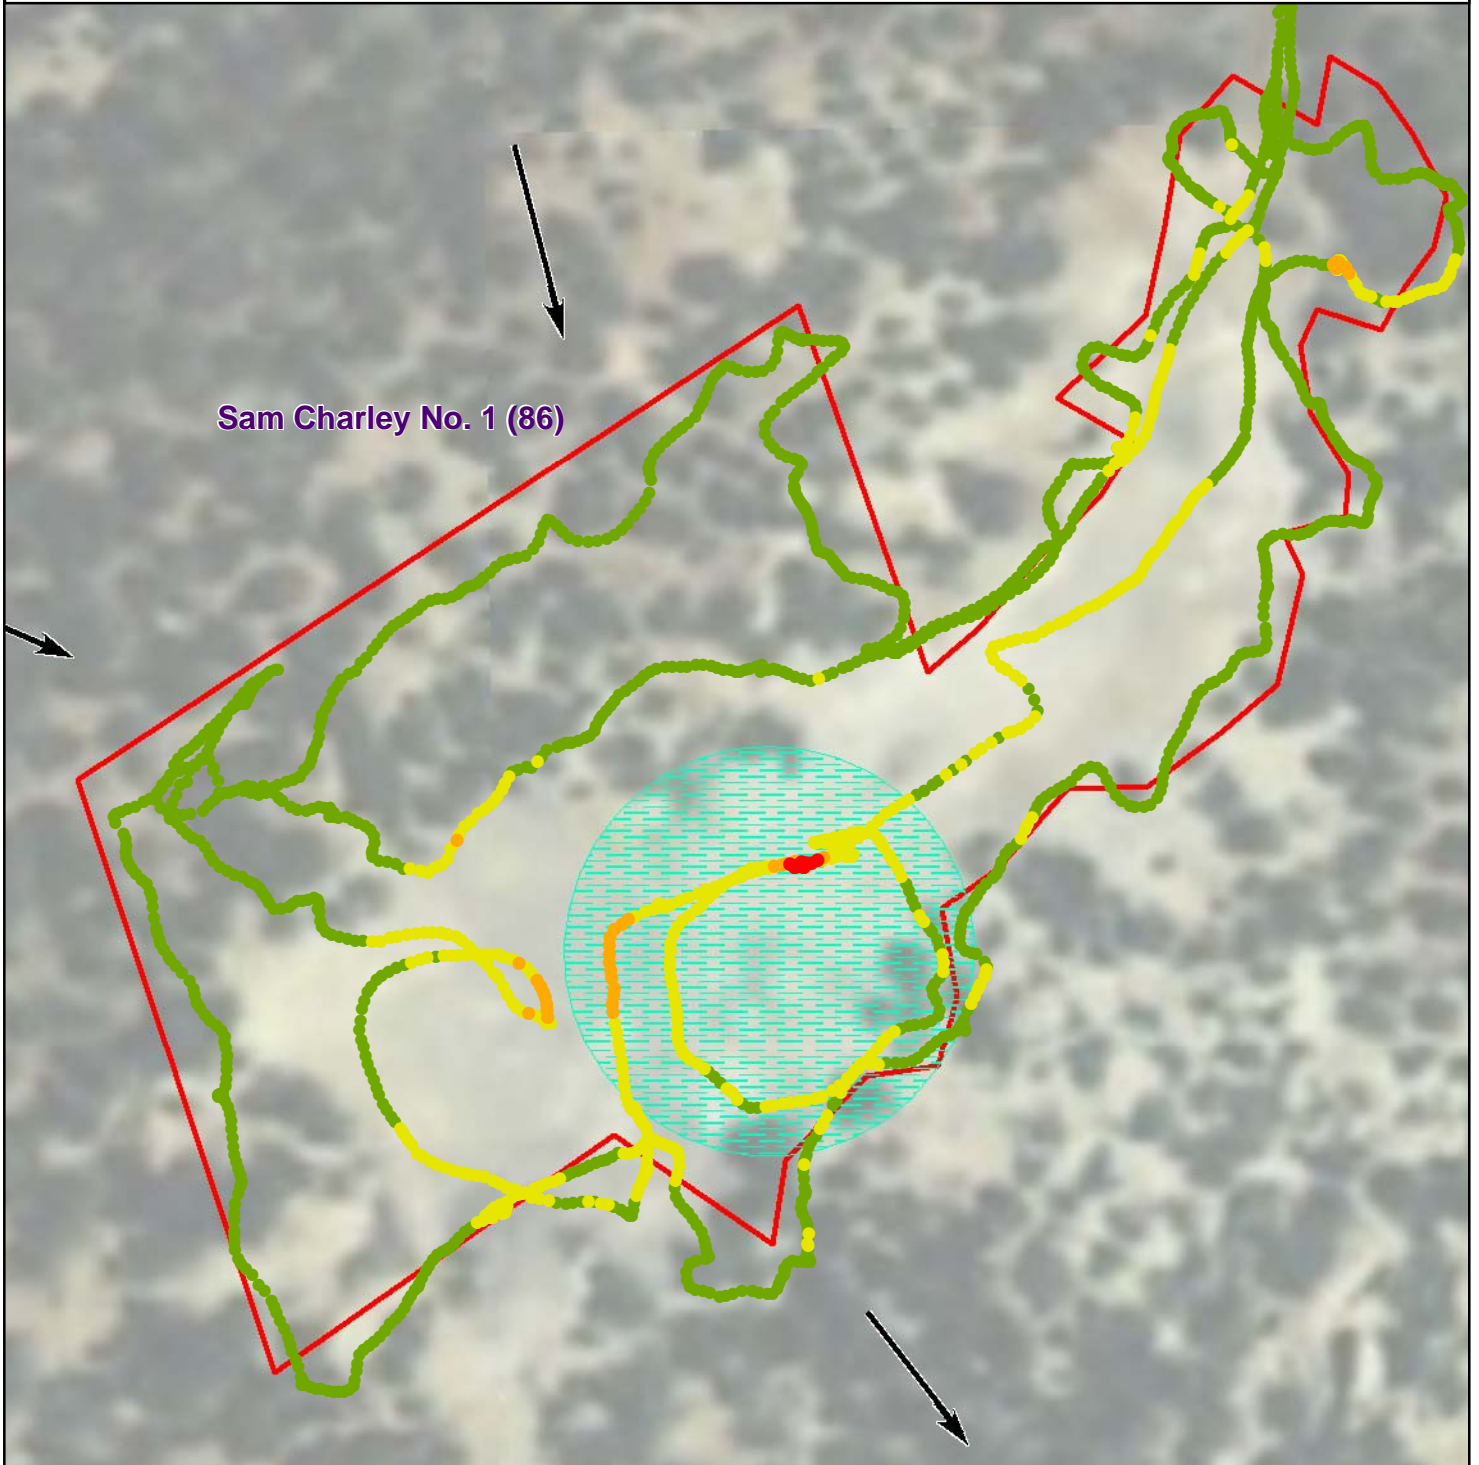
**Figure 2 - Gamma Radiation Measurements  
Sam Charley No. 1 (86)  
Black Mesa Chapter, Navajo Nation**

Measured as counts per minute (cpm) Average background 13,502 cpm
