# Navajo Abandoned Uranium Mine

## Site Screen Report

**Mine Name: Frank Todecheenie No. 1**  
**Mine ID: 87**

**August 2011**

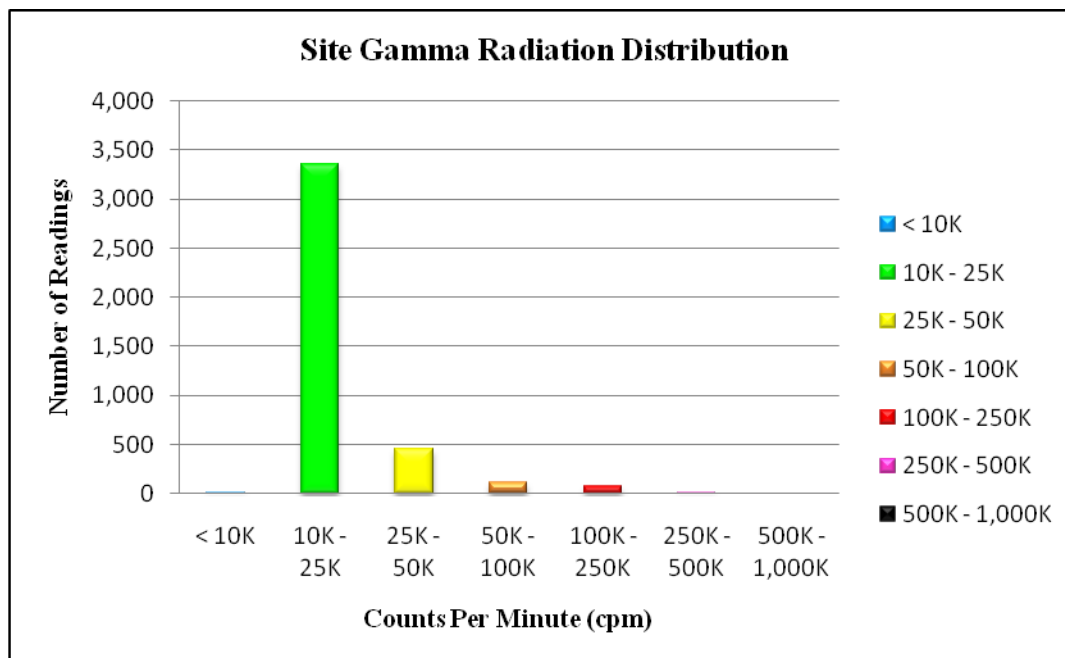
<b>Site Gamma Radiation Statistics</b>	
Number of Readings	4,000
Minimum (cpm)	9,448
Maximum (cpm)	317,597
Mean (cpm)	22,939
Median (cpm)	17,193
Standard Deviation	25,250

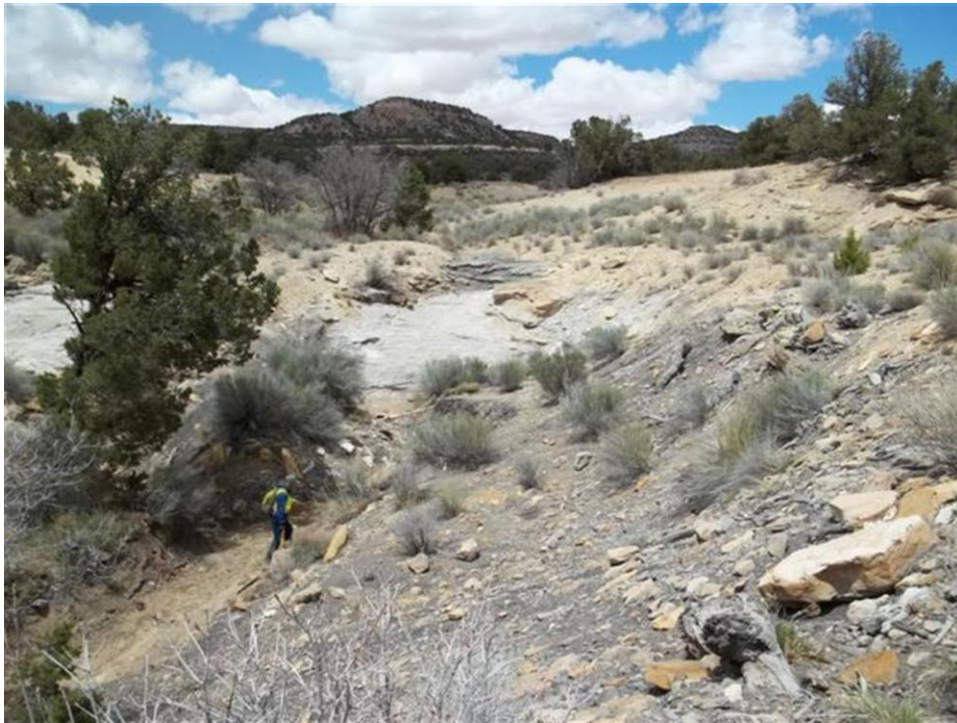
**Photo 2:** Mine Site #87; Drainage

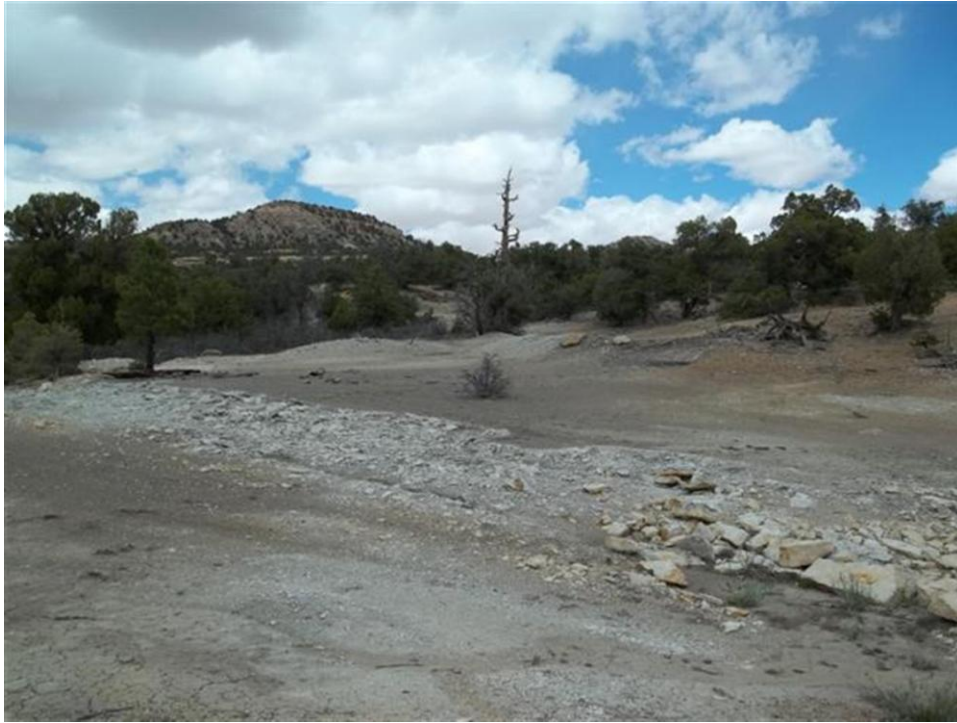
**Photo 3:** Mine Site #87; Loading area and waste rock

Northern section of site has 4 small waste rock piles, each 20 - 50 yd<sup>3</sup> surrounding potential loading area

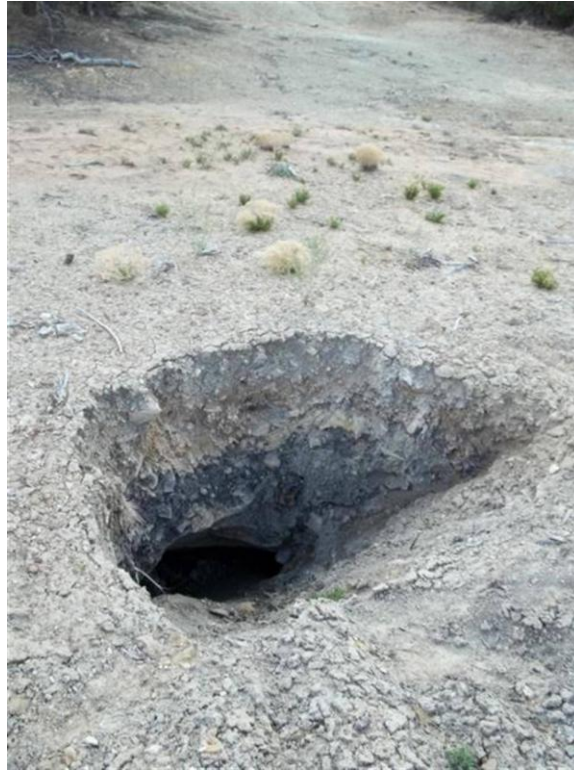
**Photo 5:** Mine Site #87; Possible collapsed adit/shaft

Possible collapsed adit

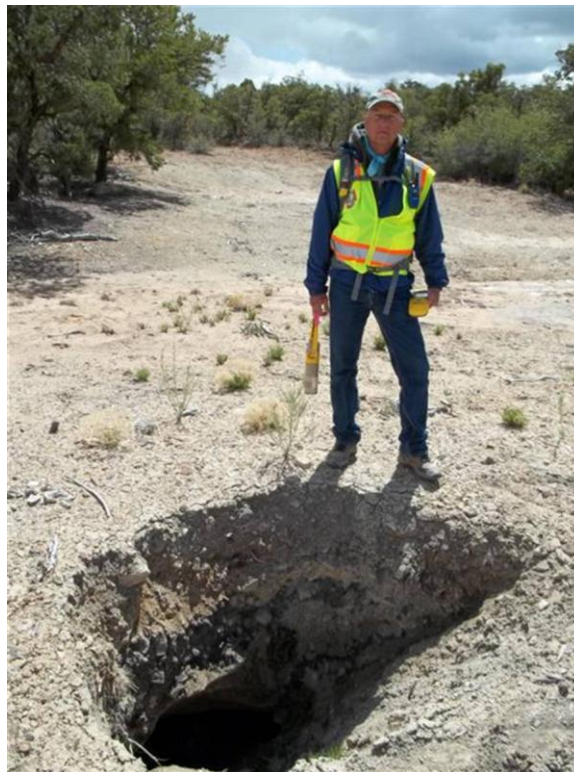
**Photo 6:** Mine Site #87; Possible collapsed adit/shaft

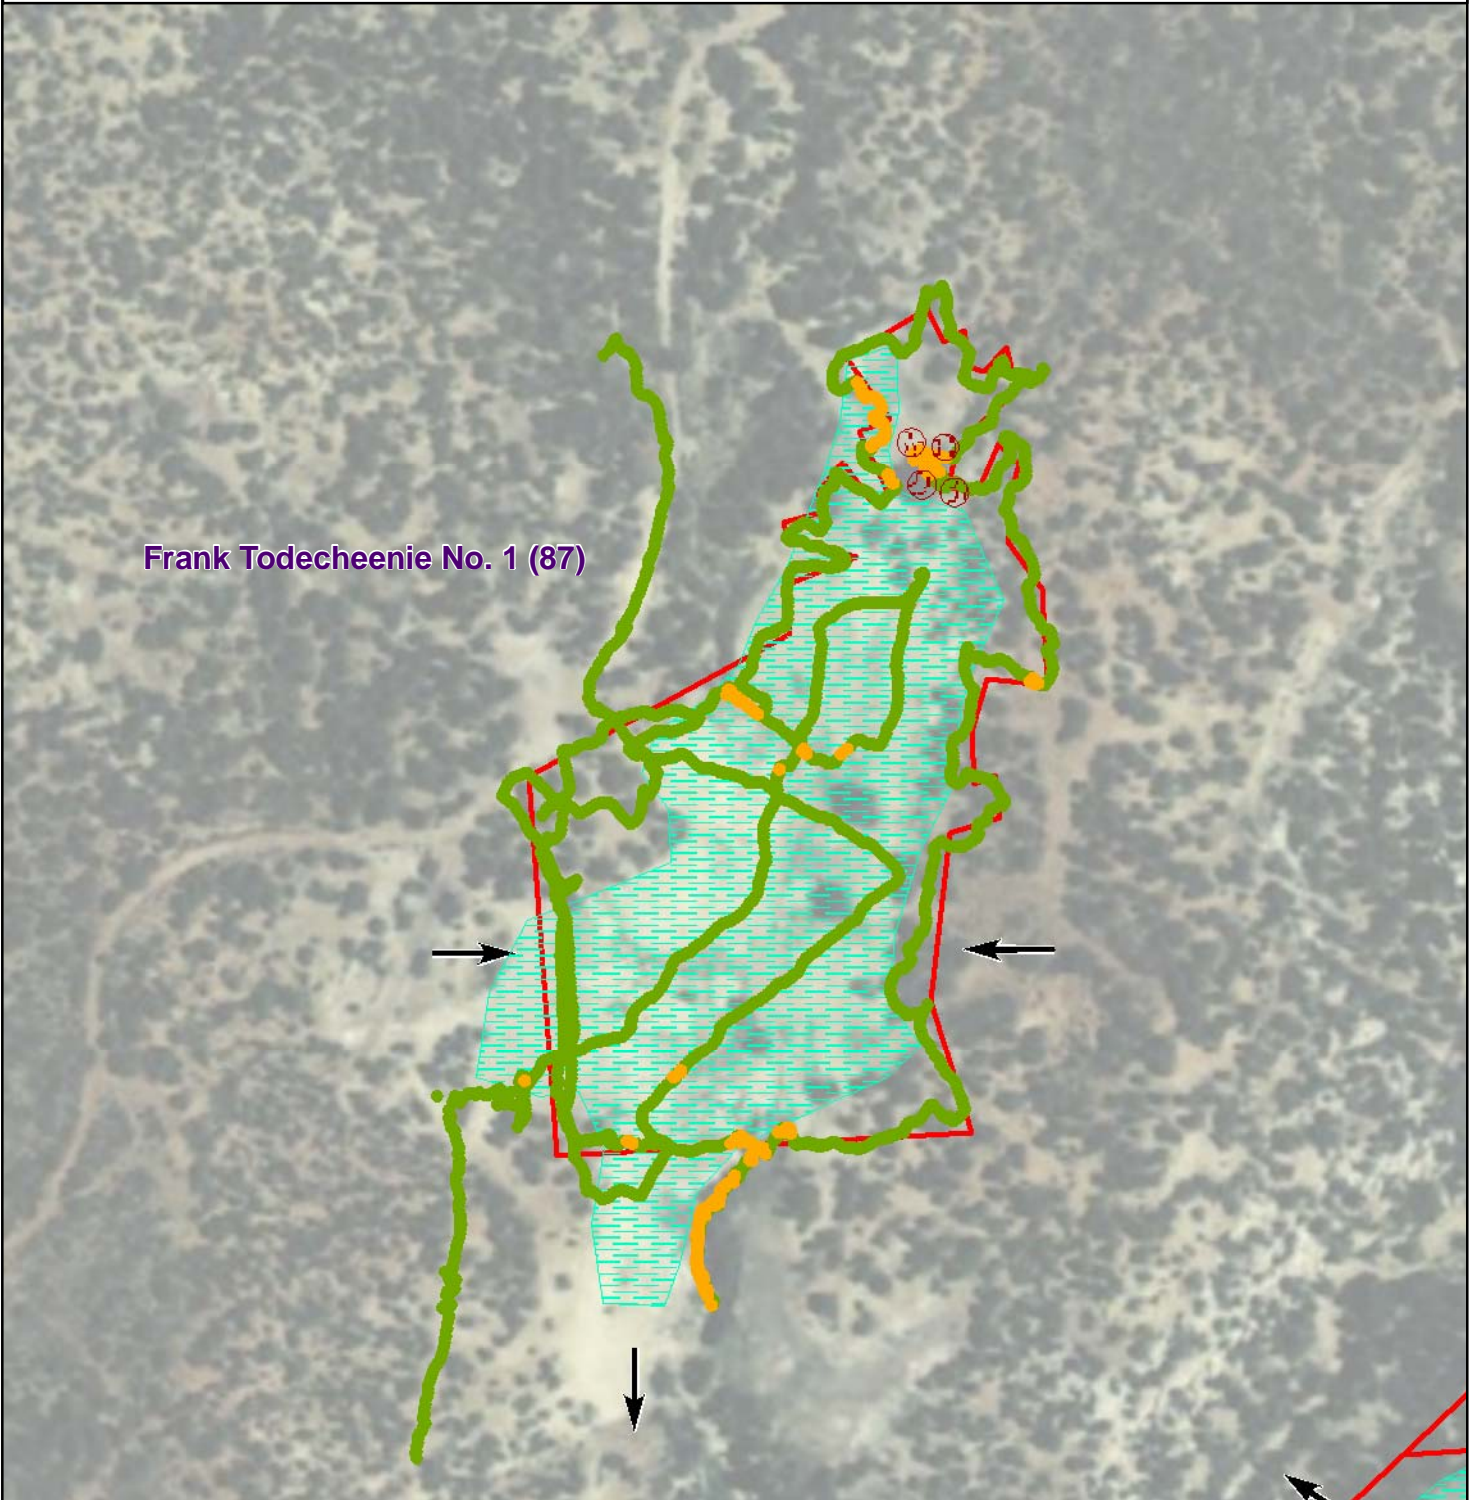
**Figure 1 - Gamma Radiation Measurements, Above Two Times Background  
 Frank Todecheenie No. 1 (87)  
 Black Mesa Chapter, Navajo Nation**

Average background 14,317 cpm

A total of 4,000 gamma radiation measurements were collected from the mine site, ranging from 9,448 cpm to 317,597 cpm. Measurements collected in the vicinity of the waste rock and reclamation area were found at a maximum level of approximately 300,000 cpm. The measurements are represented in Figures 1 and 2.

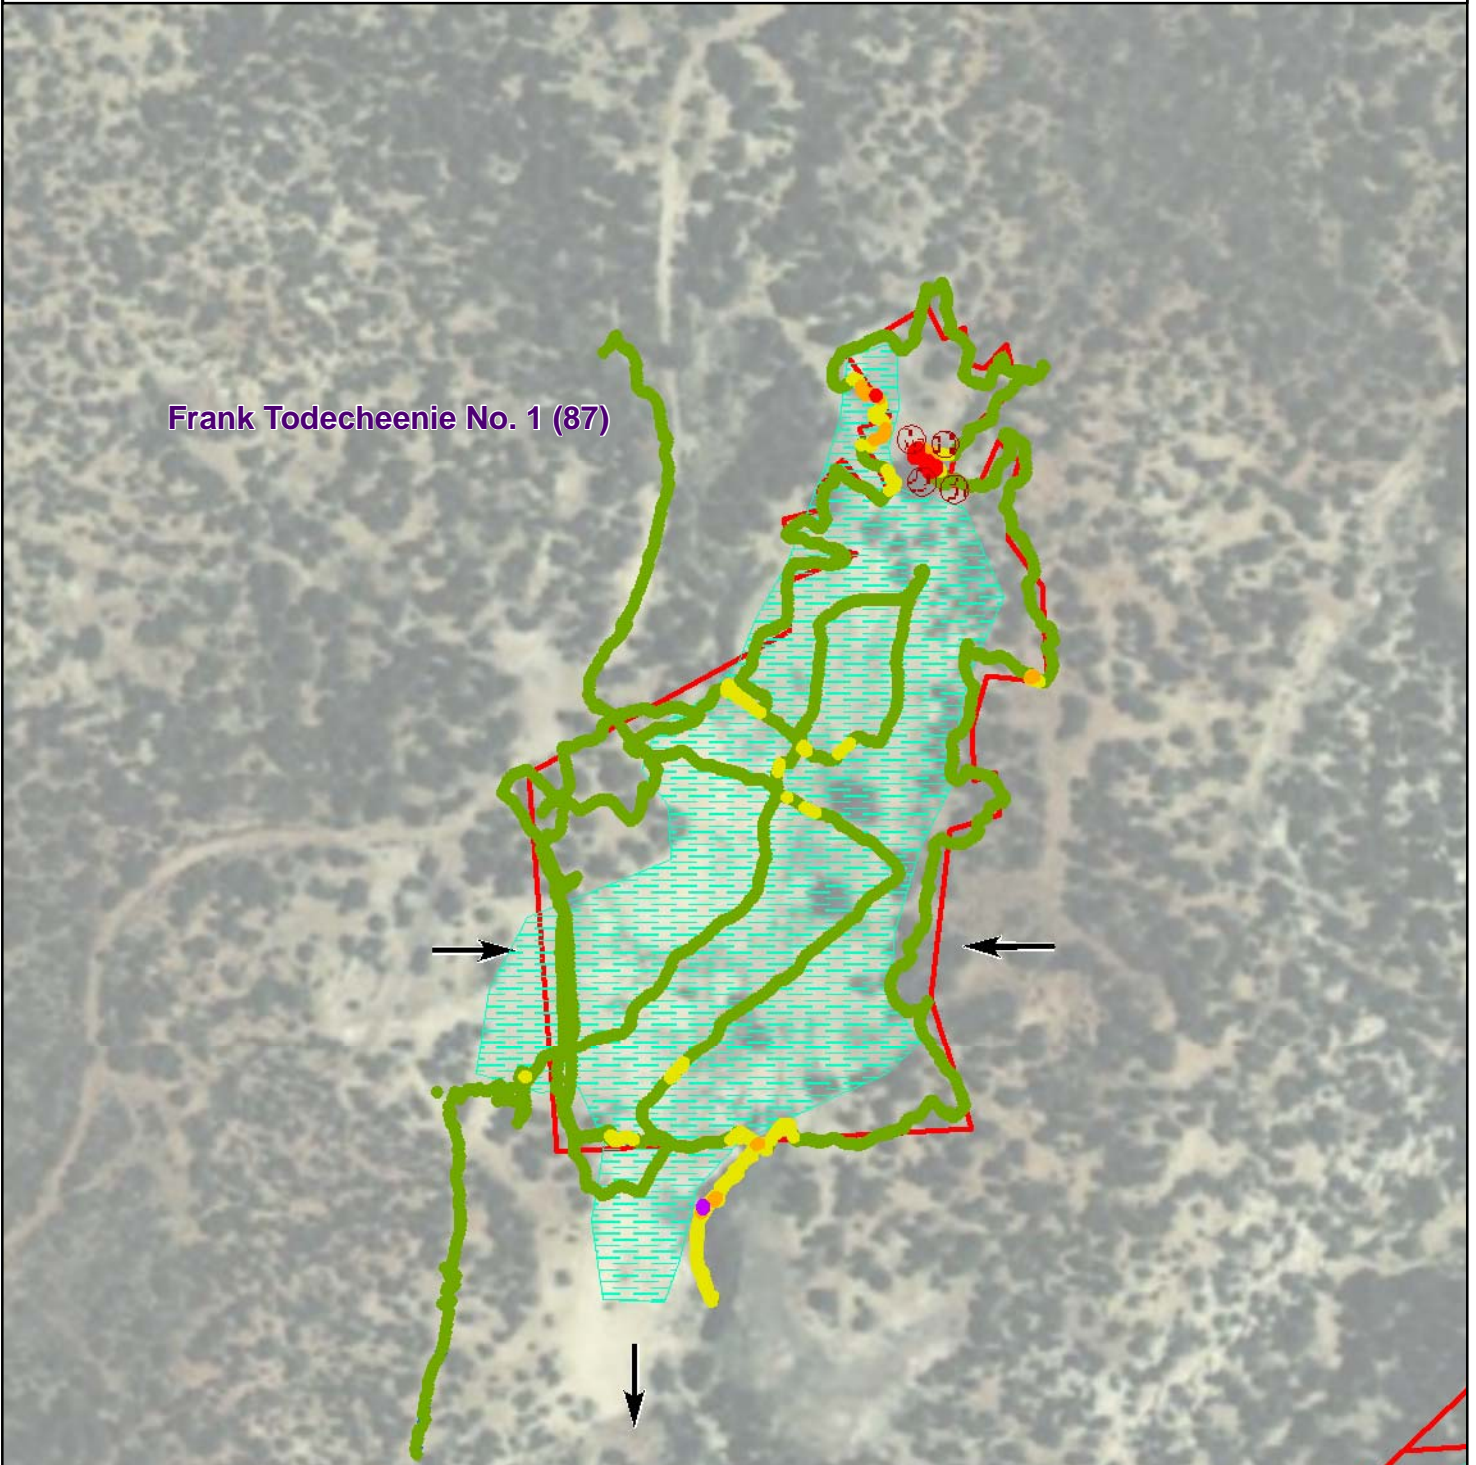
**Figure 2 - Gamma Radiation Measurements  
Frank Todecheenie No. 1 (87)  
Black Mesa Chapter, Navajo Nation**

Measured as counts per minute (cpm) Average background 14,317 cpm
