Navajo Abandoned Uranium Mine

Site Screen Report

Mine Name: Kasewood Bahe No. 1
Mine ID: 88

Weston Solutions, Inc.

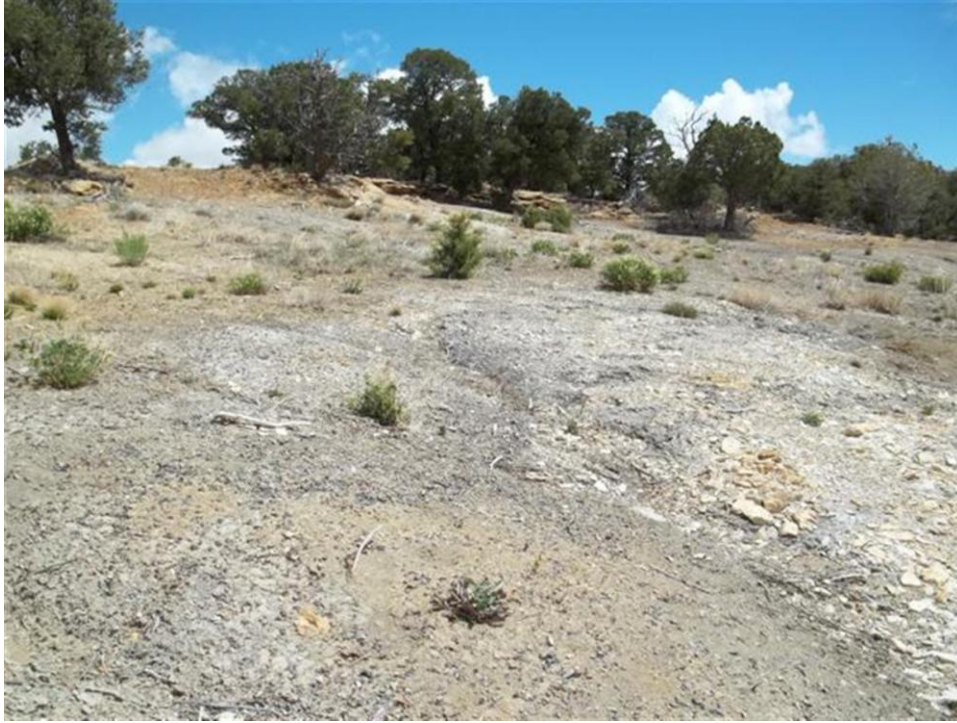
Photo 1: Mine Site #88

Reclamation cap
