Navajo Abandoned Uranium Mine

Site Screen Report

NA-0318 AUM Site

March 2010

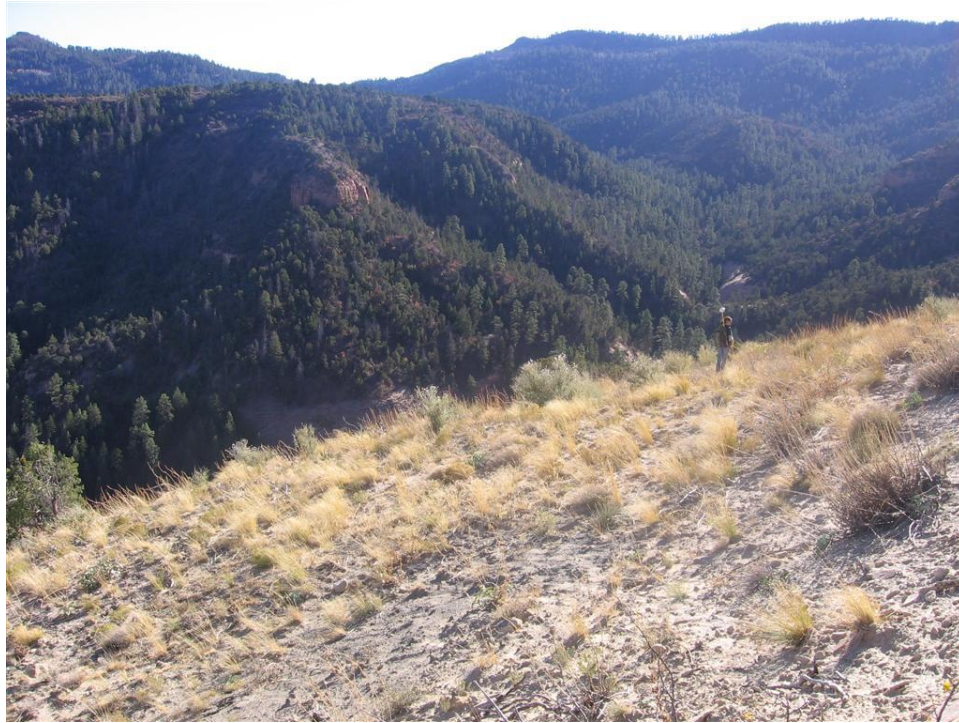
Photo 1. Mine site

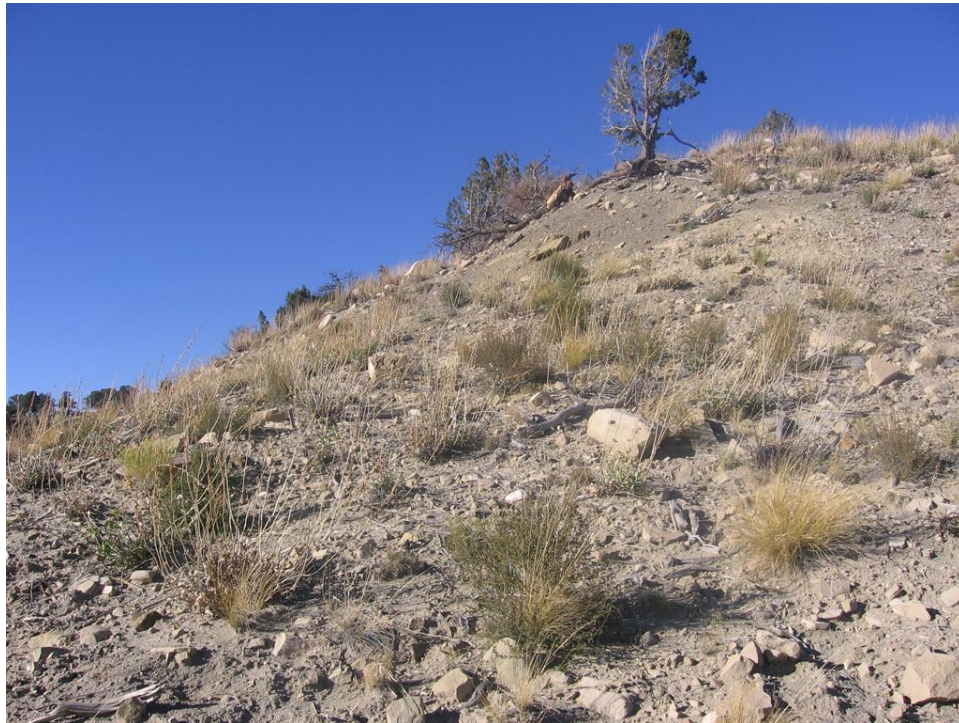
Waste pile at E-SE portion of site on slope, 60 - 70 ft wide and 100 ft long (down slope), with a total estimated volume of 1,296 yd³

Photo 2. Down slope waste debris

Unreclaimed waste pile

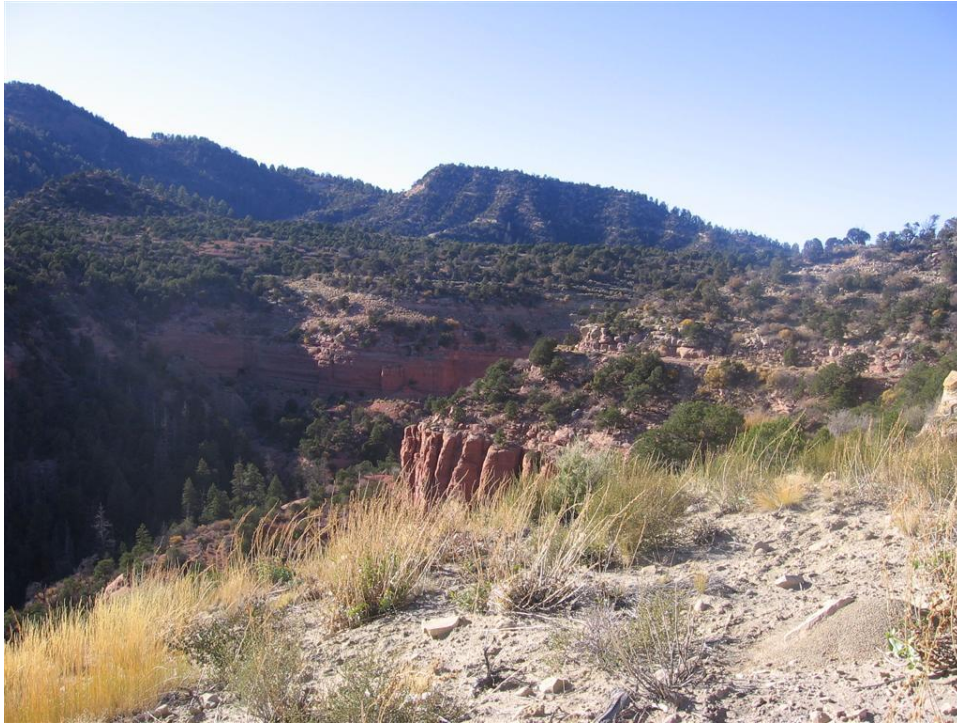
Photo 3. Cliff area

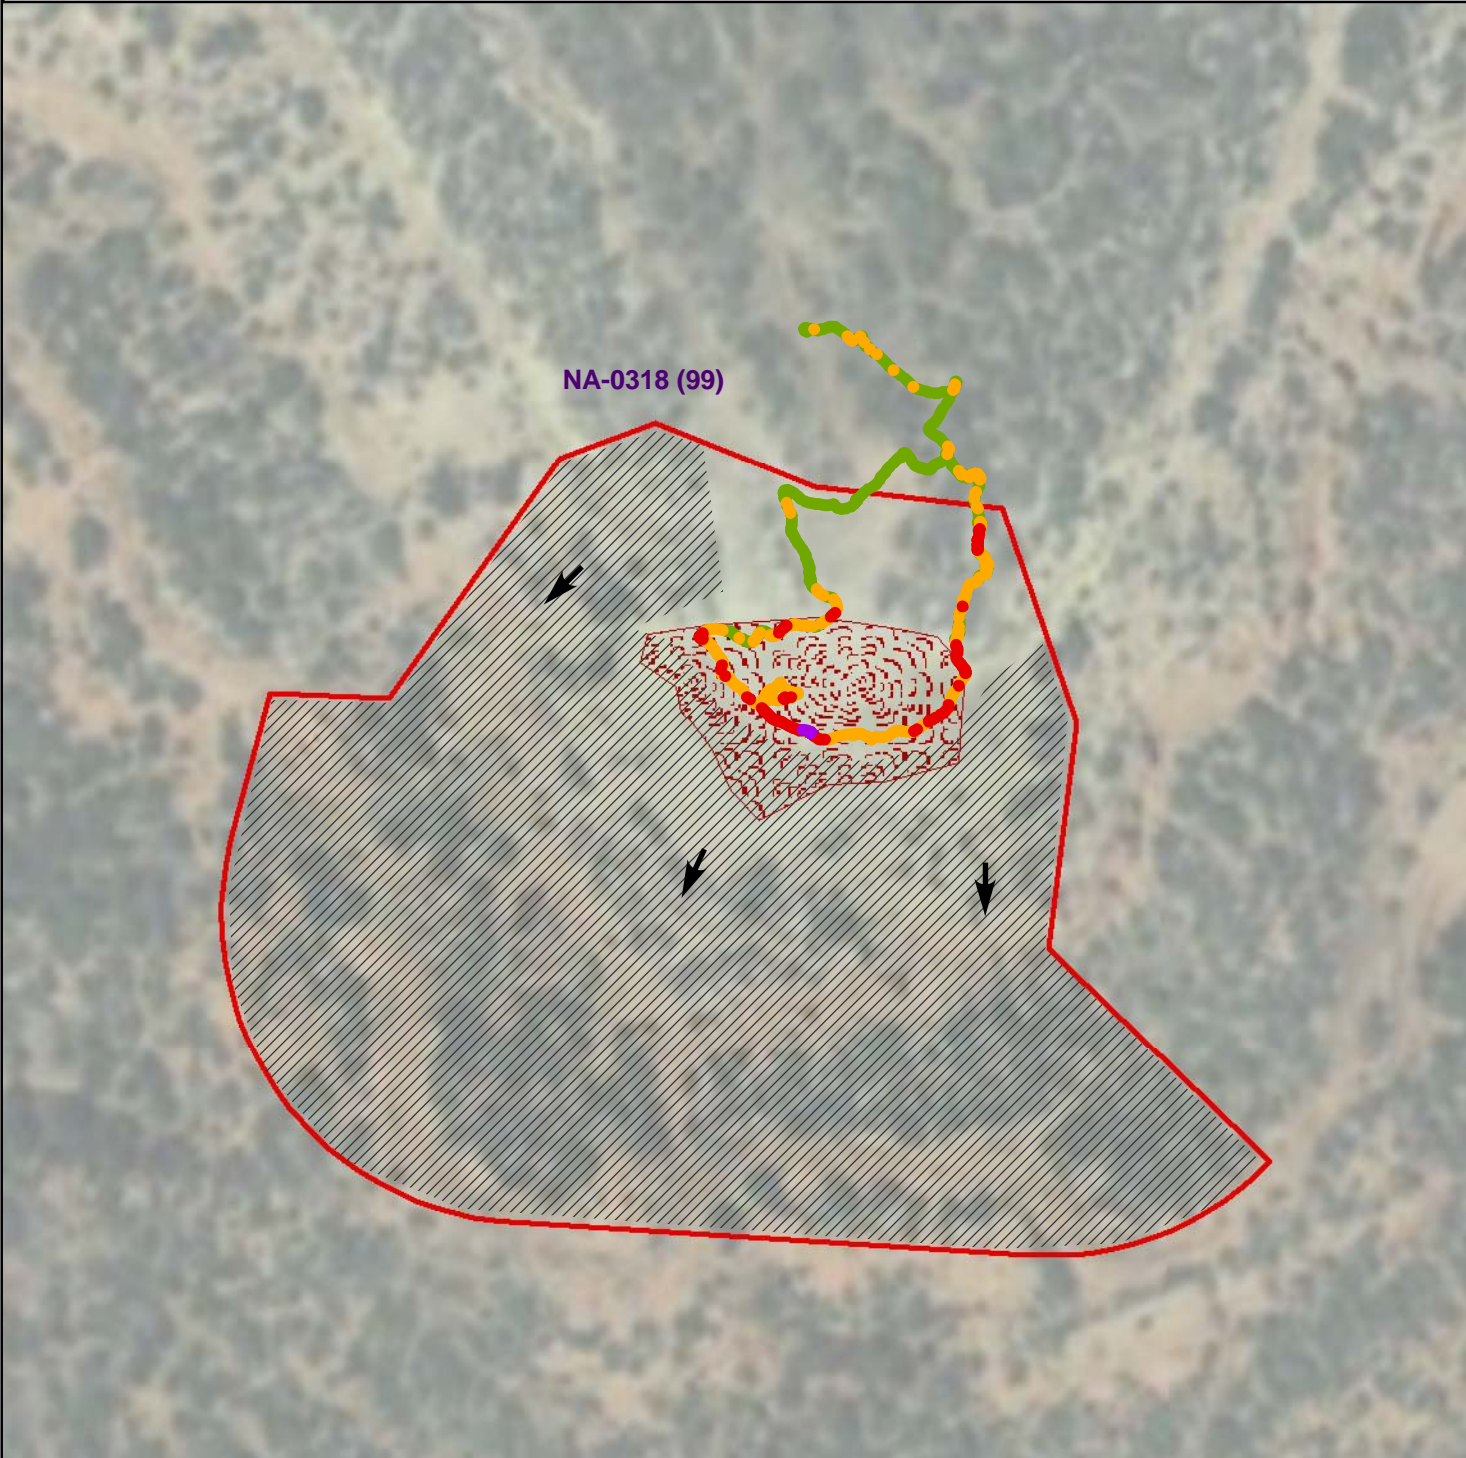
A total of 929 gamma radiation measurements were collected from the mine site, ranging from 10,405 cpm to 62,742 cpm. Measurements in the vicinity of the waste debris were found at levels above 40,000 cpm. The measurements are represented in Figures 1 and 2.

**Figure 2 - Gamma Radiation Measurements
NA-0318 (99)
Cove Chapter, Navajo Nation, Arizona**

**Gamma survey conducted 10/2009
Measured as counts per minute (cpm)**

Average background = 15,002 cpm
