**Project ID #17-0054**

# **Proctor Creek Watershed Monitoring FY2017: First Quarterly Report**

**Fulton County, GA**

**Project Dates: October 18-19, 2016**

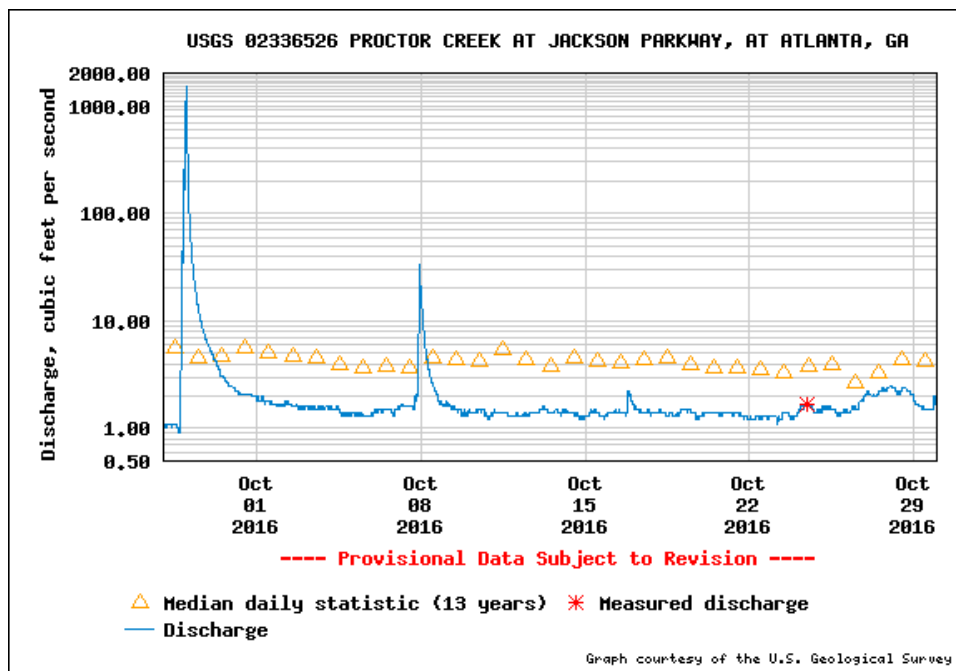
**Figure 3:** Stream discharge from September 27-October 30 2016 at the USGS James Jackson Parkway gauge, located at station PC8. The 13-year median daily statistic is shown for comparison. The current sampling event occurred on October 18-19.

The last significant rainfall prior to sampling occurred on September 27, three weeks before this sampling event, with precipitation totaling 1 inch (<http://waterdata.usgs.gov>). Two smaller events occurred on October 7 and October 16, at approximately 0.13 and 0.03 inches, respectively. Discharge was well below the 13-year median daily value throughout October (Figure 3). The USGS Jackson Parkway gauge recorded discharge that fluctuated from 1.3-1.5 cubic feet per second (cfs) over the 2-day sampling period. Discharge measurements for each station are shown in Table 2. There was no flowing water at Lillian Cooper Park (PC14), so no flow measurements or water samples were collected at that station, and velocity was too low to obtain acceptable measurements at North CSO (PC4). Flow in the main channel was also difficult to measure due to a beaver dam at Hollowell (PC5) and deep, slow-moving water at Kerry Circle (PC7). Data at these two stations were outside of quality control acceptance criteria and therefore omitted from the dataset.

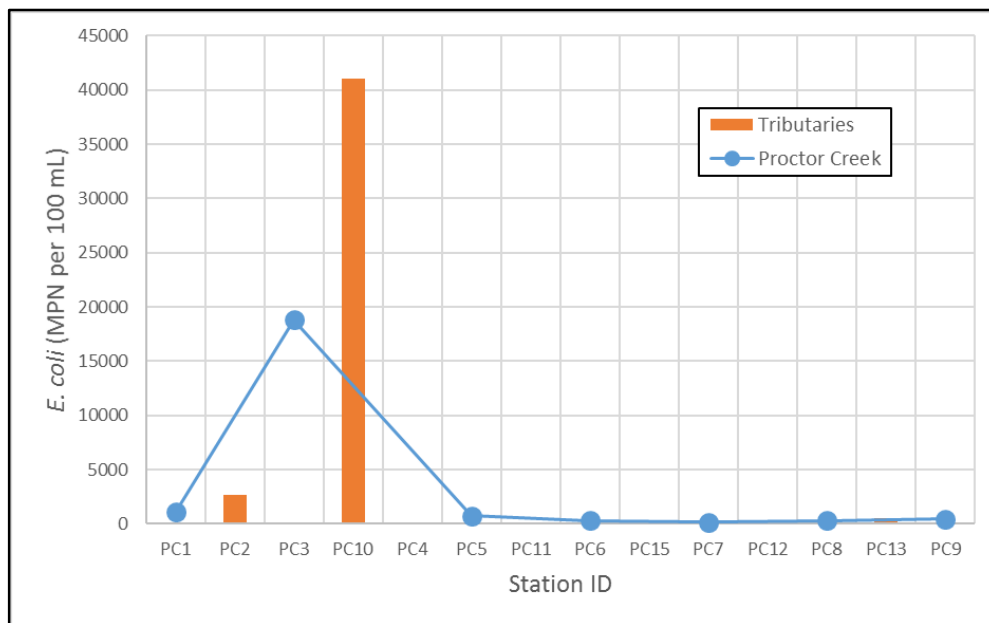
**Figure 4:** *E. coli* (MPN per 100 mL) in Proctor Creek and its tributaries. Locations are shown from upstream to downstream, in order from left to right.

Data for fecal coliform counts are provided in Table 2, reported as the most probable number (MPN) of *E. coli* per 100 mL. While the Georgia state water quality standard is written in terms of fecal coliform, not specifically *E. coli*, the *E. coli* data provide a conservative estimate of fecal coliform since they are a subset of this group. Therefore, exceedance of the standard by *E. coli* indicates a likely exceedance by fecal coliform bacteria as a whole. The applicable standard for this sampling period (between May and October) for fishing and/or recreational waters is a geometric mean of 200 per 100 mL, calculated using at least four samples during a 30-day period (Ga. Comp. R. & Regs. r. 391-3-6-.03(6)). Only one sample was collected at each station during this sampling event, which precludes the calculation of a geometric mean. However, 9 of the 14 samples contained concentrations of *E. coli* higher than that standard (Table 2). Counts were especially high, at 1,000 MPN per 100 mL or more, in Proctor Creek at Burbank (PC1), North Avenue (PC3), and the Greensferry tributary (PC2), but highest overall at 41,060 MPN at the Lindsay Street tributary (PC10) (Figure 4).

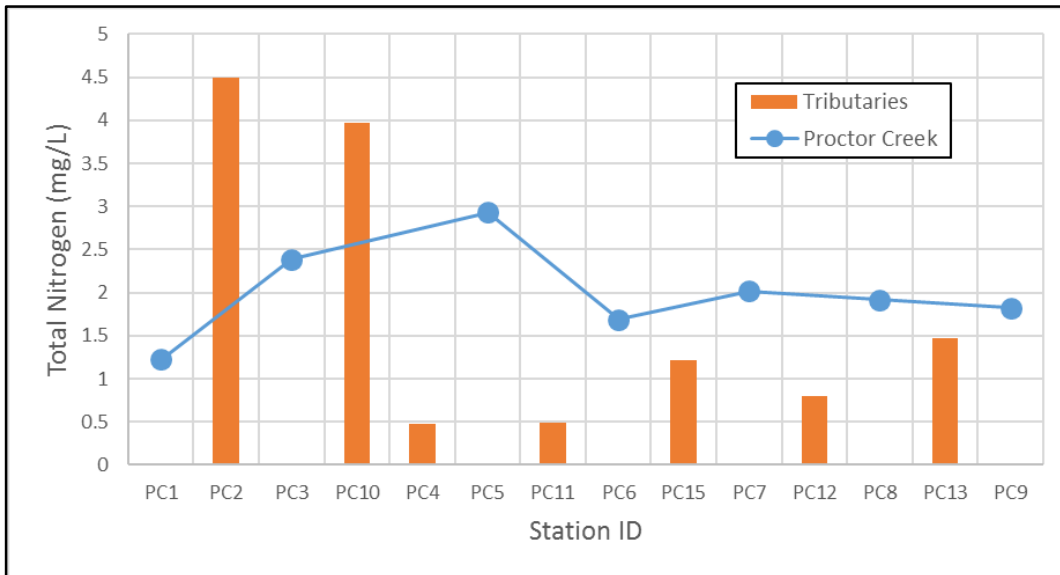
**Figure 5:** Total nitrogen (mg/L) in Proctor Creek and its tributaries. Locations are shown from upstream to downstream, in order from left to right.

Inorganic chemistry data for surface water samples are shown in Tables 3-4. Total nitrogen (TN) was highest at Greensferry (PC2) and Lindsay Street (PC10) (Figure 5), with the dissolved fraction ranging 71-96% across stations in the form of nitrate-nitrite, with two exceptions. At Greensferry, ammonia accounted for 24% of the total with 64% nitrate-nitrite. At North Avenue CSO (PC4), ammonia accounted for 72% of the total, with nitrate-nitrite below detection. There was also a residual concentration of 0.094 mg/L ammonia (3% of TN) downstream of North Avenue CSO at Hollowell (PC5). Total phosphorus levels were highest at Greensferry, with increases in the main channel downstream that declined from Hollowell to Northwest (Figure 6).

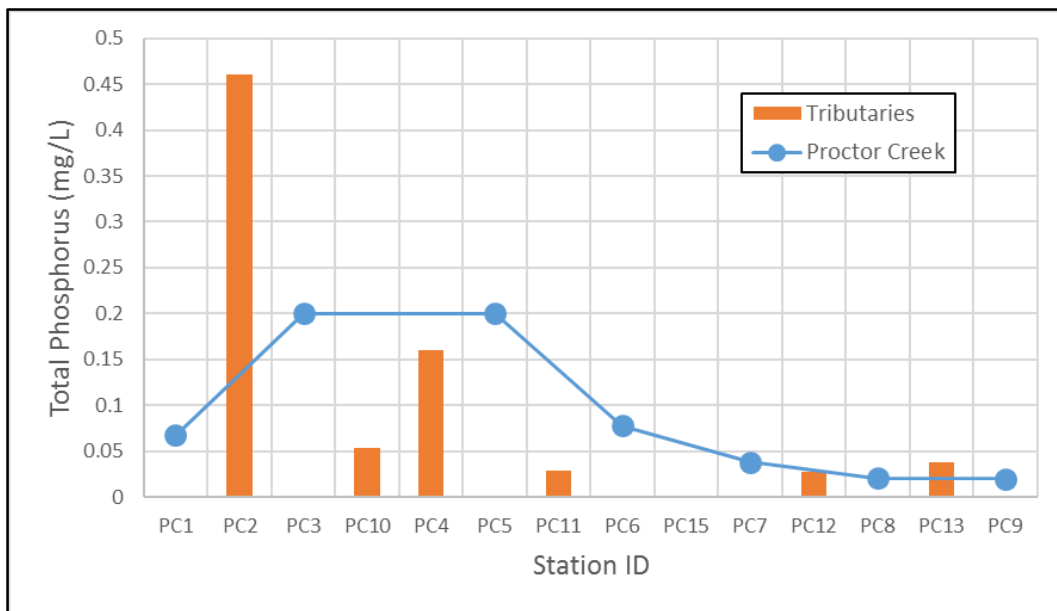
**Figure 6:** Total phosphorus (mg/L) in Proctor Creek and its tributaries. Locations are shown from upstream to downstream, in order from left to right.
