Chesapeake Energy – Eastern Division Aerial Leak Detection in Natural Gas Gathering Pipelines

May 14, 2009

Apogee Leak Detection System

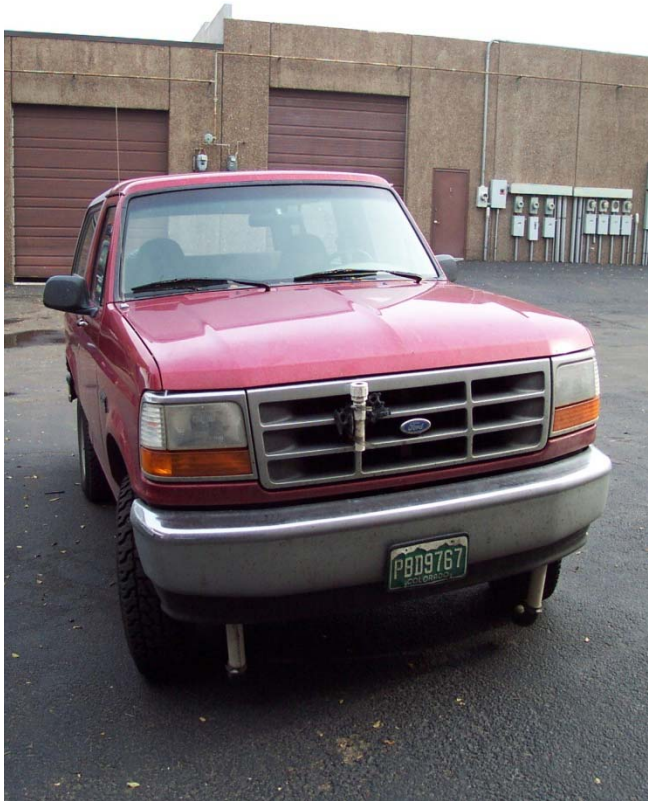
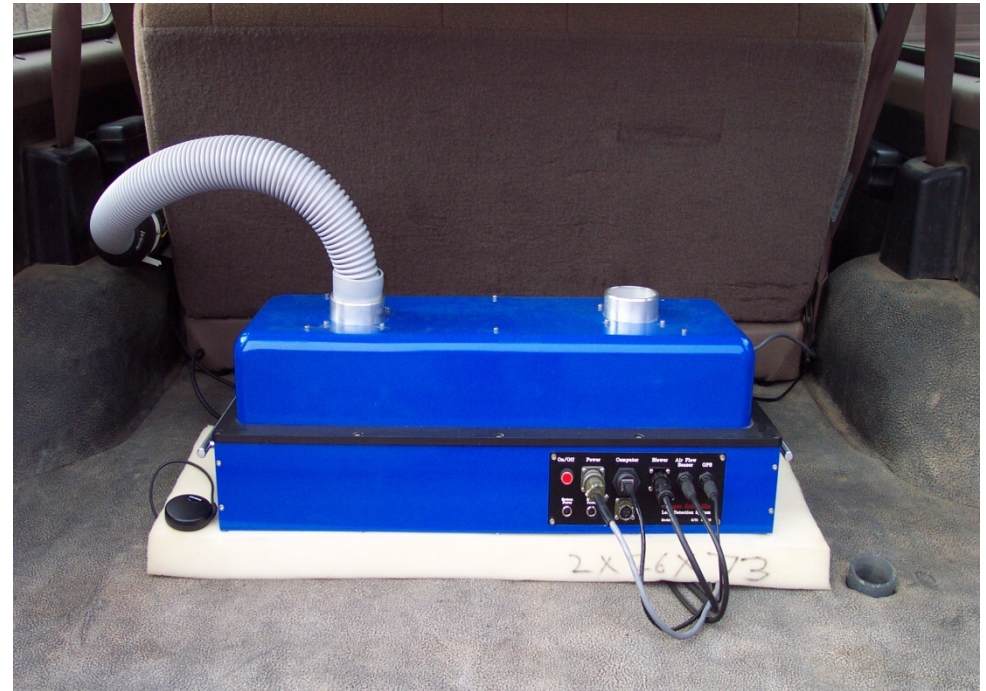
Truck Mounted LDS

- High Speed – High Sensitivity Three Gas Detector for Mobile applications
 - Methane
 - Total Hydrocarbons
 - Carbon Dioxide
- GPS with real time mapping system
- Integrated Geographic Information System (GIS)

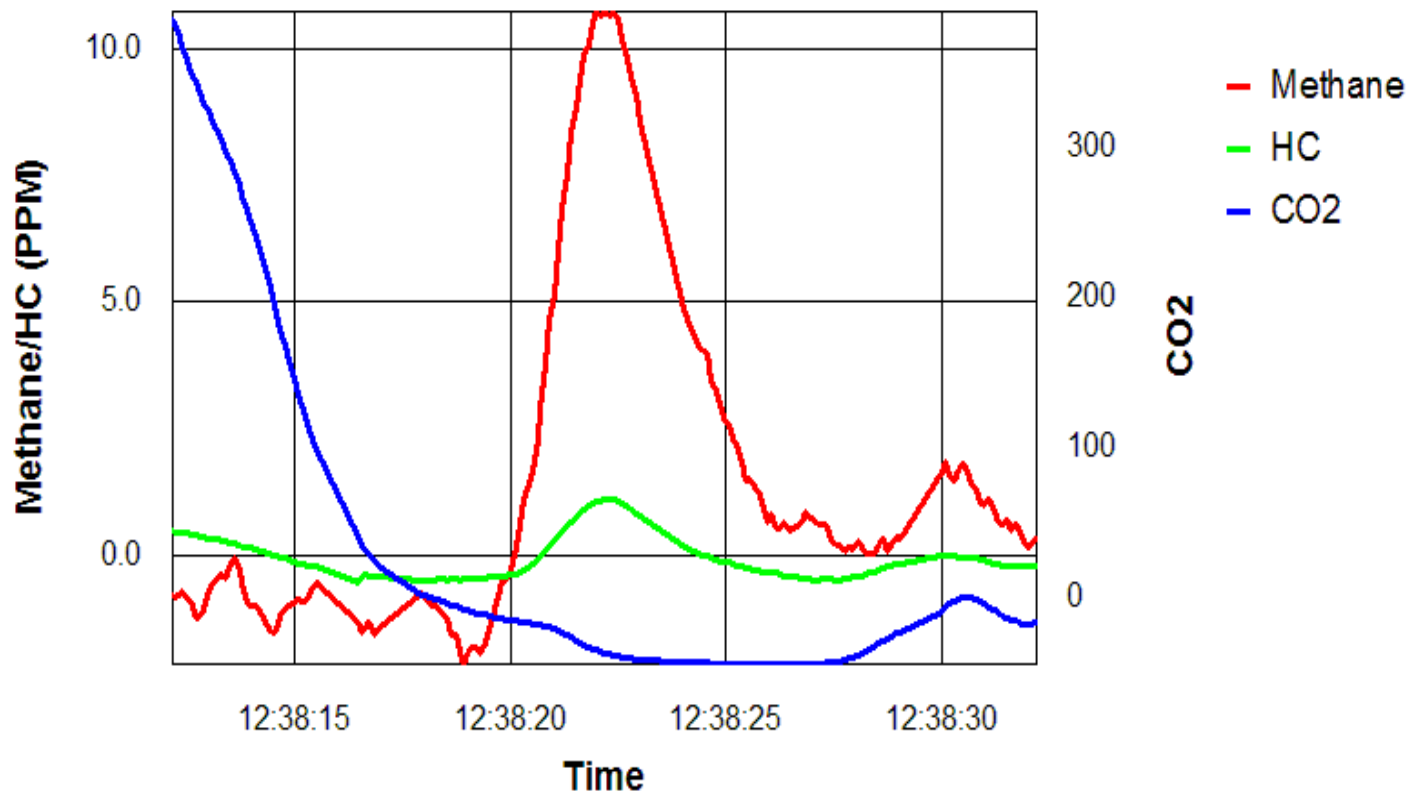
- Mostly methane, small amount of HC, No CO2

→ Dry Gas leak

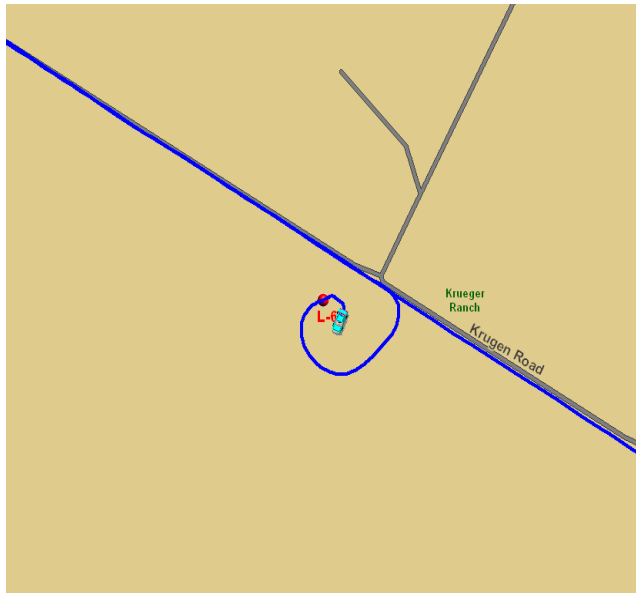
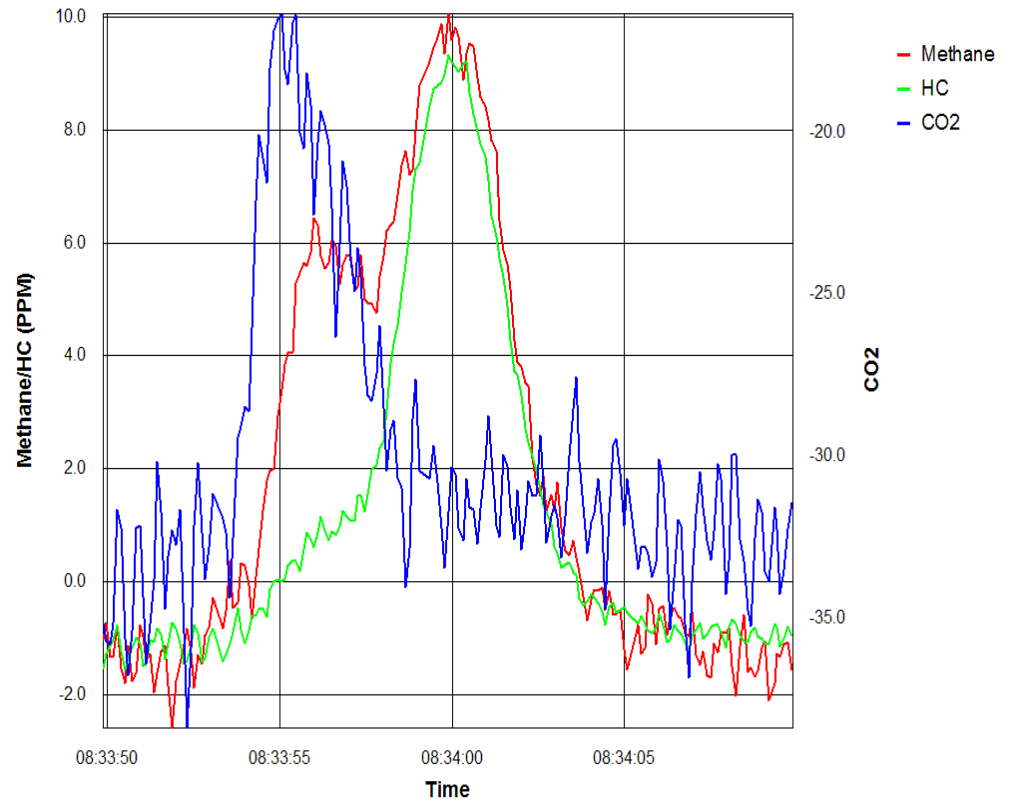
- Methane and HC, No CO2
- Rich Gas leak

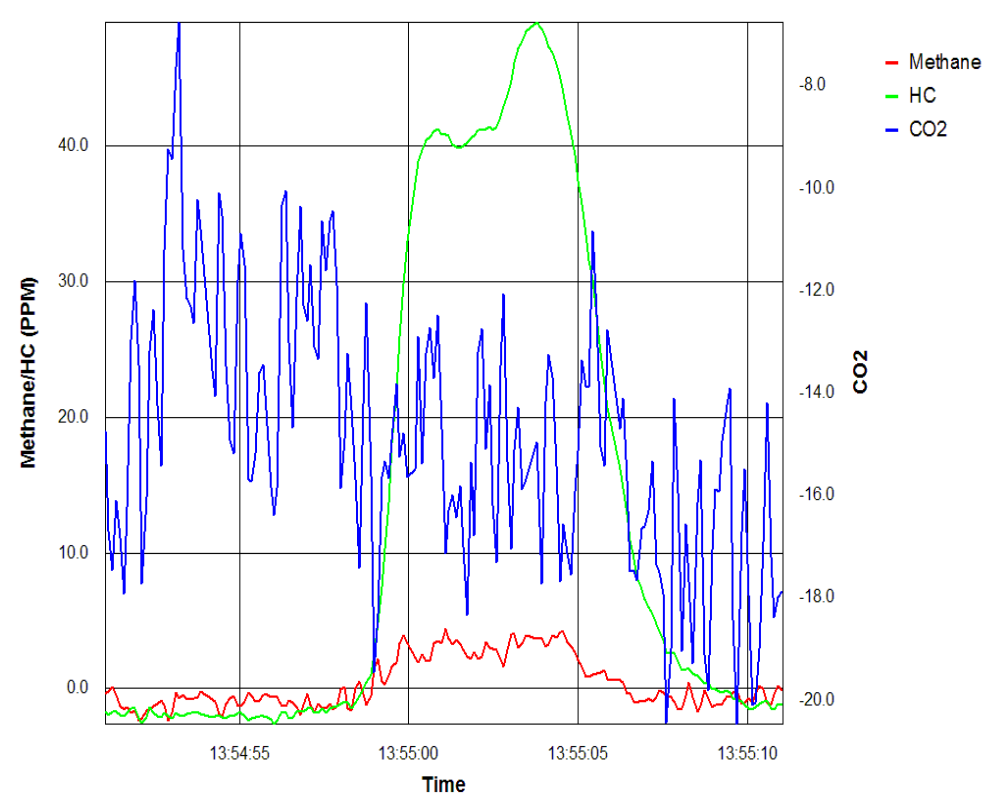
Non-Methane Hydrocarbon Gas

- HC, no methane or CO2
→ Propane or other HC leak

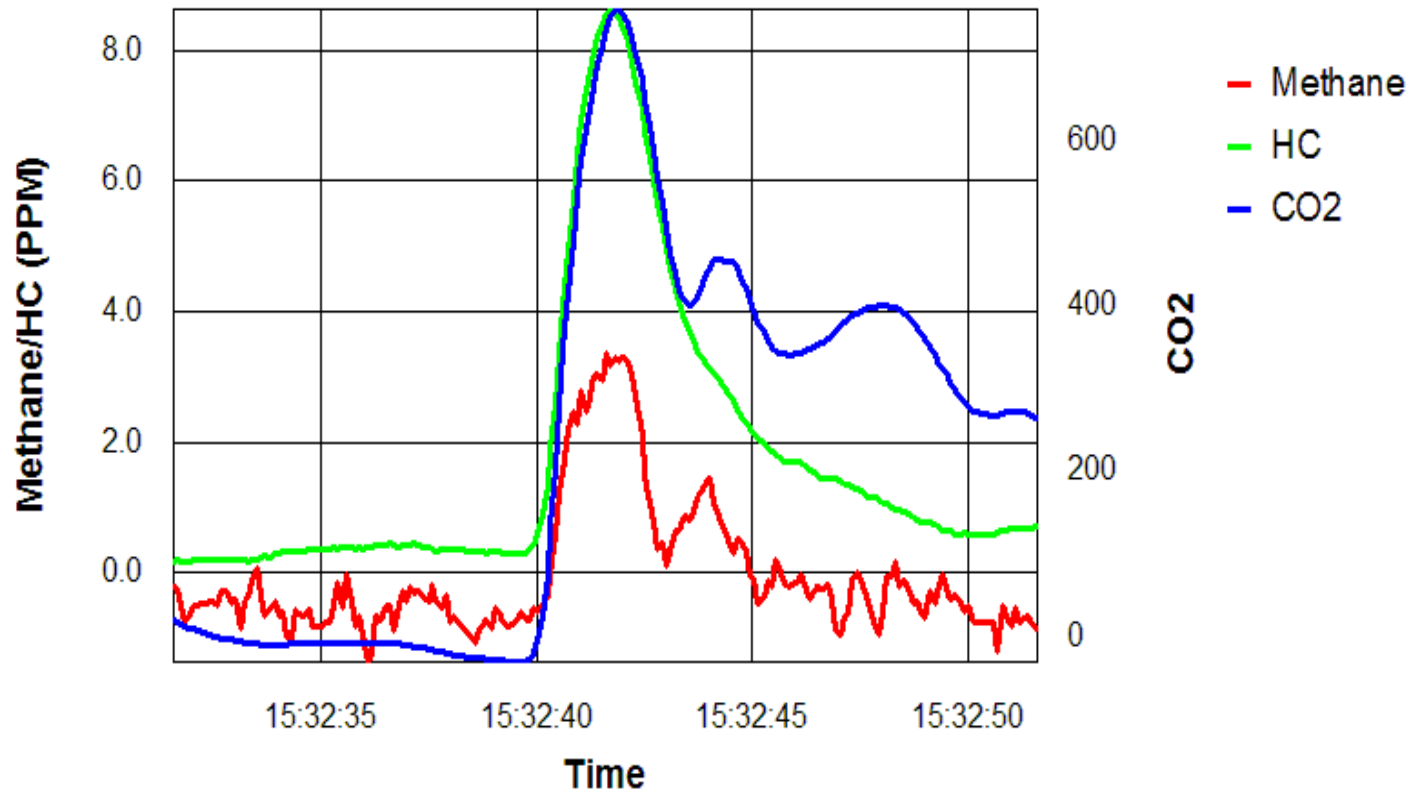
Vehicle Exhaust

- Methane, HC, and CO2
- Exhaust Gas – Not a leak

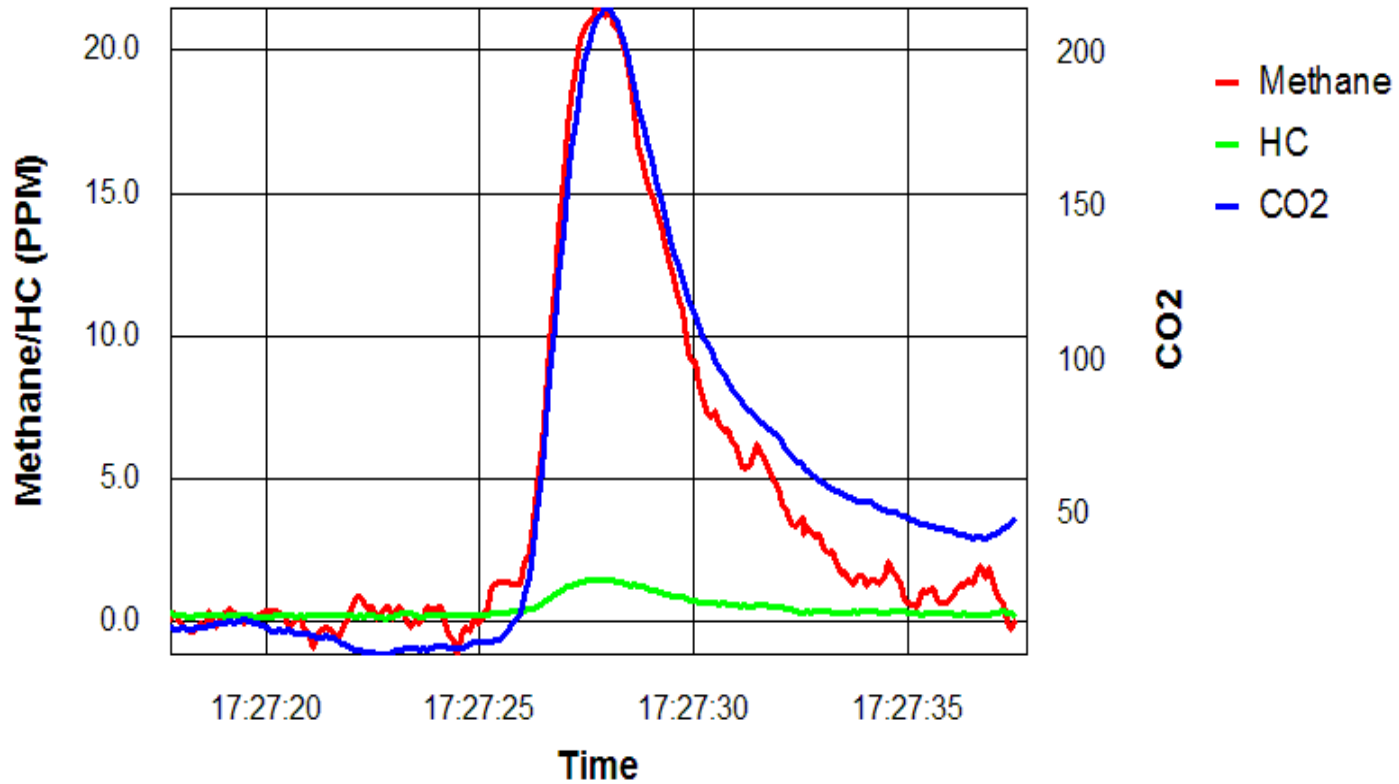
Landfill Gas

- Methane and CO2, No HC
- Landfill or Sewer Gas

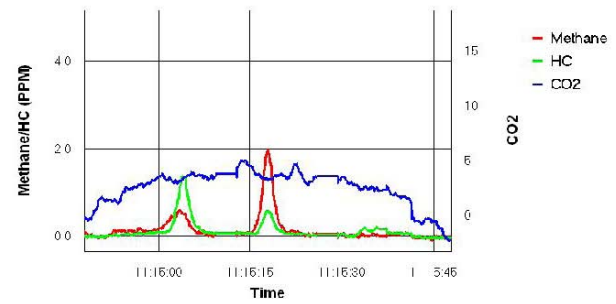
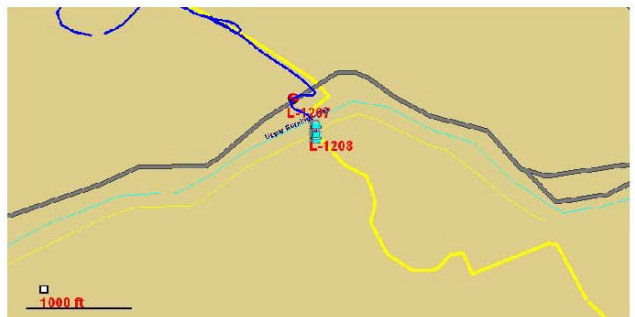
LDS Leak Report

Leak ID: L-1208
Project Name: SW
Date/Time Found: 06/25/2008 11:15
Max Methane Conc: 1.98 PPM
HC:CH4 Ratio: 0.28 R2 = 0.99
Address: Not Found
Lat: 37.827816
Lon: -82.382766
Altitude: 816 ft.
Vehicle Speed: 23 mph
Operator: Marpat
Comments:

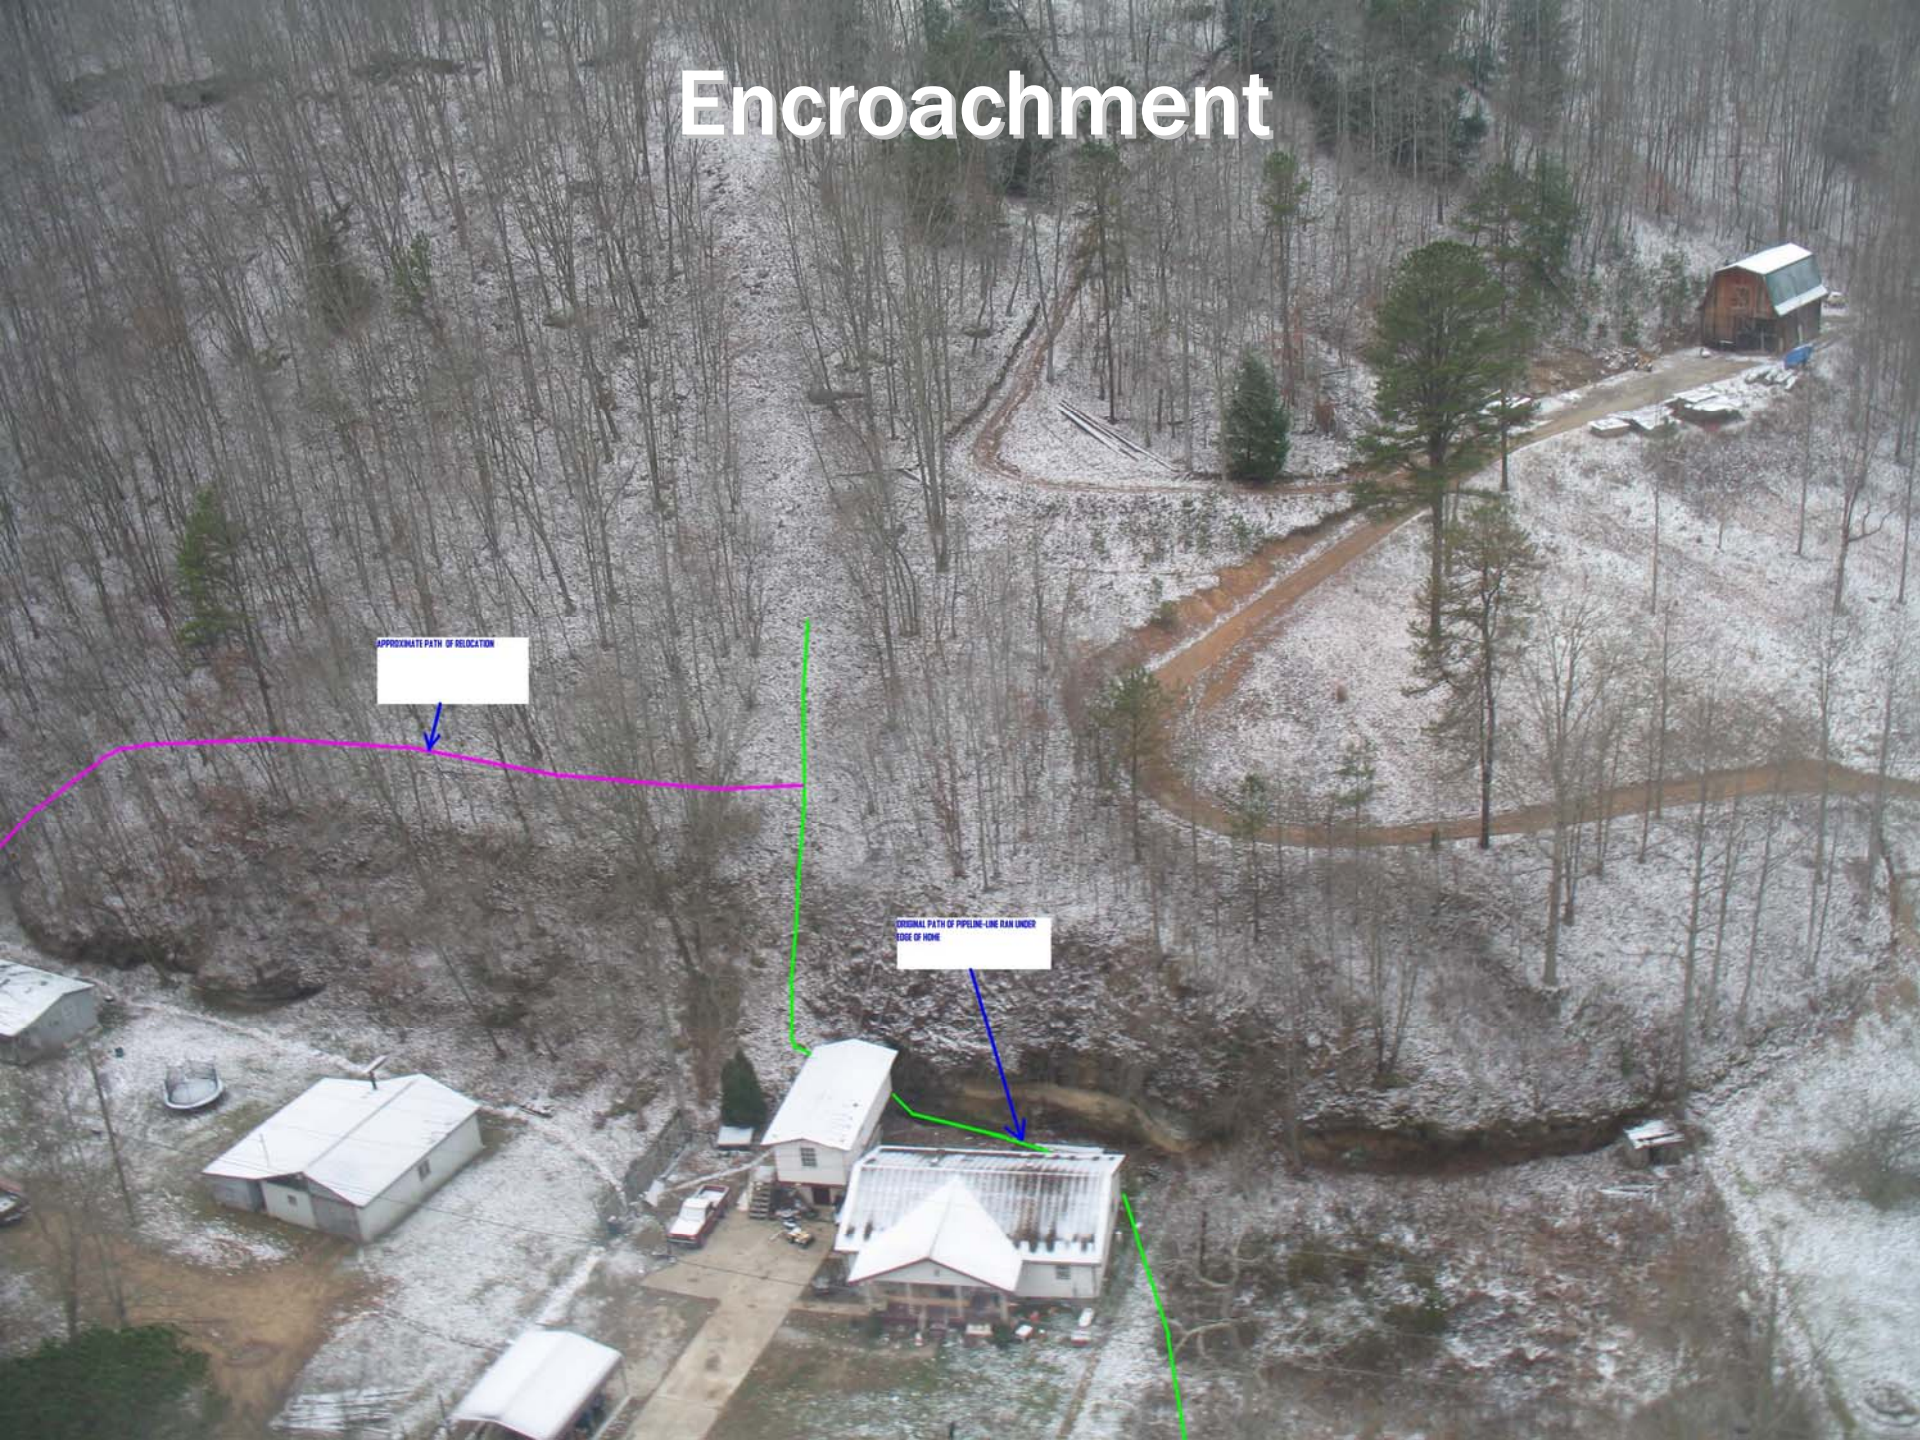
Encroachment

APPROXIMATE PATH OF RELOCATION

ORIGINAL PATH OF PIPELINE—LINE RAN UNDER
EDGE OF HOME

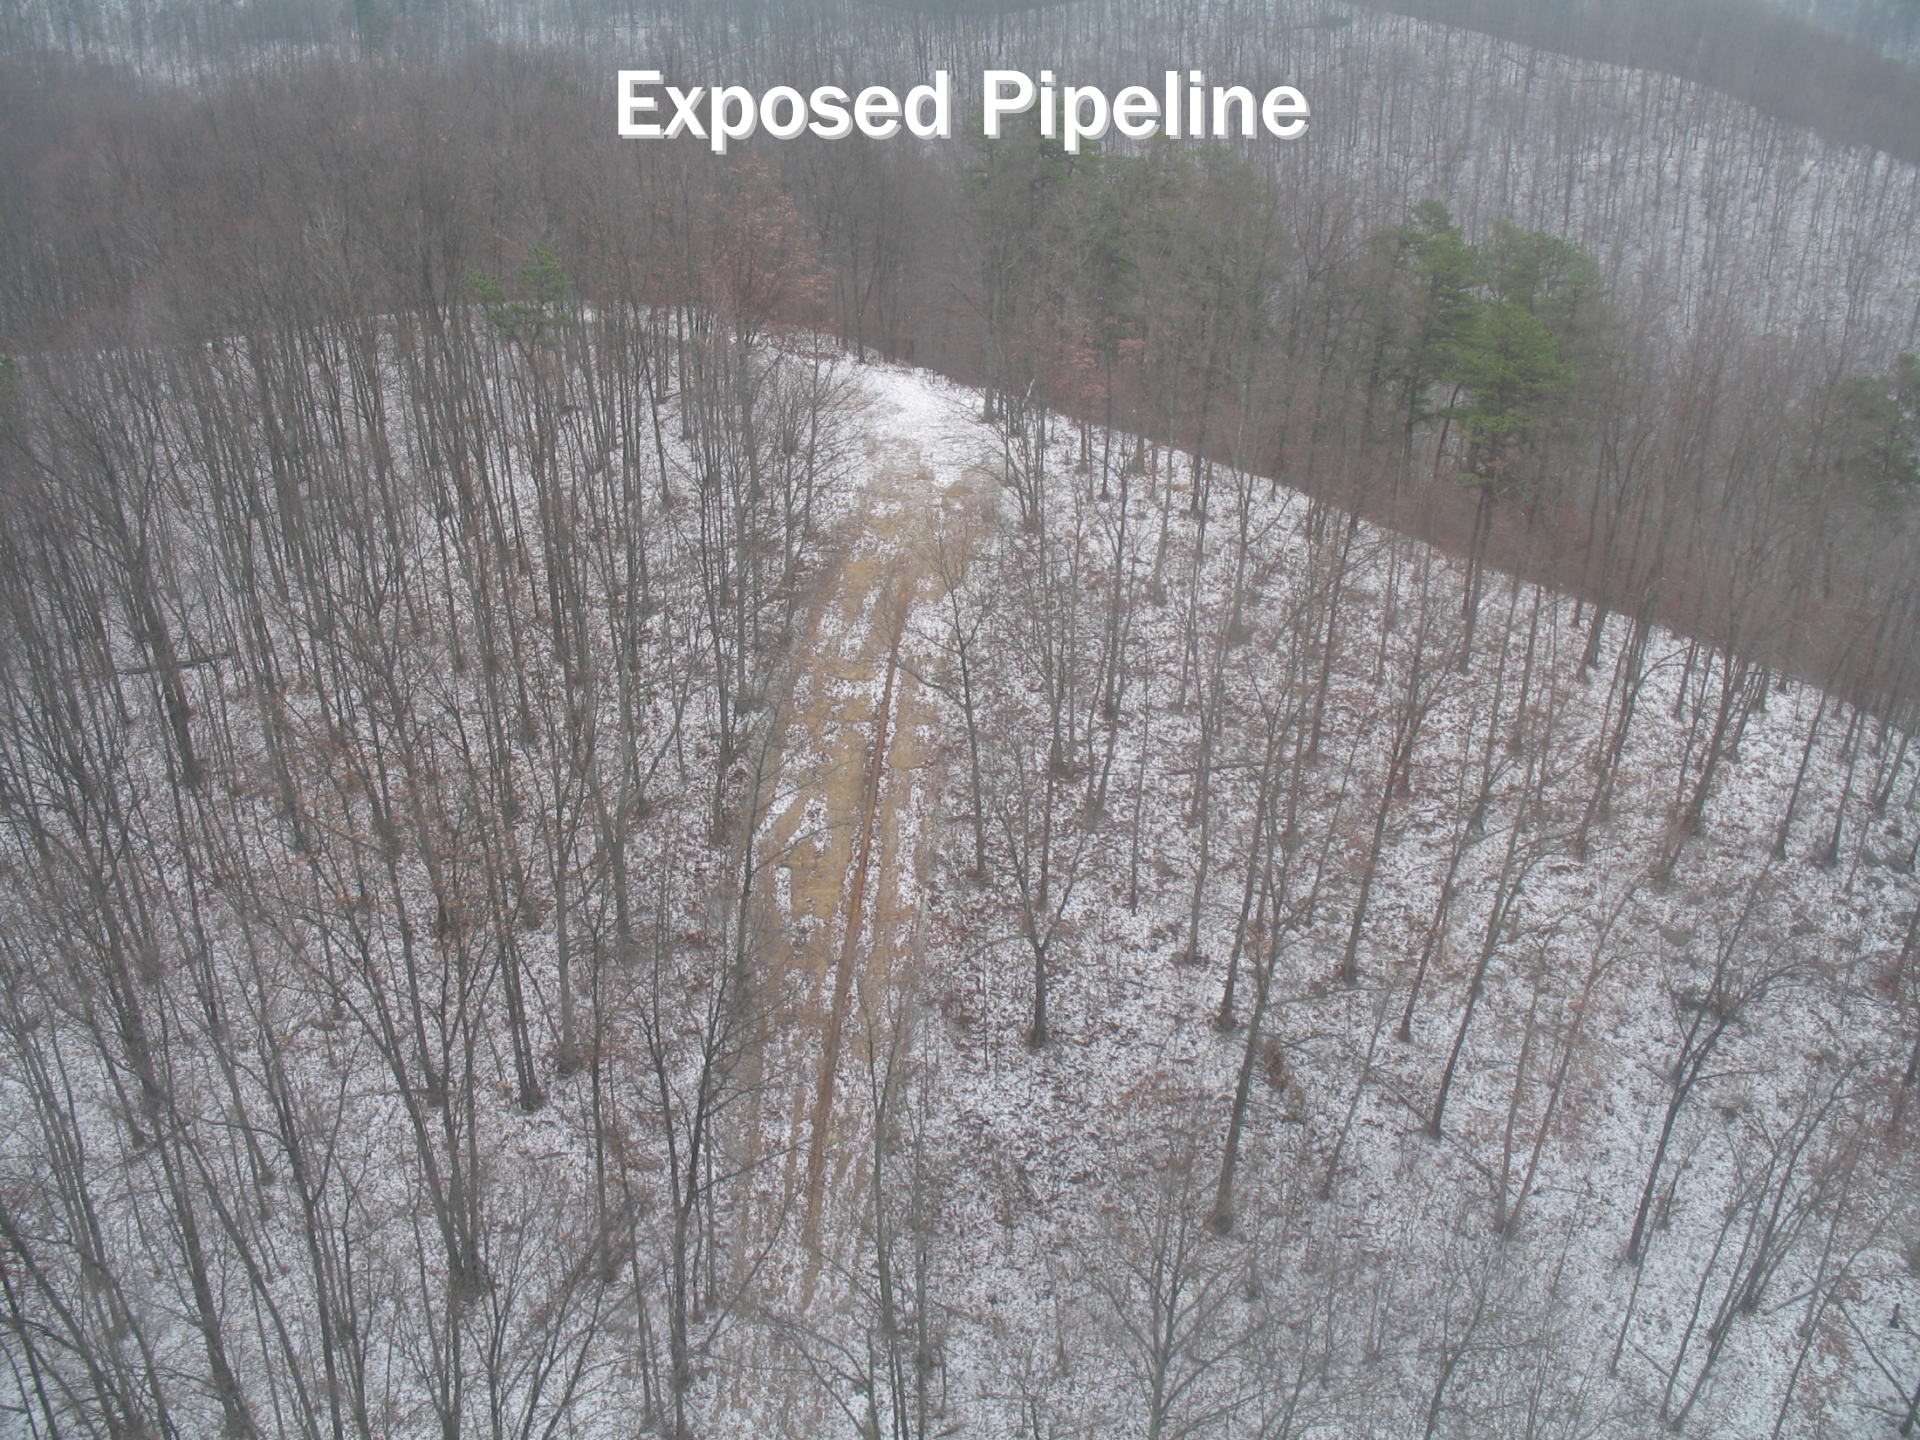
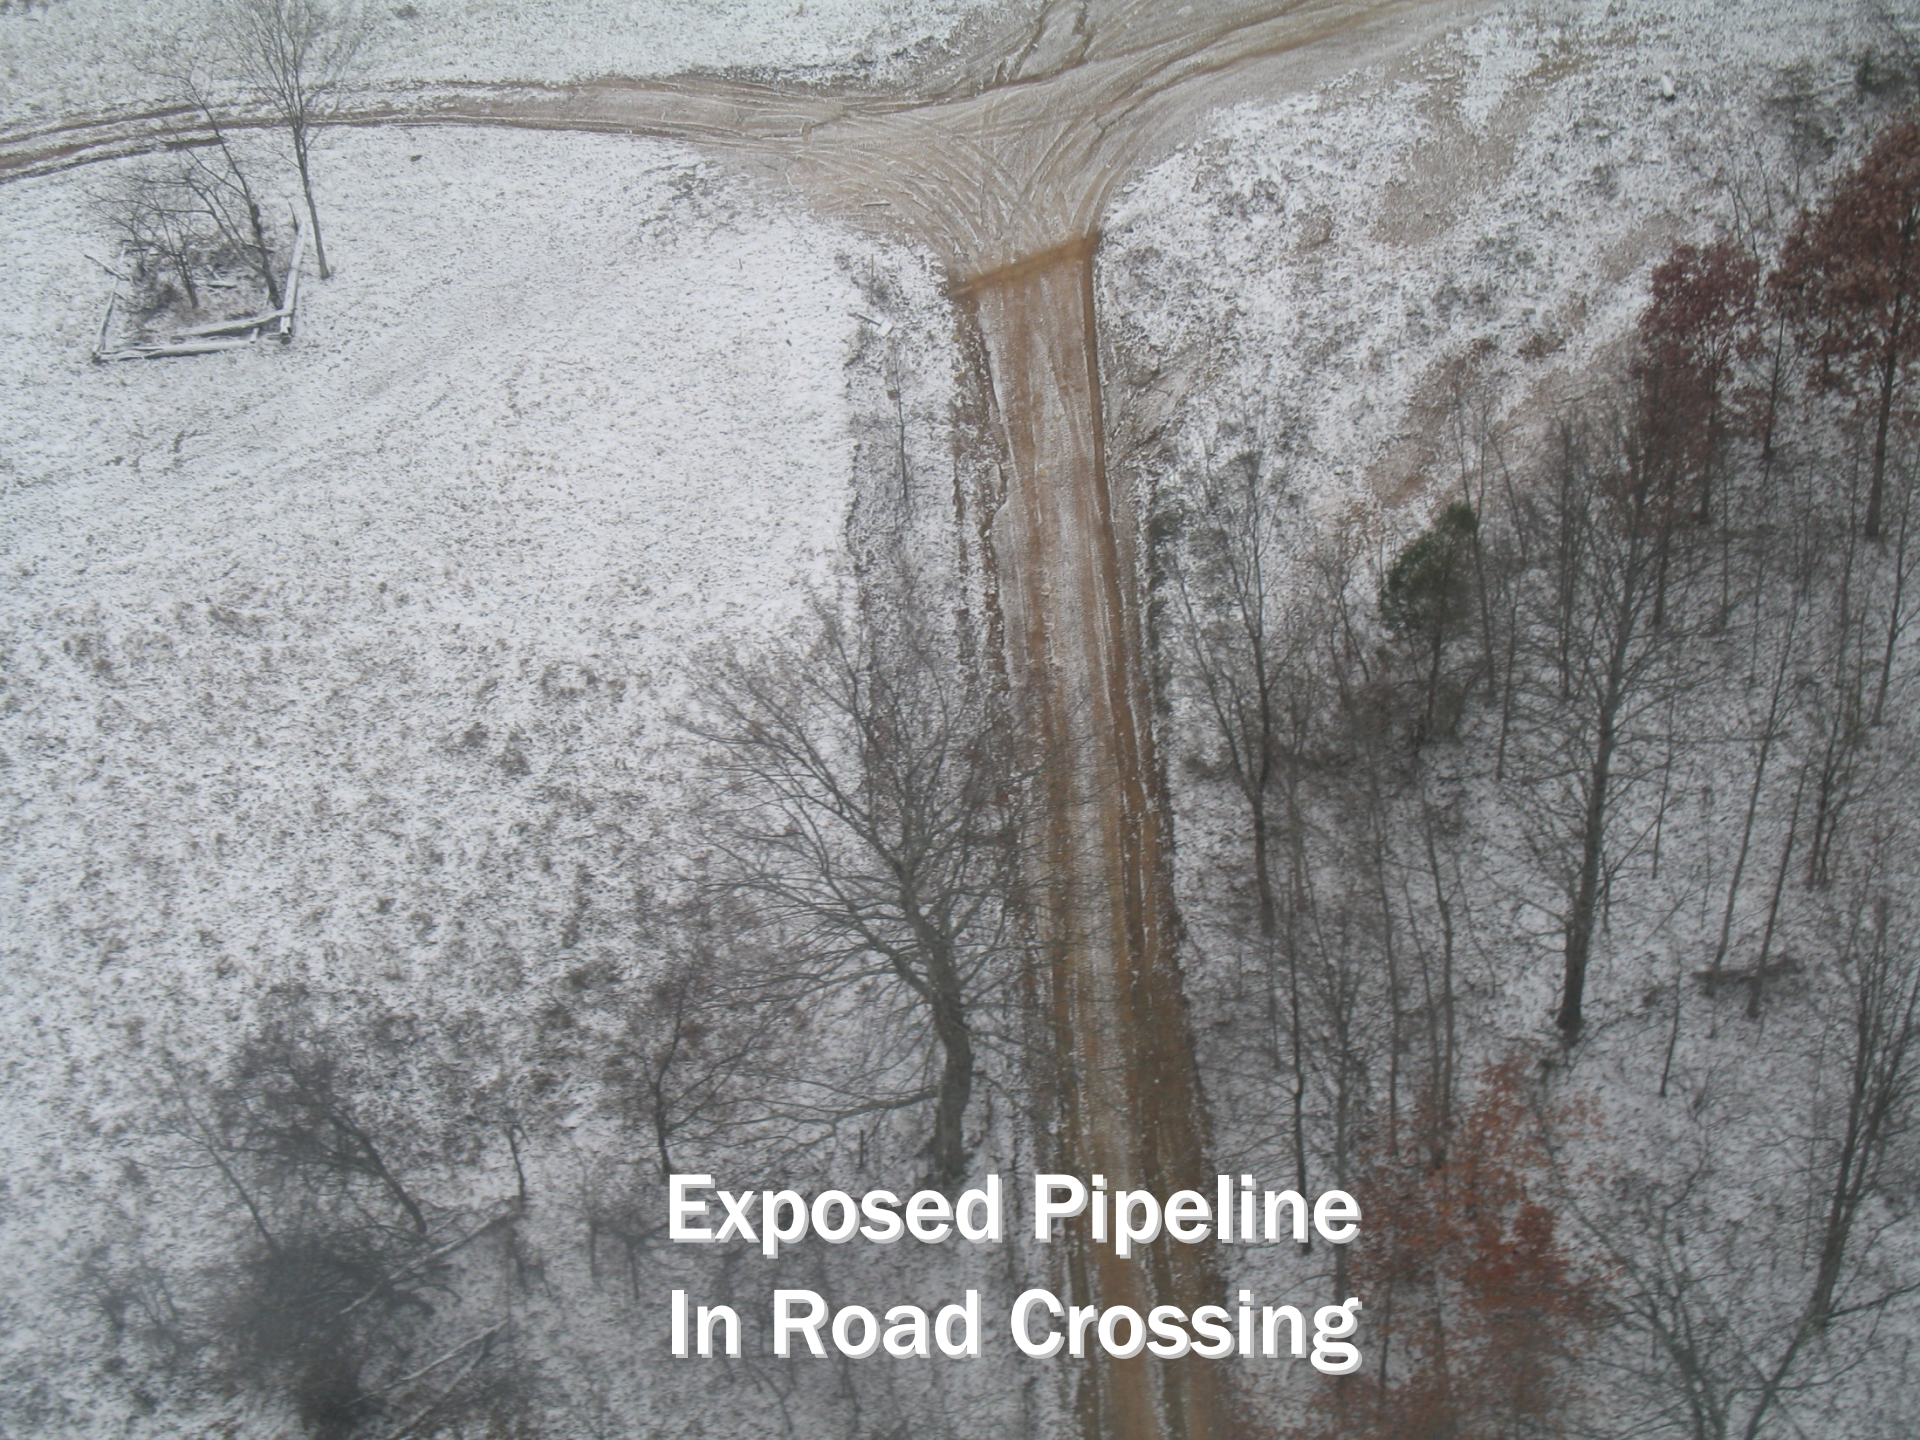
Exposed Pipeline

**Exposed Pipeline
In Road Crossing**
