Underground Storage Tank System Evaluation Final Report

Red Hill Bulk Fuel Storage Facility Joint Base Pearl Harbor-Hickam

June 2017

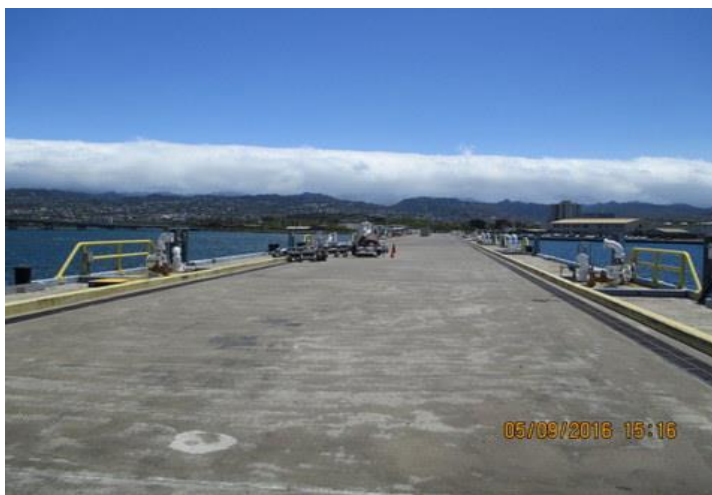
Figure 2. Overview Photo of the Hotel Pier

After the opening conference on May 9th, the field team viewed the Hotel Pier (see Figure 2). The Hotel Pier is the main loading and unloading pier adjacent to Building 1757. This location also births the largest ships of any pier connected to the UST system. The Hotel Pier comprises four "hotels" (each "hotel" is a group of connections for the JP-5, JP-8, and F-76 pipelines). The Hotel Pier is made of concrete with spill and leak containment; it does not have any loading arms. It

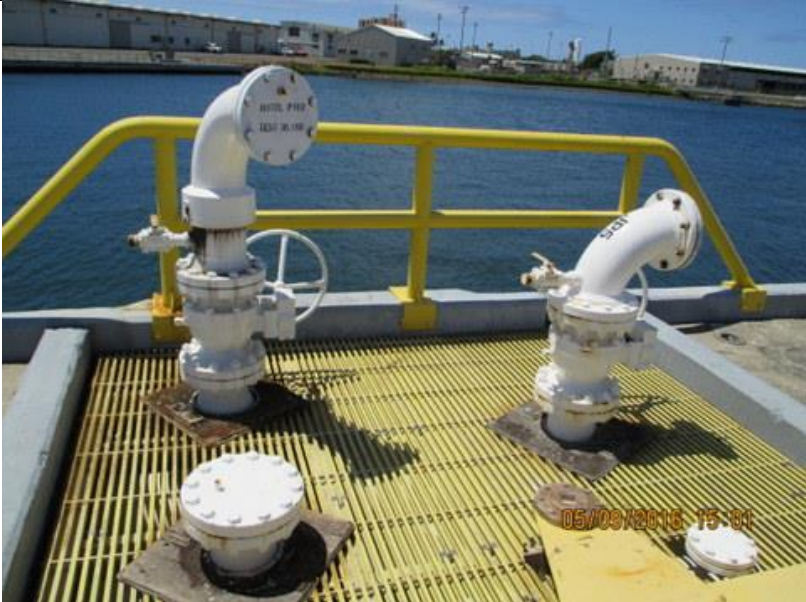
DATE TAKEN: 5/9/2016	
TAKEN BY: Chris Krejci	SITE LOCATION: Red Hill Facility
PHOTO #: 15	
COMMENTS: One "Hotel" of four on the Hotel Pier, with risers for all three fuels stored at the Red Hill Facility

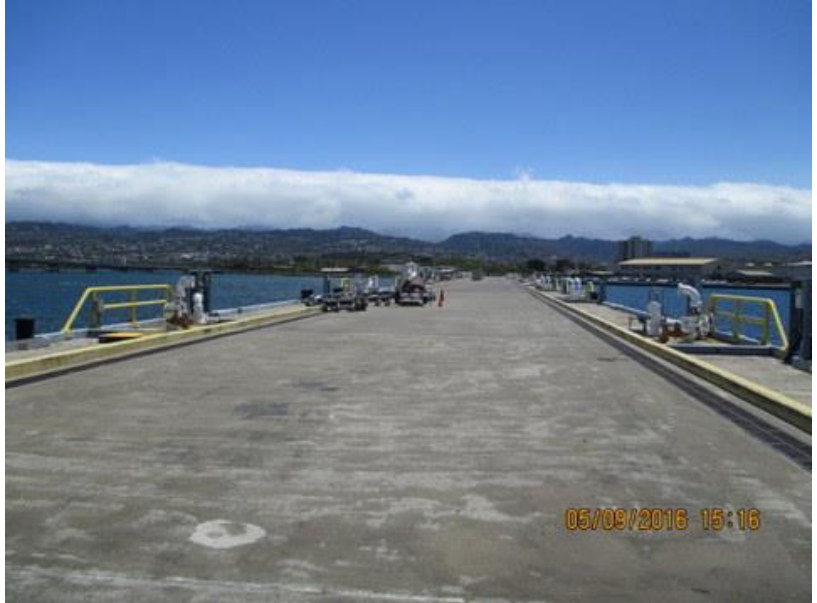
DATE TAKEN: 5/9/2016	
TAKEN BY: Chris Krejci	SITE LOCATION: Red Hill Facility
PHOTO #: 18	
COMMENTS: Hotel Pier looking east from the end of the pier toward Red Hill

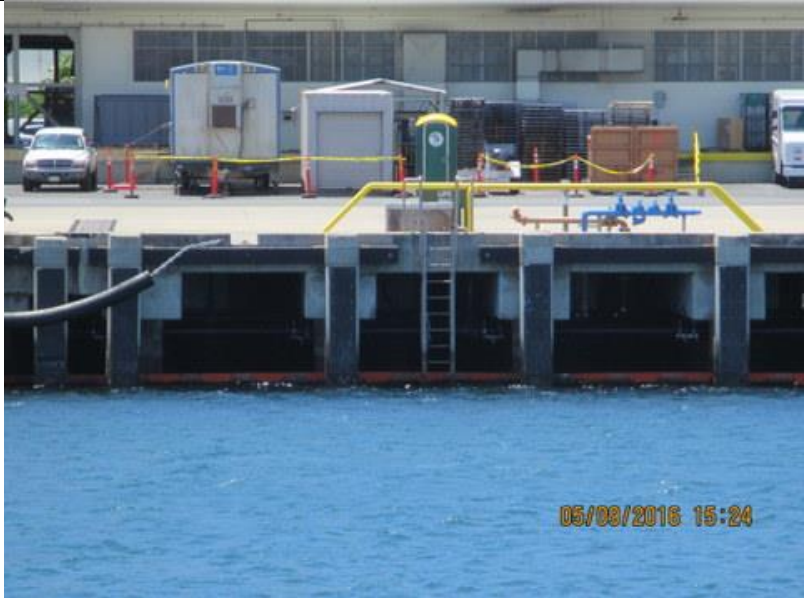
DATE TAKEN: 5/9/2016	
TAKEN BY: Chris Krejci	SITE LOCATION: Red Hill Facility
PHOTO #: 19	
COMMENTS: View of docks adjacent to pier illustrating the boom system in place to control oil spills in emergencies

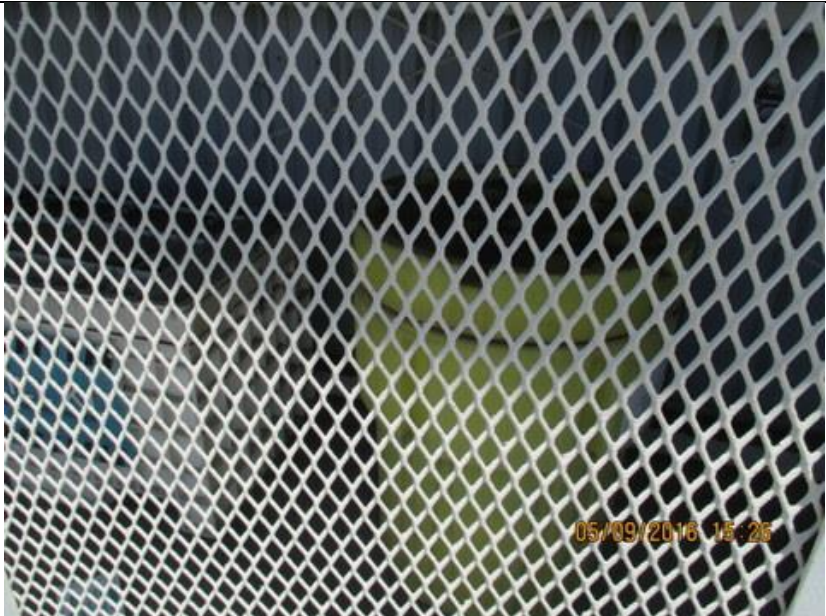
DATE TAKEN: 5/9/2016	
TAKEN BY: Chris Krejci	SITE LOCATION: Red Hill Facility
PHOTO #: 20	
COMMENTS: Spill response kits inside of cage on Hotel Pier

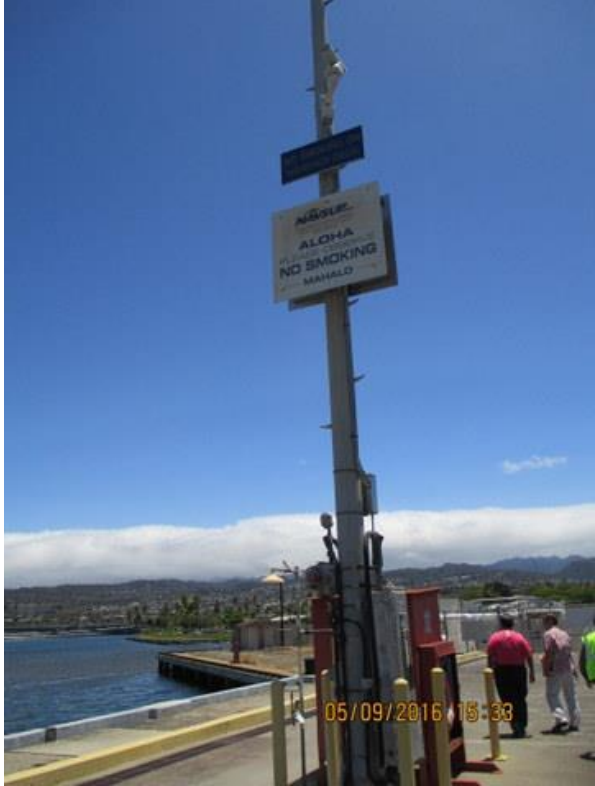
DATE TAKEN: 5/9/2016	
TAKEN BY: Chris Krejci	SITE LOCATION: Red Hill Facility
PHOTO #: 21	
COMMENTS: Alarm system at Hotel Pier

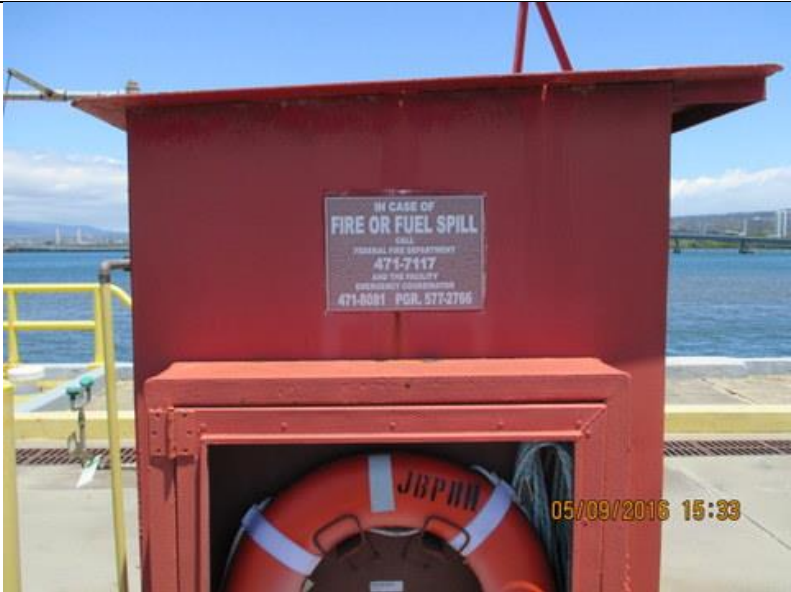
DATE TAKEN: 5/9/2016	
TAKEN BY: Chris Krejci	SITE LOCATION: Red Hill Facility
PHOTO #: 22	
COMMENTS: Emergency response number posted

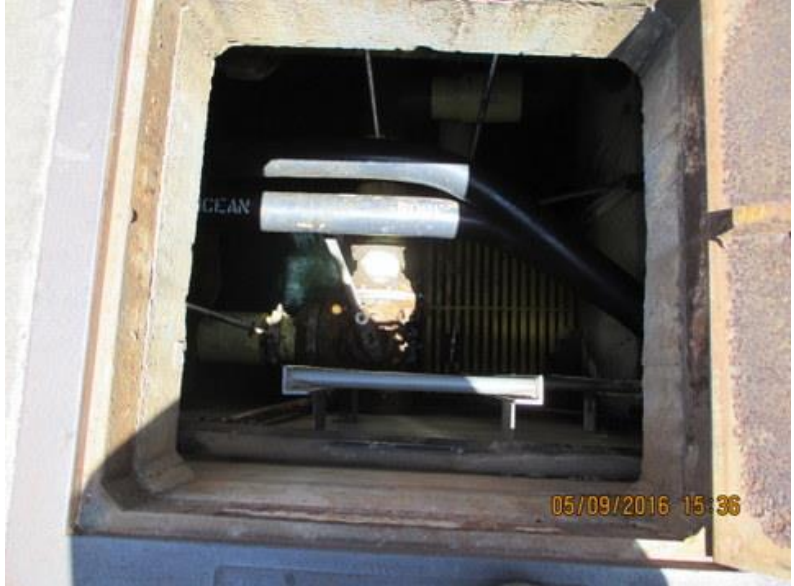
DATE TAKEN: 5/9/2016	
TAKEN BY: Chris Krejci	SITE LOCATION: Red Hill Facility
PHOTO #: 23	
COMMENTS: Diversion valve for Hotel Pier storm water drainage system

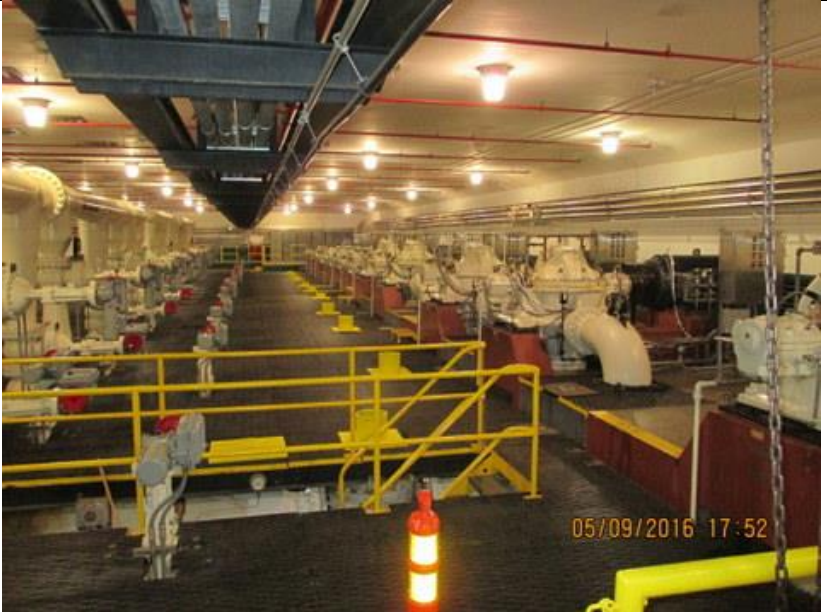
DATE TAKEN: 5/9/2016	
TAKEN BY: Chris Krejci	SITE LOCATION: Red Hill Facility
PHOTO #: 27	
COMMENTS: Pumphouse

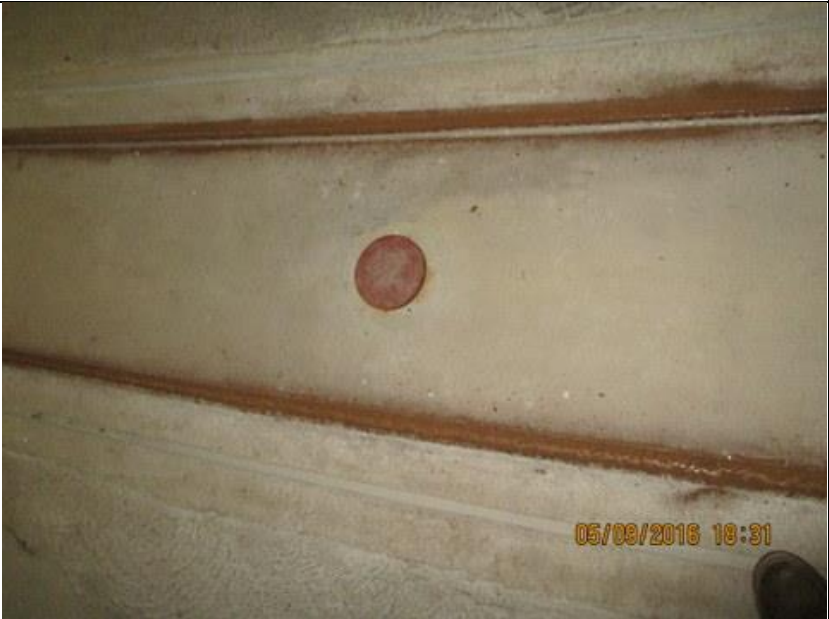
DATE TAKEN: 5/9/2016	
TAKEN BY: Chris Krejci	SITE LOCATION: Red Hill Facility
PHOTO #: 31	
COMMENTS: Tile covering French drain beneath Red Hill Facility tunnel

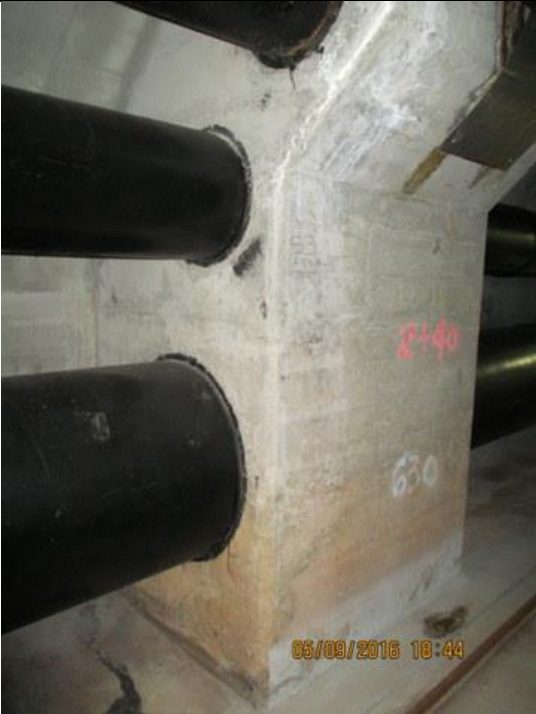
DATE TAKEN: 5/9/2016	
TAKEN BY: Chris Krejci	SITE LOCATION: Red Hill Facility
PHOTO #: 32	
COMMENTS: Pipelines supported by concrete wall in tunnel

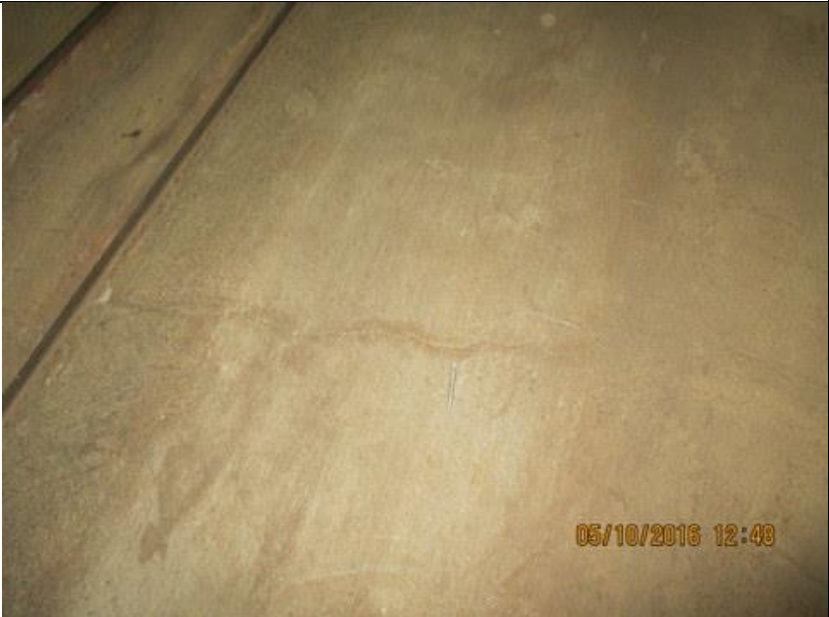
DATE TAKEN: 5/10/2016	
TAKEN BY: Chris Krejci	SITE LOCATION: Red Hill Facility
PHOTO #: 34	
COMMENTS: Minor cracking in tunnel floor

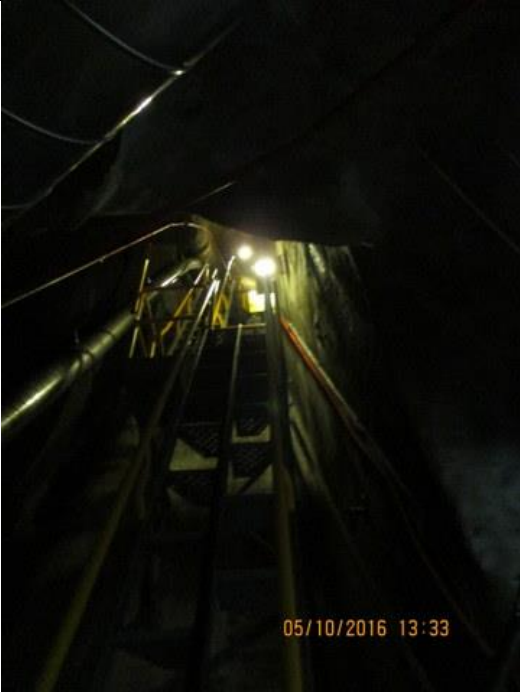
DATE TAKEN: 5/10/2016	
TAKEN BY: Chris Krejci	SITE LOCATION: Red Hill Facility
PHOTO #: 35	
COMMENTS: Stairway leading to gauging port on top of underground storage tanks

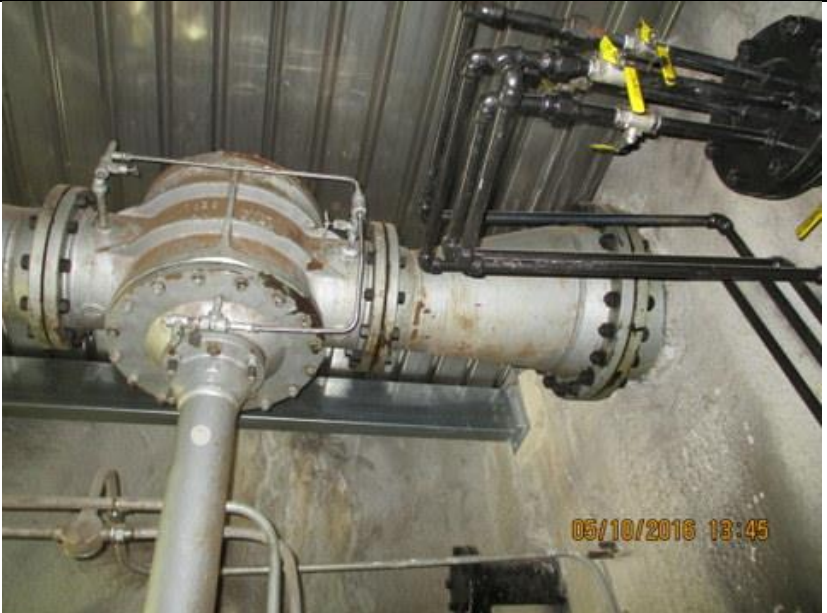
DATE TAKEN: 5/10/2016	
TAKEN BY: Chris Krejci	SITE LOCATION: Red Hill Facility
PHOTO #: 36	
COMMENTS: SP-26 Underground storage tank nozzle and skin valve

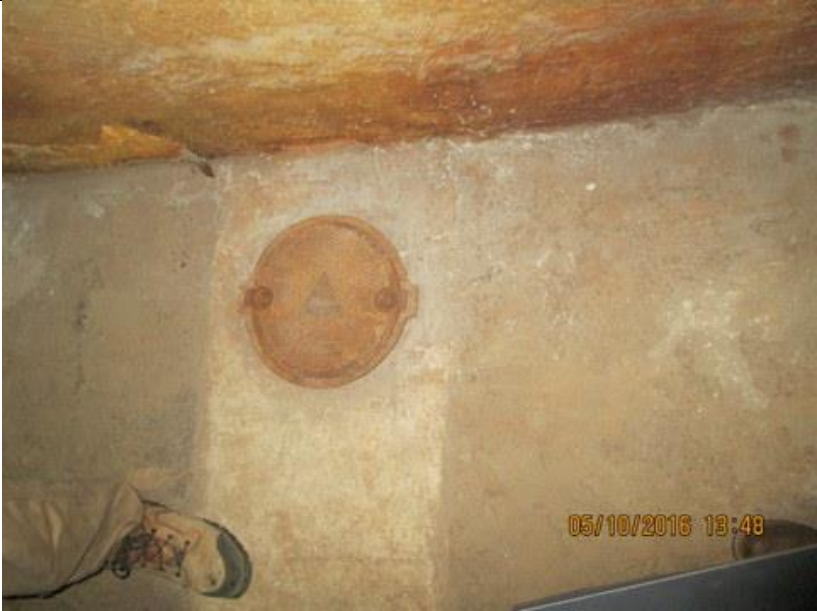
DATE TAKEN: 5/10/2016	
TAKEN BY: Chris Krejci	SITE LOCATION: Red Hill Facility
PHOTO #: 37	
COMMENTS: Cover for soil vapor monitoring wells

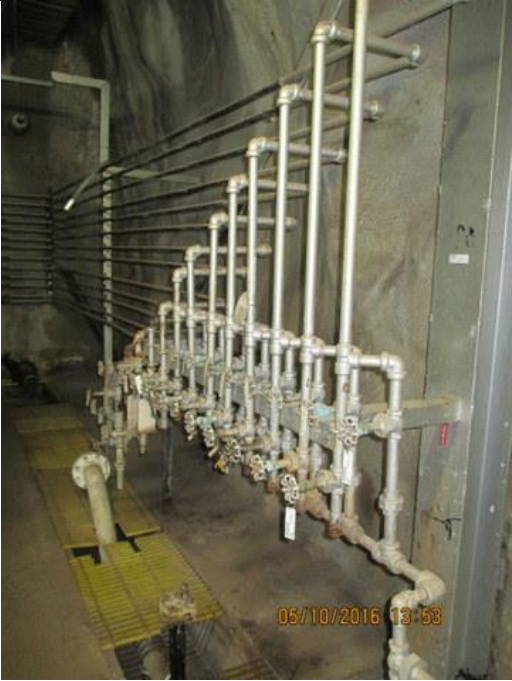
DATE TAKEN: 5/10/2016	
TAKEN BY: Chris Krejci	SITE LOCATION: Red Hill Facility
PHOTO #: 39	
COMMENTS: Tell-tale system on Tank 19 (Tank 19 has been permanently removed from service and the tell-tale system has been decommissioned).

The Red Hill Facility employs three methods of leak detection: (1) annual tank tightness testing; (2) ATG; and (3) soil gas monitoring. Although the Navy conducts groundwater monitoring, EPA does not consider this activity to be a leak detection method at this site. Each of these methods, including groundwater monitoring, is described in the subsections below. In addition to these methods, the Red Hill Facility previously employed the use of a tell-tale system comprising a series of steel pipes that penetrated the walls of the USTs near the tank bottom to observe fluid outside the steel shell of each tank; however, this system was decommissioned at all of the tanks and is no longer used due to concerns regarding corrosion and vulnerability of the tell-tale piping to leakage.

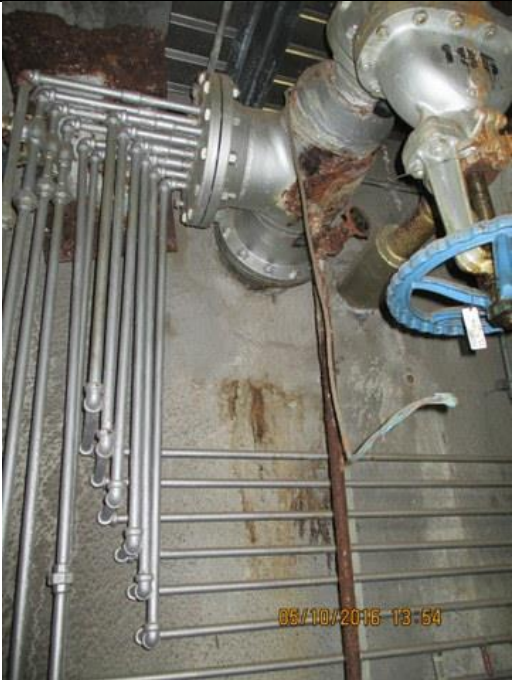
DATE TAKEN: 5/10/2016	
TAKEN BY: Chris Krejci	SITE LOCATION: Red Hill Facility
PHOTO #: 40	
COMMENTS: Tell-tale system on Tank 19 (Tank 19 has been permanently removed from service and the tell-tale system has been decommissioned).

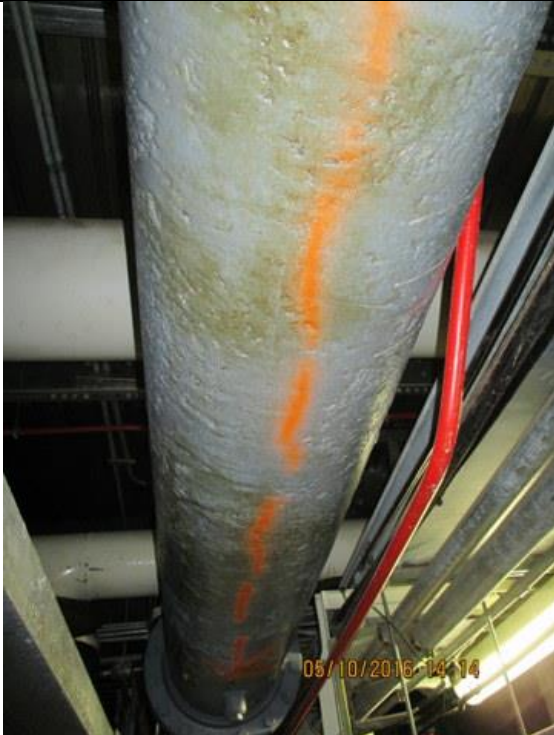
DATE TAKEN: 5/10/2016	
TAKEN BY: Chris Krejci	SITE LOCATION: Red Hill Facility
PHOTO #: 42	
COMMENTS: Pitting on pipeline

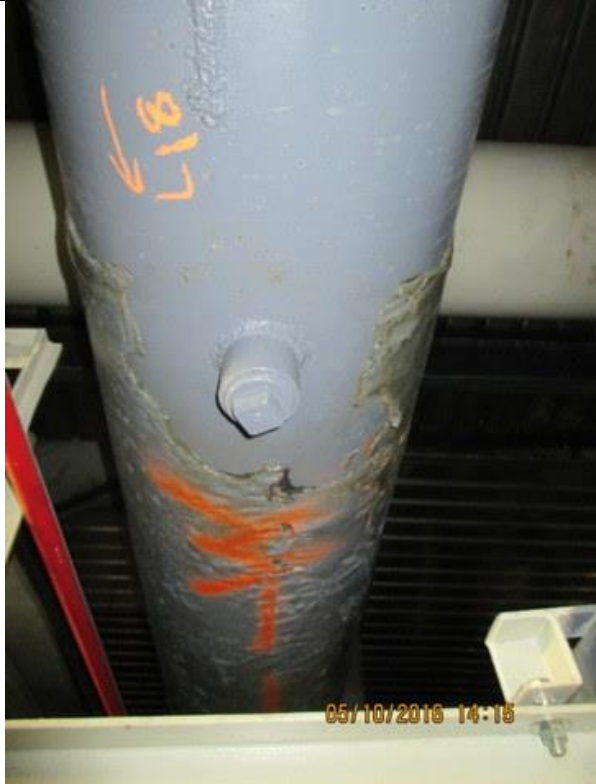
DATE TAKEN: 5/10/2016	
TAKEN BY: Chris Krejci	SITE LOCATION: Red Hill Facility
PHOTO #: 43	
COMMENTS: Typical surface defects on pipeline

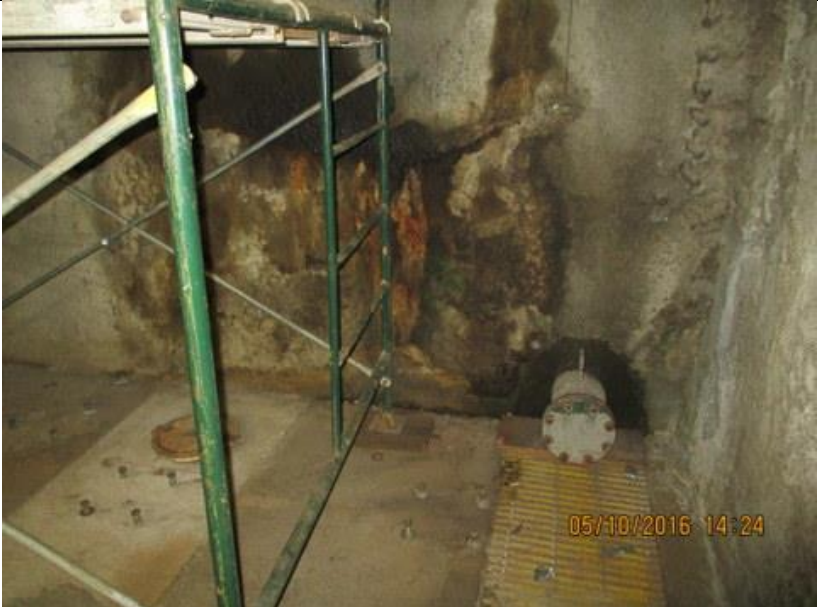
DATE TAKEN: 5/10/2016	
TAKEN BY: Chris Krejci	SITE LOCATION: Red Hill Facility
PHOTO #: 44	
COMMENTS: Staining on Tank 5, just below and to the right of the nozzle.

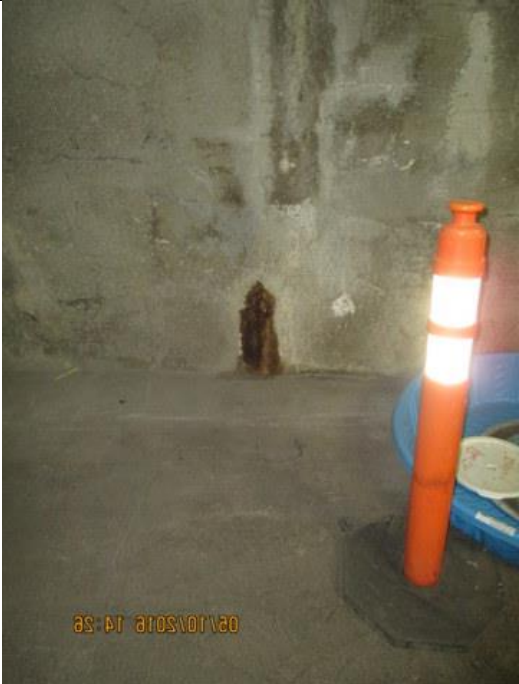
DATE TAKEN: 5/10/2016	
TAKEN BY: Chris Krejci	SITE LOCATION: Red Hill Facility
PHOTO #: 46	
COMMENTS: Staining on tunnel wall (appearance similar to bunker oil)

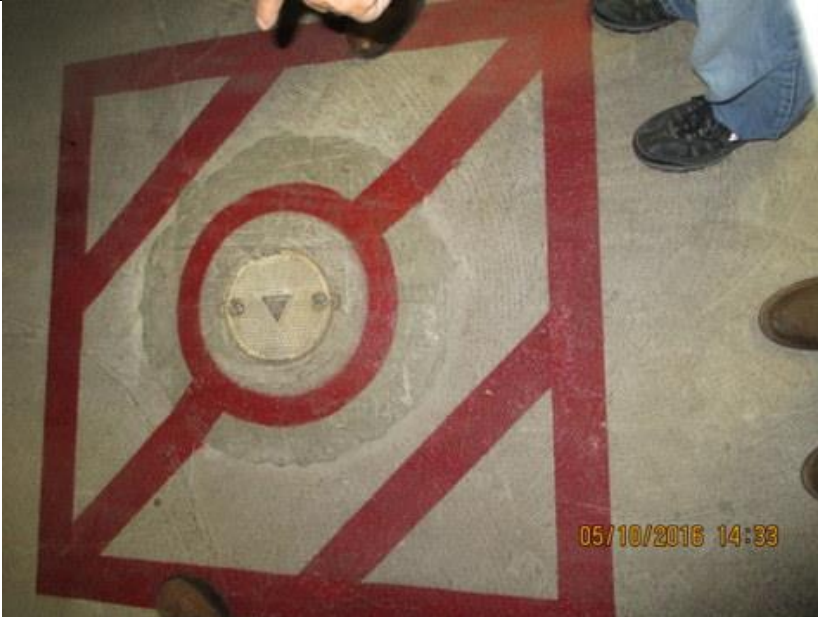
DATE TAKEN: 5/10/2016	
TAKEN BY: Chris Krejci	SITE LOCATION: Red Hill Facility
PHOTO #: 48	
COMMENTS: Typical flush-mounted groundwater monitoring well near underground storage tanks

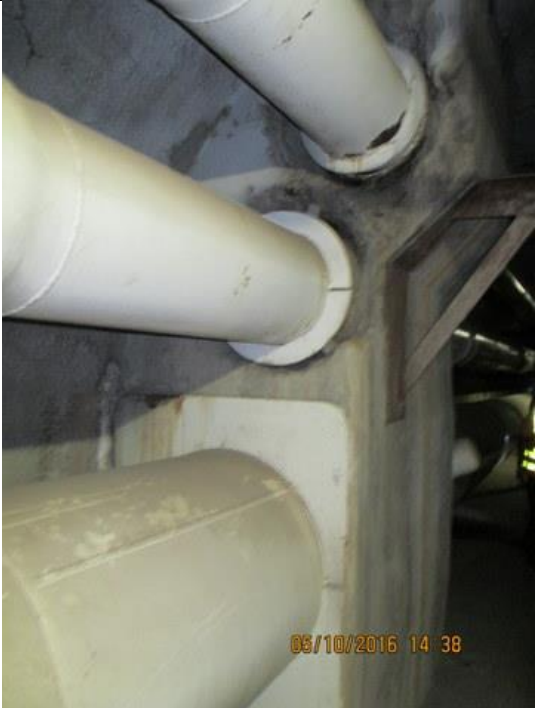
DATE TAKEN: 5/10/2016	
TAKEN BY: Chris Krejci	SITE LOCATION: Red Hill Facility
PHOTO #: 49	
COMMENTS: Pipelines supported by concrete wall in tunnel

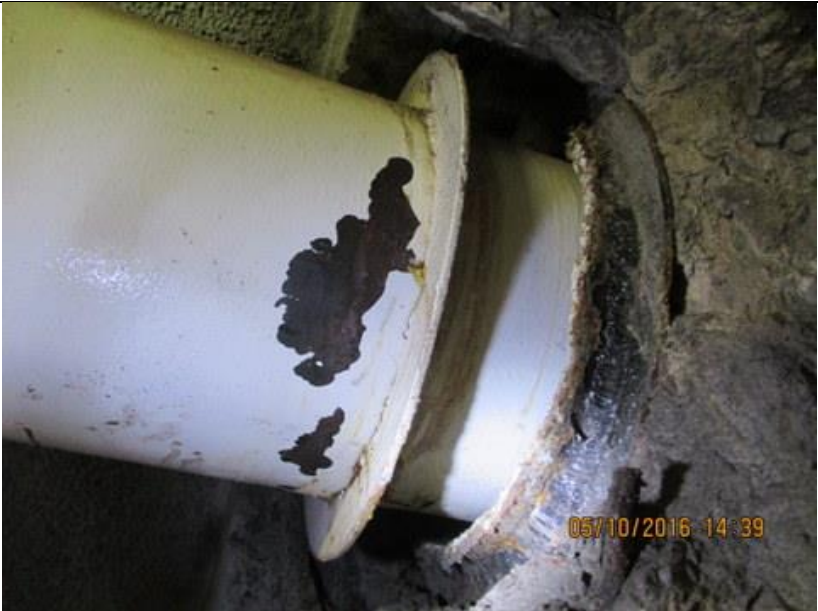
DATE TAKEN: 5/10/2016	
TAKEN BY: Chris Krejci	SITE LOCATION: Red Hill Facility
PHOTO #: 50	
COMMENTS: Pipelines supported by concrete wall in tunnel

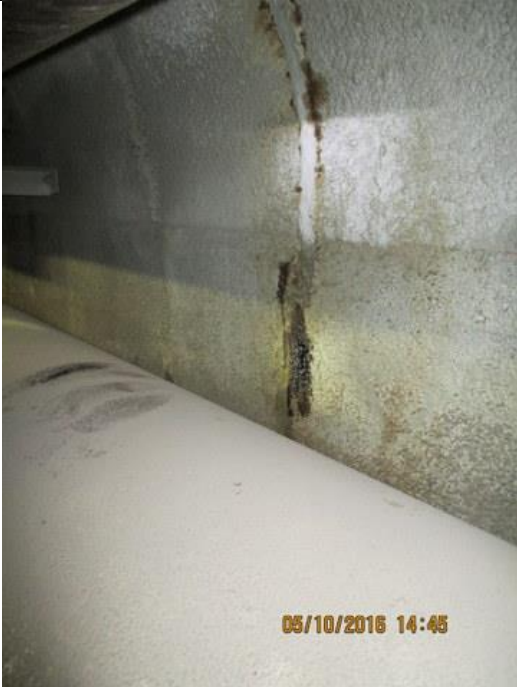
DATE TAKEN: 5/10/2016	
TAKEN BY: Chris Krejci	SITE LOCATION: Red Hill Facility
PHOTO #: 51	
COMMENTS: Flashing lining tunnel walls in some areas

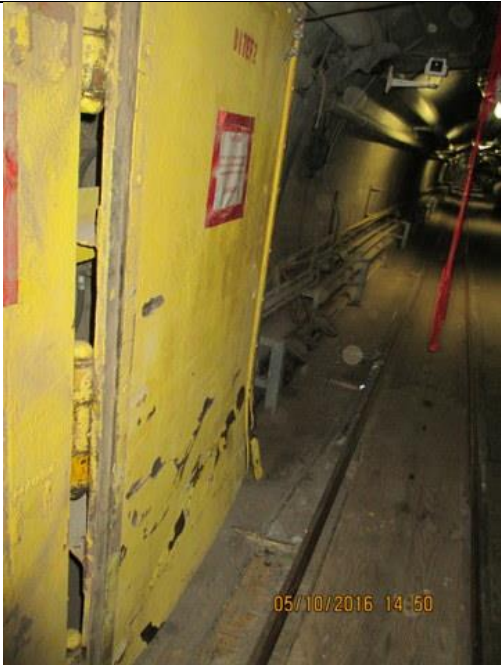
DATE TAKEN: 5/10/2016	
TAKEN BY: Chris Krejci	SITE LOCATION: Red Hill Facility
PHOTO #: 52	
COMMENTS: Oil-tight door

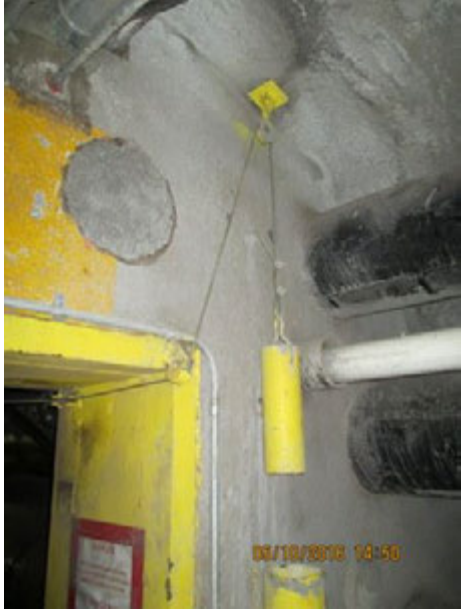
DATE TAKEN: 5/10/2016	
TAKEN BY: Chris Krejci	SITE LOCATION: Red Hill Facility
PHOTO #: 53	
COMMENTS: Counterweight for oil-tight door

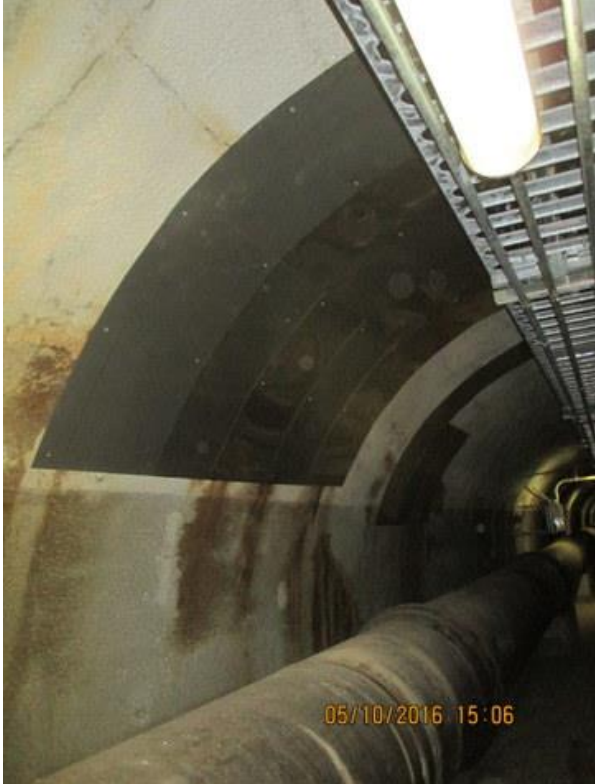
DATE TAKEN: 5/10/2016	
TAKEN BY: Chris Krejci	SITE LOCATION: Red Hill Facility
PHOTO #: 54	
COMMENTS: Flashing lining tunnel walls in some areas

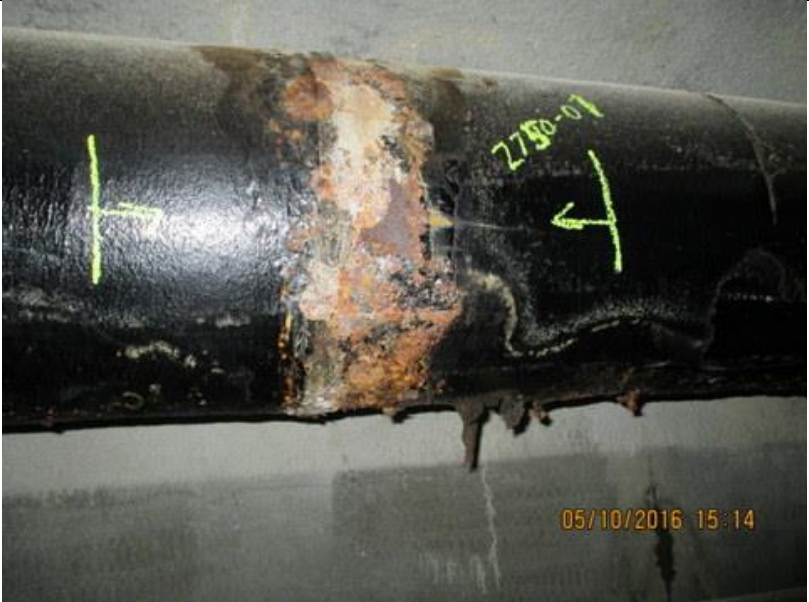
DATE TAKEN: 5/10/2016	
TAKEN BY: Chris Krejci	SITE LOCATION: Red Hill Facility
PHOTO #: 55	
COMMENTS: Typical Surface defects noted on piping, showing failure of the pipeline protective wrap. Facility staff noted that this does not affect piping integrity, and the protective wrapping is actually scheduled for removal.

<p>A photograph of a dark-colored pipe with a significant section of rust and peeling black protective wrap. Handwritten yellow markings include a vertical line on the left, a horizontal line with an arrow pointing right, and the alphanumeric code '2780-01' with an arrow pointing to the damaged area. A timestamp '05/10/2016 15:14' is visible in the bottom right corner of the photo.</p>

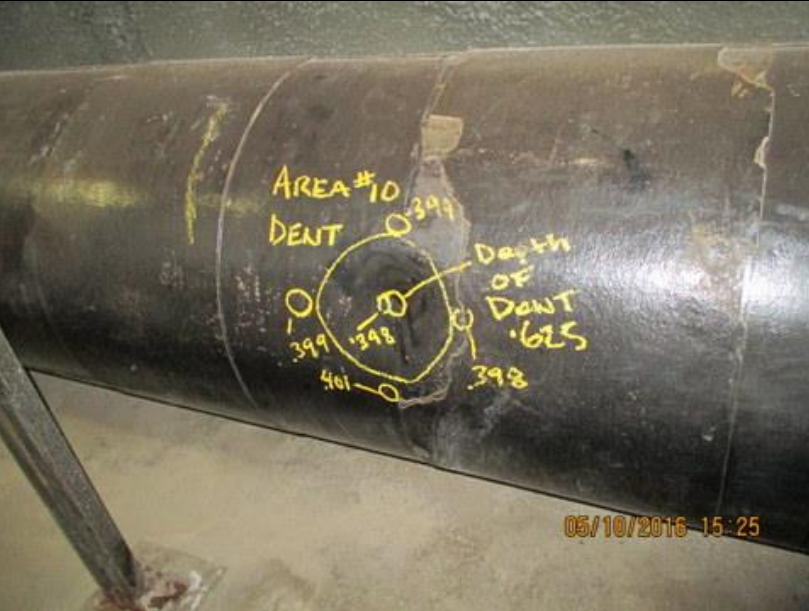
DATE TAKEN: 5/10/2016	
TAKEN BY: Chris Krejci	SITE LOCATION: Red Hill Facility
PHOTO #: 56	
COMMENTS: Markings describing pipe defects

<p>A photograph of a pipe with a circular dent. Handwritten yellow markings include 'AREA #10 DENT' and 'Depth OF DENT .625'. A circle is drawn around the dent with several points marked with numbers: 399, 398, 401, and 398. A timestamp '05/10/2016 15:25' is visible in the bottom right corner of the photo.</p>

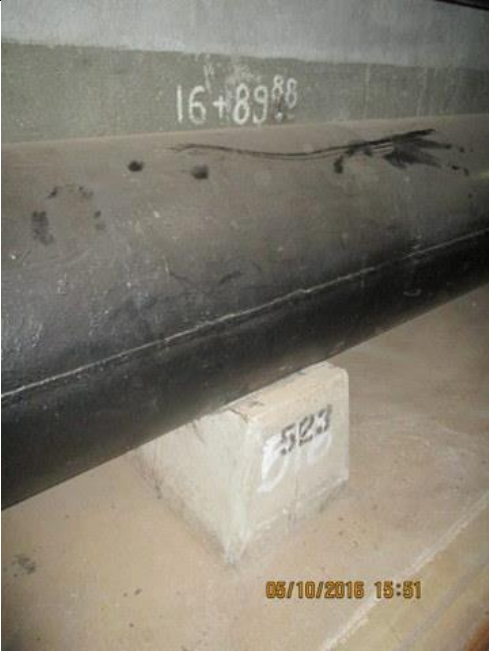
DATE TAKEN: 5/10/2016	
TAKEN BY: Chris Krejci	SITE LOCATION: Red Hill Facility
PHOTO #: 57	
COMMENTS: Pipe support in tunnel

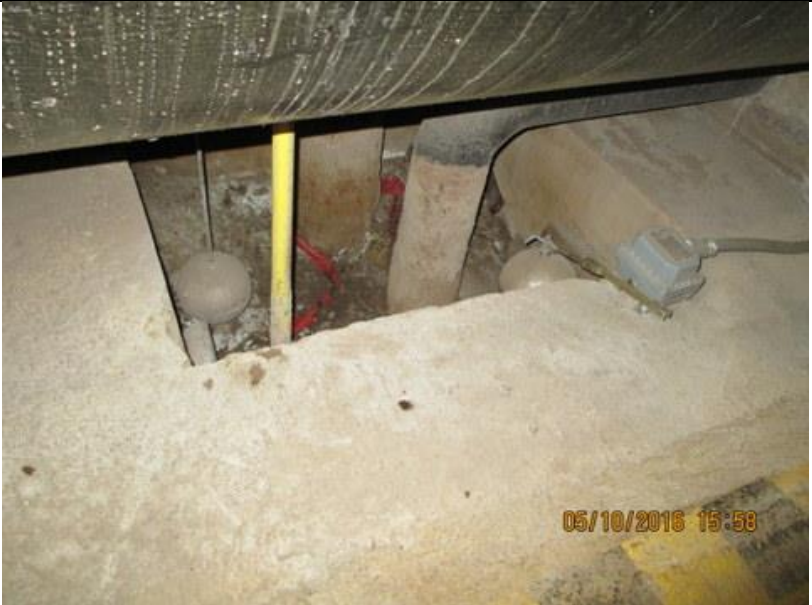
DATE TAKEN: 5/10/2016	
TAKEN BY: Chris Krejci	SITE LOCATION: Red Hill Facility
PHOTO #: 58	
COMMENTS: Sump and float switch in tunnel

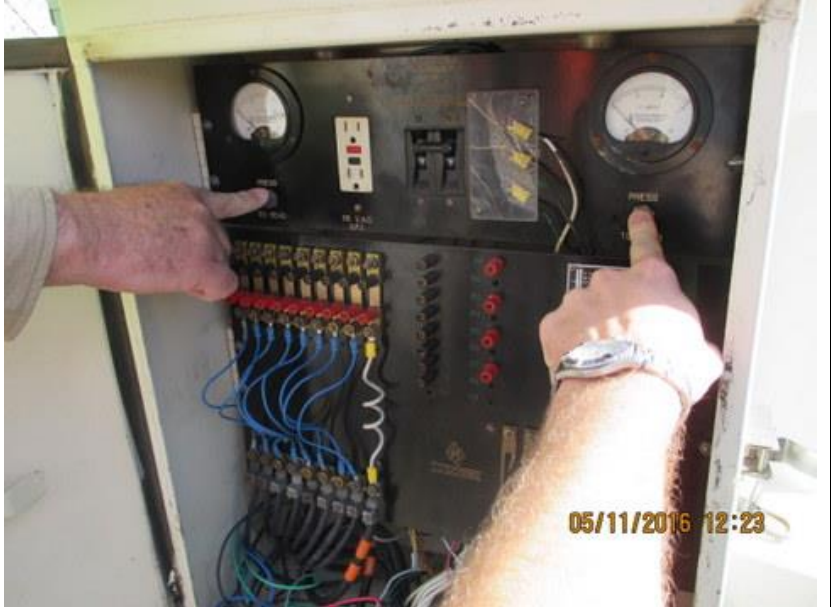
During the evaluation, ERG collected voltage and current readings from the easily accessible rectifiers. However, many of the rectifiers read zero voltage and current, and Red Hill Facility staff indicated that rectifiers are routinely checked using a multimeter, because some of the meters on the rectifiers do not function properly. During the evaluation, ERG requested information on all rectifier readings for the two months prior to the evaluation for all impressed current systems, as well as a summary of what the voltage and current values should be for each item. Attachment D summarizes the data provided by the Navy, along with the maximum percent change observed in the voltage and current over the two-month period of interest.

DATE TAKEN: 5/11/2016	
TAKEN BY: Chris Krejci	SITE LOCATION: Red Hill Facility
PHOTO #: 59	
COMMENTS: Rectifier near Hotel Pier showing no voltage or current

After the evaluation, Navy personnel indicated that some of the rectifiers had zero readings as a result of the Upper Tank Farm piping and AST cathodic protection system awaiting repairs at the time of the evaluation. As of May 9, 2017, the cathodic protection contractor has made repairs to all rectifiers with the exception of rectifiers 9, 12, and 13 which are scheduled for repair in June 2017. Navy personnel noted that the cathodic protection system has a number of redundancies that still enable cathodic protection coverage with the noted rectifiers off line.
