UNITED STATES ENVIRONMENTAL PROTECTION AGENCY
REGION 5

SUBJECT: INSPECTION REPORT – S.H. Bell Company, Chicago, IL

Date of Inspection: May 19, 2014

Purpose of Inspection: The purpose of conducting a second inspection of S.H. Bell was to determine compliance with their permit and various Illinois State Implantation Plan (IL SIP) requirements, including fugitive dust crossing the property boundary and opacity exceedances. We brought a Method 9 certified reader, Katy Bellairs, with us to read opacity off S.H. Bells' stockpiled materials.

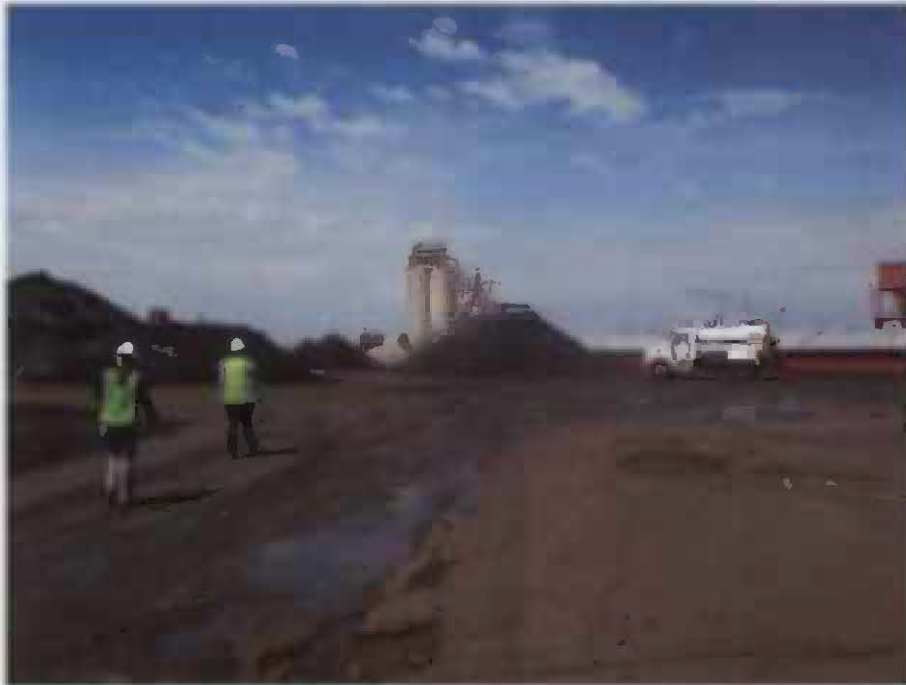
Photo 1. IMG_0346 at 11:04 am: Two USEPA inspectors walking toward SHB's water truck, watering stockpiled material.

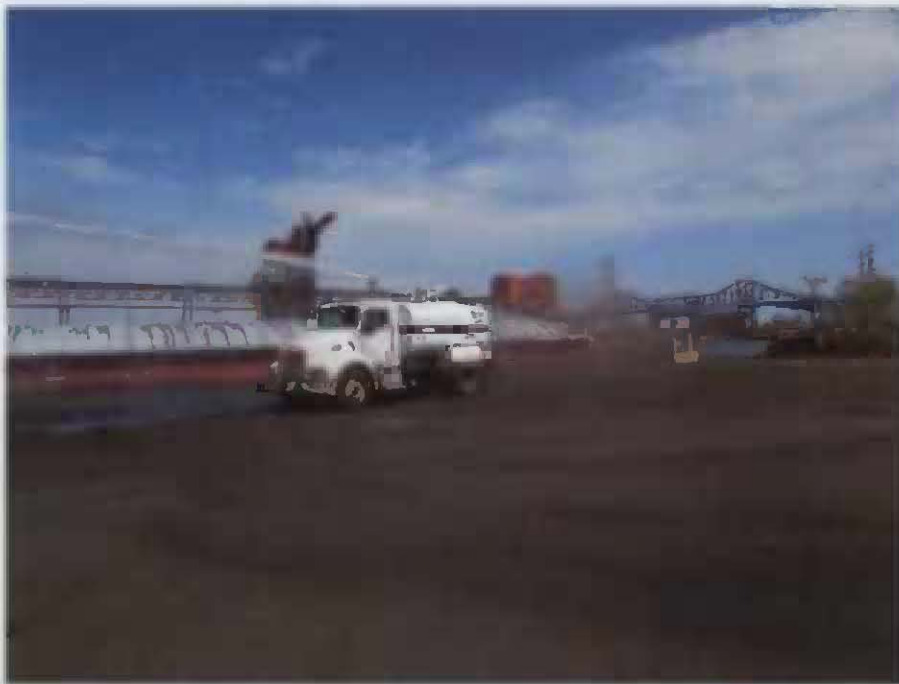
Photo 2. IMG_0347 at 11:05 am: SHB's watering truck onsite watering stockpiled material. SHB's water truck was onsite for the entirety of our inspection.

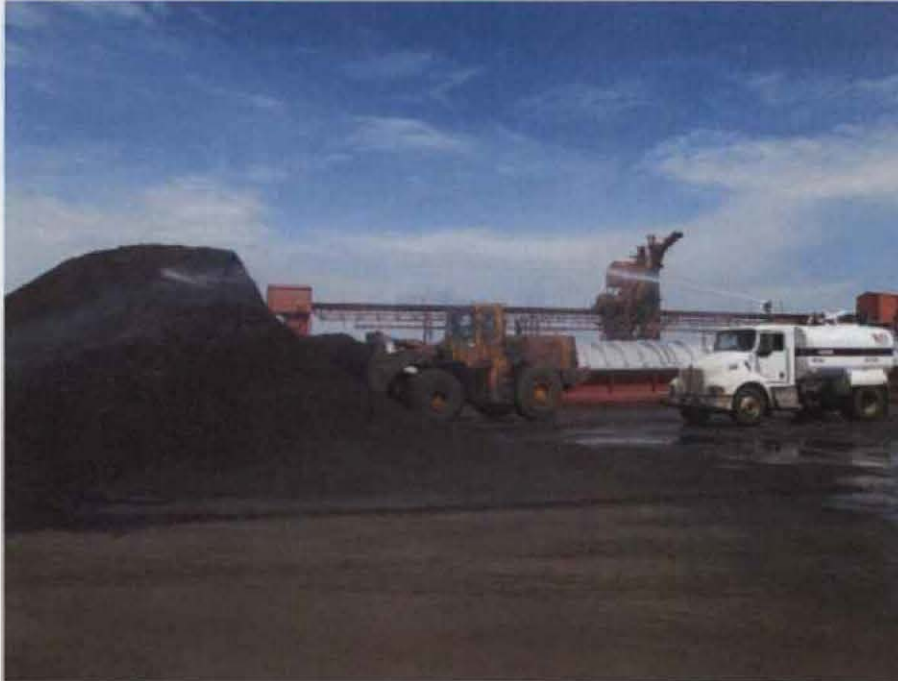
Photo 3. IMG_0348 at 11:11 am: SHB watering a DRI pile.

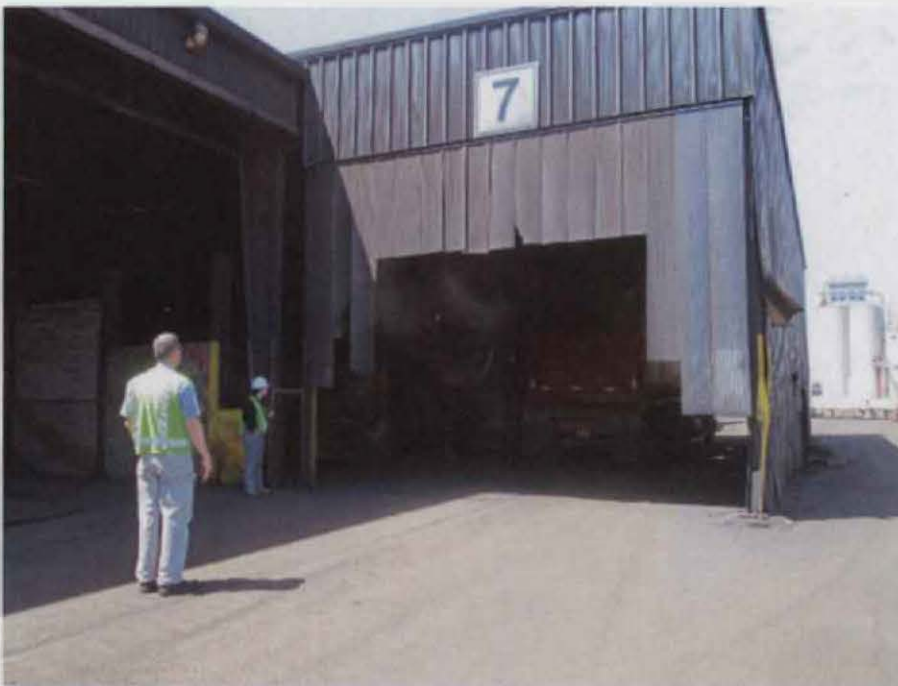
We walked around the yard so Ms. Bellairs could determine where she could begin taking Method 9 readings. We observed watering onto stockpiles in SHB’s yard along with wet roads (Photo 1, 2, 3). We continued walking around the yard and next observed truck loading operations in Building 7 (Photo 4). At 11:21 am we walked to the barge slip to observe direct reduce iron material (DRI) being unloaded (Photo 5). Barge unloading resumed at 11:31 am.

Photo 4. IMG_0349 at 11:22 am: Truck loading operations in Building 7. Note the fugitive dust escaping the enclosure.

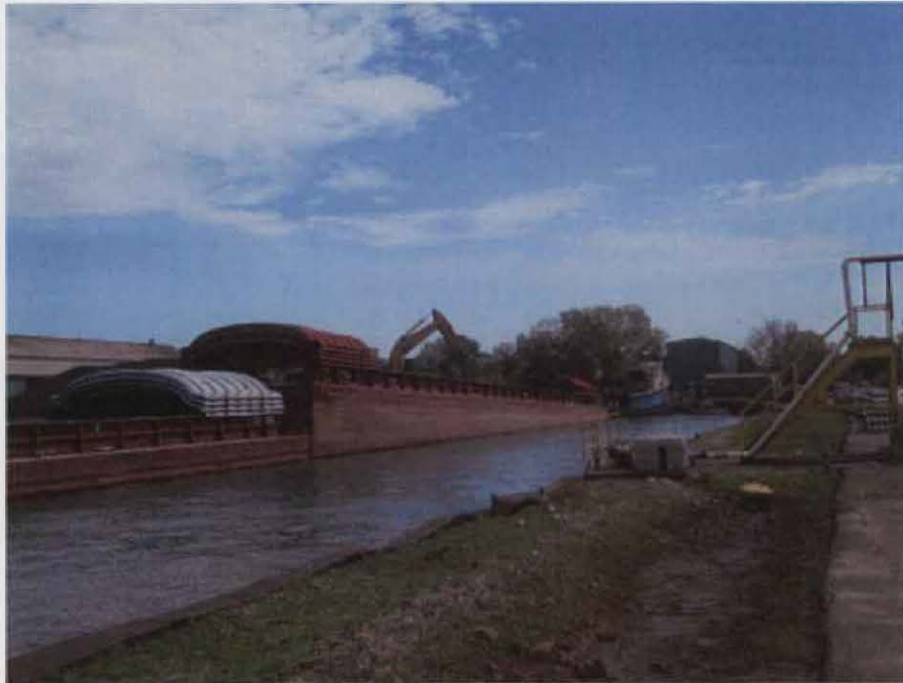
Photo 6. IMG_0351 at 11:30 am: Barge unloading of DRI during the inspection.

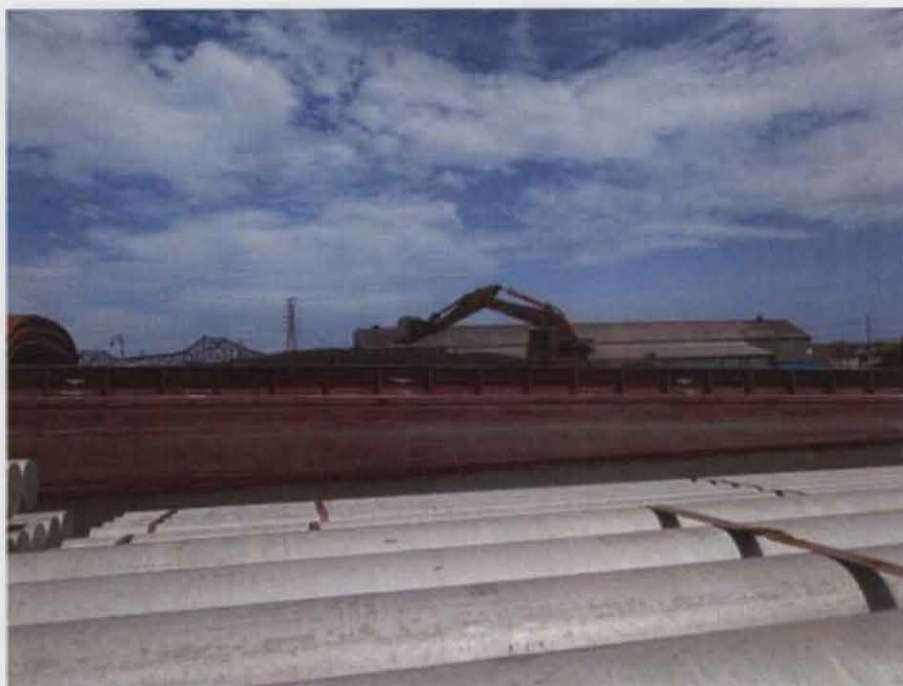
Ms. Bellairs began her Method 9 readings at 11:33 am from north of Building #3 (Photo 6, 7). She observed unloading of DRI from Trinidad. Mr. Langbehn stated that the DRI can be watered without compromising the product. At 11:34 am I observed the roadway being watered (Photo 8).

Photo 7. IMG_0352 at 11:32 am: USEPA perspective for Method 9 readings during barge unloading operations of DRI.

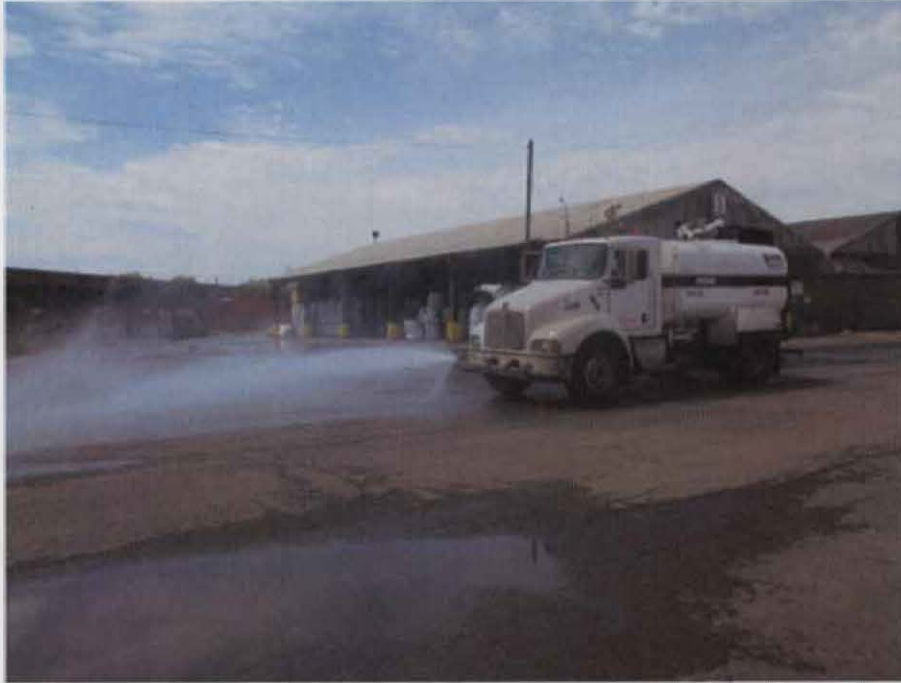
Photo 8. IMG_0355 at 11:36 am: Frequent roadway watering during the inspection.

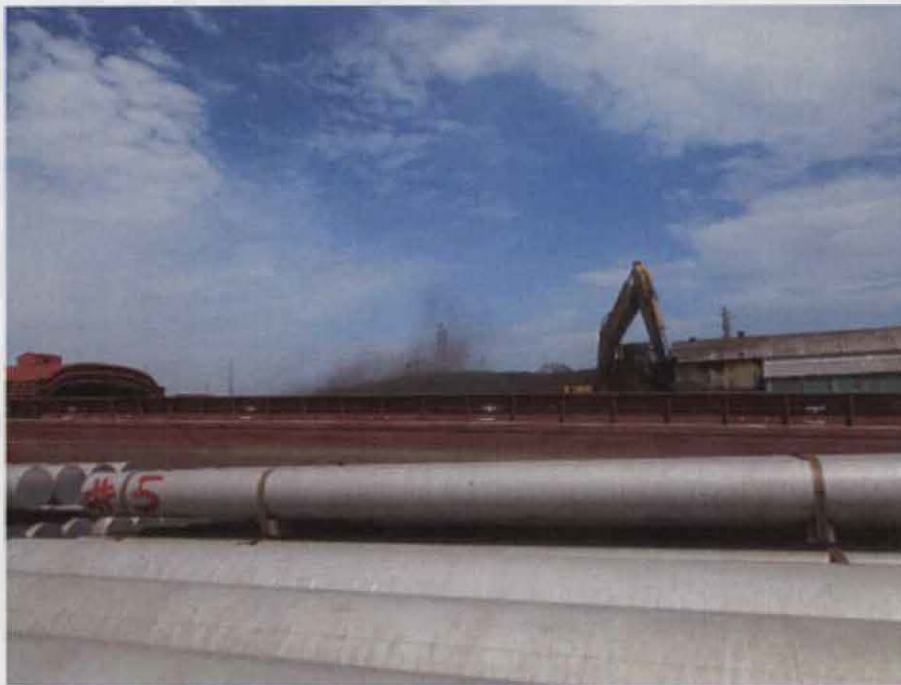
During Ms. Bellairs Method 9 readings, Ms. Smith and I observed visible emissions coming off the stockpiled material and from inside the barge (Photo 9).

Photo 9. IMG_0356 at 11:36 am: Fugitive dust leaving the DRI pile during the Method 9 readings.

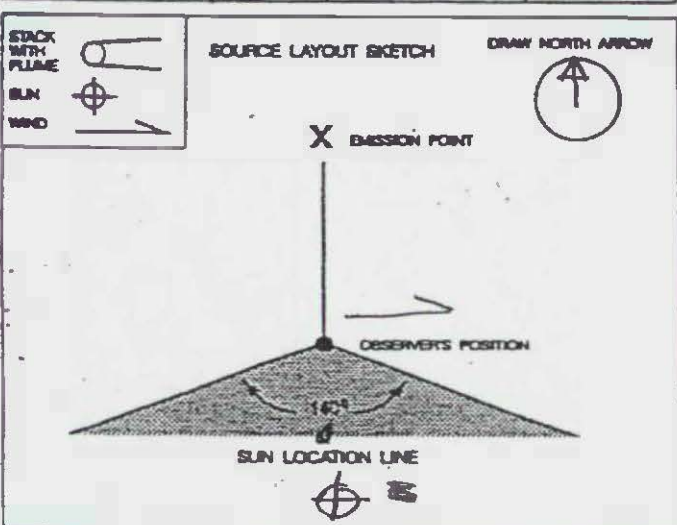
DESCRIBE EMISSION POINT
**Road way for 1st Reading
Barge/Barge Pile 2nd Reading**

DISTANCE FROM OBSERVER DIRECTION FROM OBSERVER
START 25' END 25' START N END N

VERTICAL ANGLE TO PLUME HORIZONTAL ANGLE TO PLUME
35° 10°

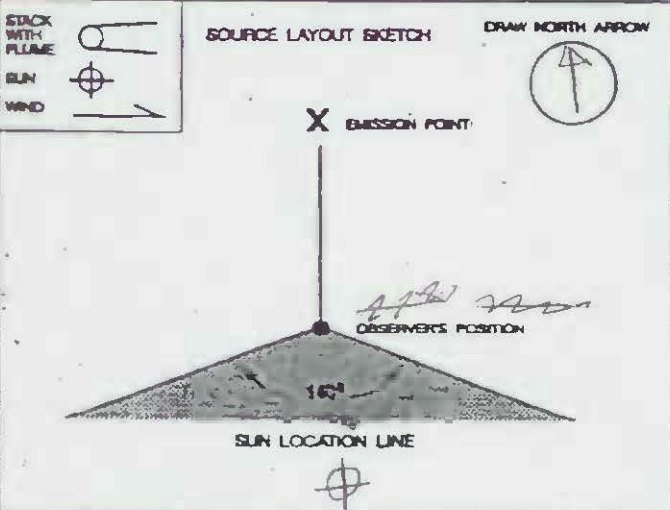
SOURCE LAYOUT SKETCH

COMPANY NAME SH Bell		
LOCATION 10217 South Ave 0		
CITY STATE ZIP Chicago IL 60617		
PROCESS EQUIPMENT Barge	OPERATING MODE operating	
CONTROL EQUIPMENT none	OPERATING MODE	
DESCRIBE EMISSION POINT Barge & Barge Pile Loading		
HEIGHT ABOVE GROUND LEVEL 15 1/2	HEIGHT RELATIVE TO OBSERVER START 10' END 10'	
DISTANCE FROM OBSERVER START 25' END 25'	DIRECTION FROM OBSERVER START N END N	
VERTICAL ANGLE TO PLUME 35°	HORIZONTAL ANGLE TO PLUME 10°	
DESCRIBE EMISSIONS		
START Black Dust END Black Dust		
EMISSION COLOR Black IF WATER DROPLET PLUME <input type="checkbox"/>		
POINT IN THE PLUME AT WHICH OPACITY WAS DETERMINED START middle END middle		
DESCRIBE PLUME BACKGROUND		
START Blue Sky END Blue Sky		
BACKGROUND COLOR Black SKY CONDITIONS Blue Sky		
WIND SPEED START 15 mph END 15 mph WIND DIRECTION START S END S		
AMBIENT TEMP START 66° END 66° WET BULB TEMP RH percent		
STACK WITH PLUME
