DOCUMENTATION OF ENVIRONMENTAL INDICATOR DETERMINATION

*RCRA Corrective Action
Environmental Indicator (EI) RCRIS code (CA725)
Current Human Exposures Under Control*

Facility Name: *Thermo King de Puerto Rico, Inc.*

Facility Address: B Street, Zeno Gandía Industrial Park, Hato Abajo, Arecibo, Puerto Rico

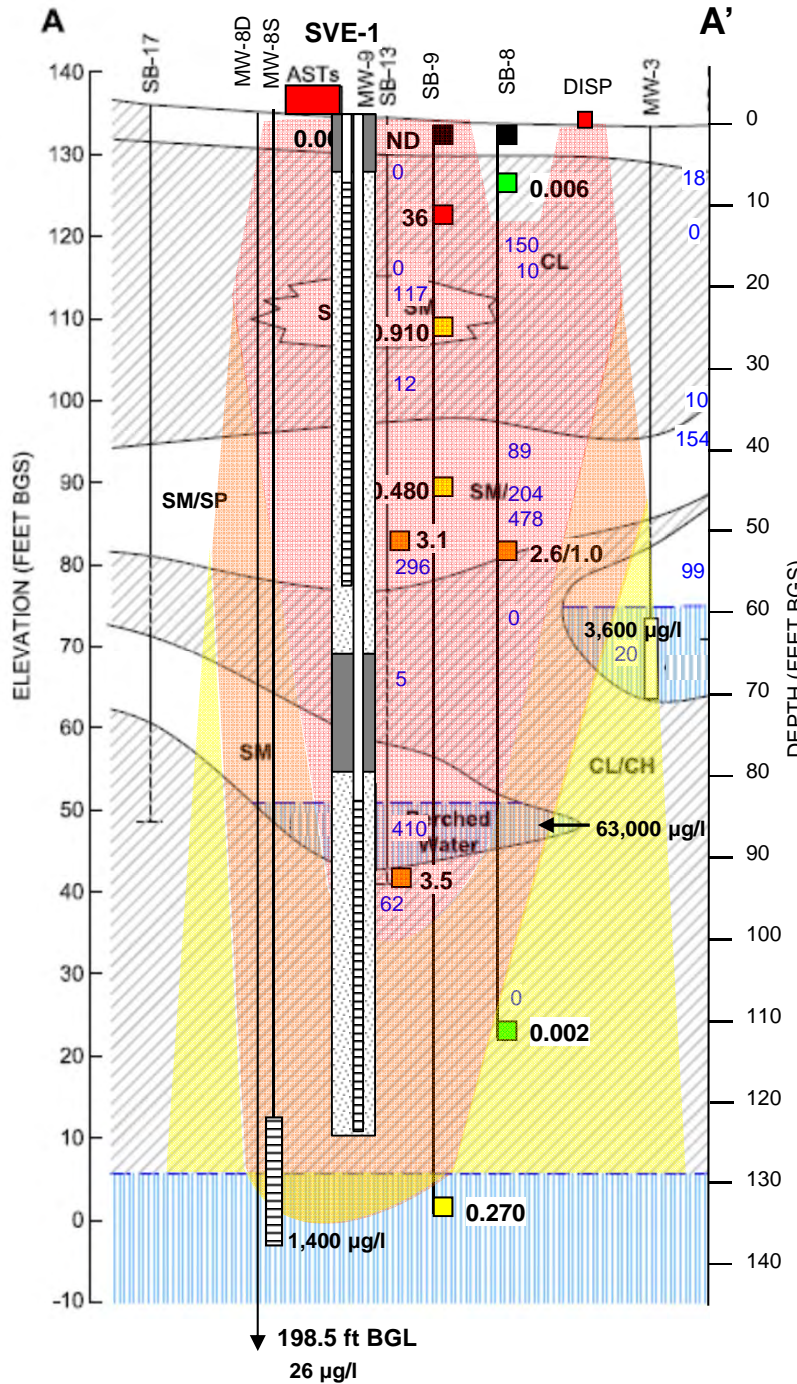
CROSS SECTION

DEPTH TO GROUND WATER ~129 ft BGS

SOIL VAPOR & GROUND WATER DATA

WELL	AQUIFER	SOIL VAPOR (ppmV)	GW 1,1-DCE (µg/l)
MW-3	PERCHED	519	2,800
MW-8S	SHALLOW	510	1,200
MW-9	PERCHED	1,166	52,000
MW-13	PERCHED	78	260

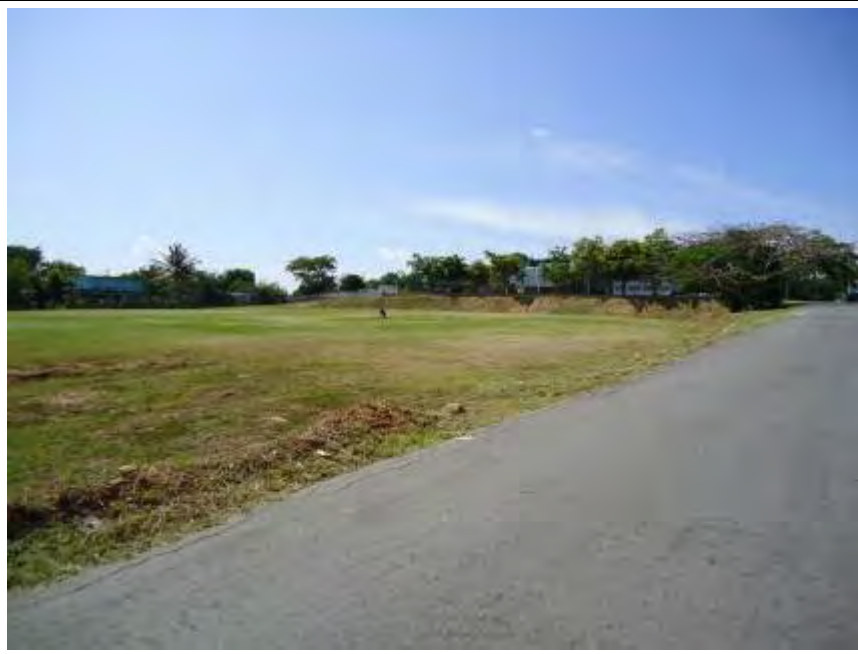
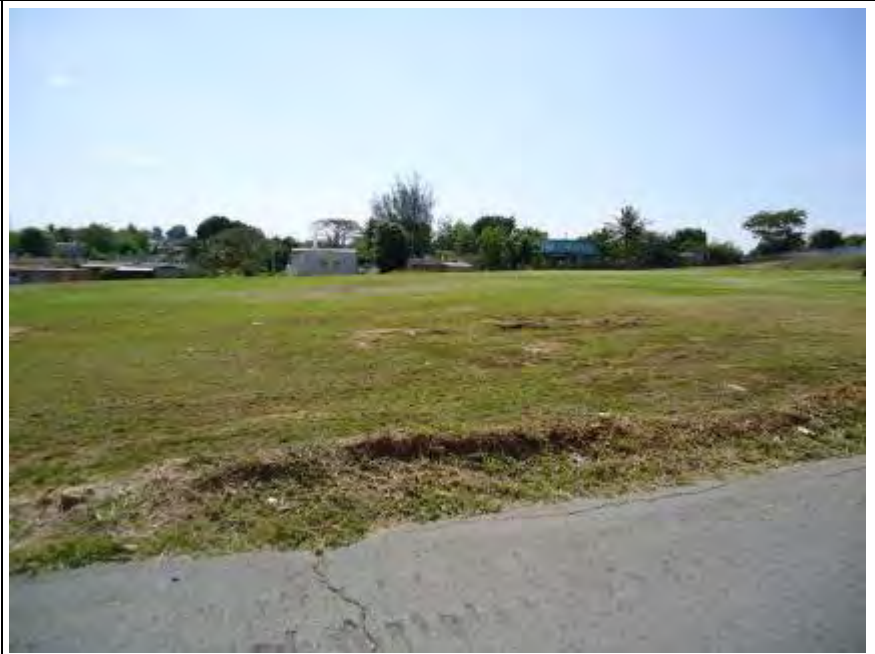
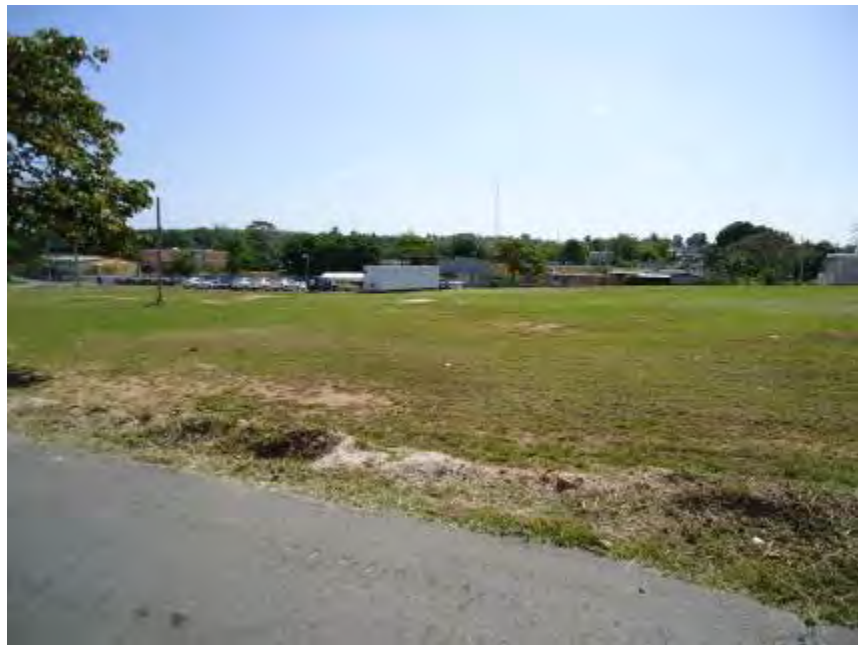
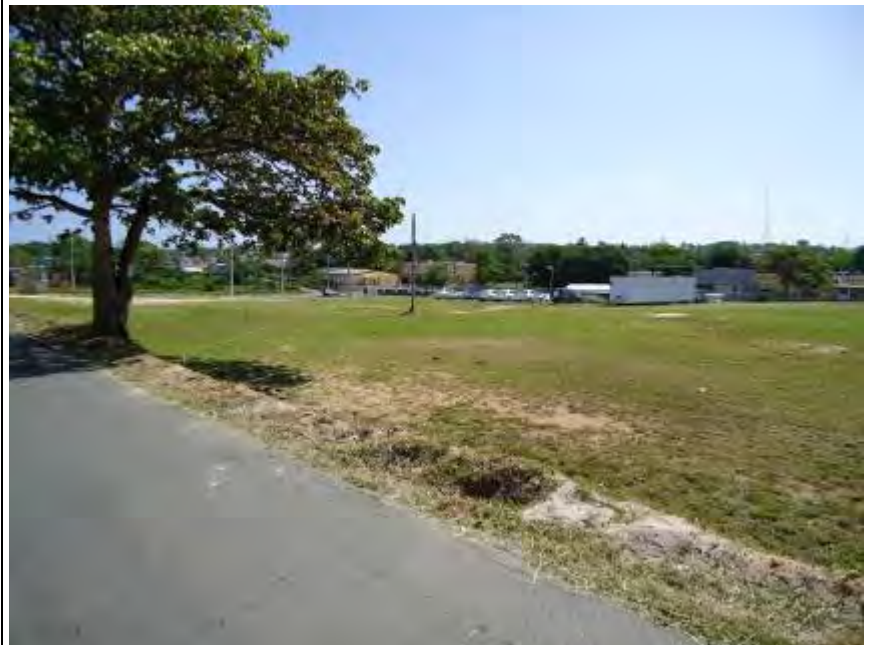
Well #13 area – Looking southeast. Lat: 18°27'46.2"N Long: 66°45'09.3"W

Well #13 area – Looking east. Lat: 18°27'46.2"N Long: 66°45'09.3"W

Well #13 area – Looking northeast. Lat: 18°27'46.2"N Long: 66°45'09.3"W

Well #13 area – Looking north. Lat: 18°27'46.2"N Long: 66°45'09.3"W

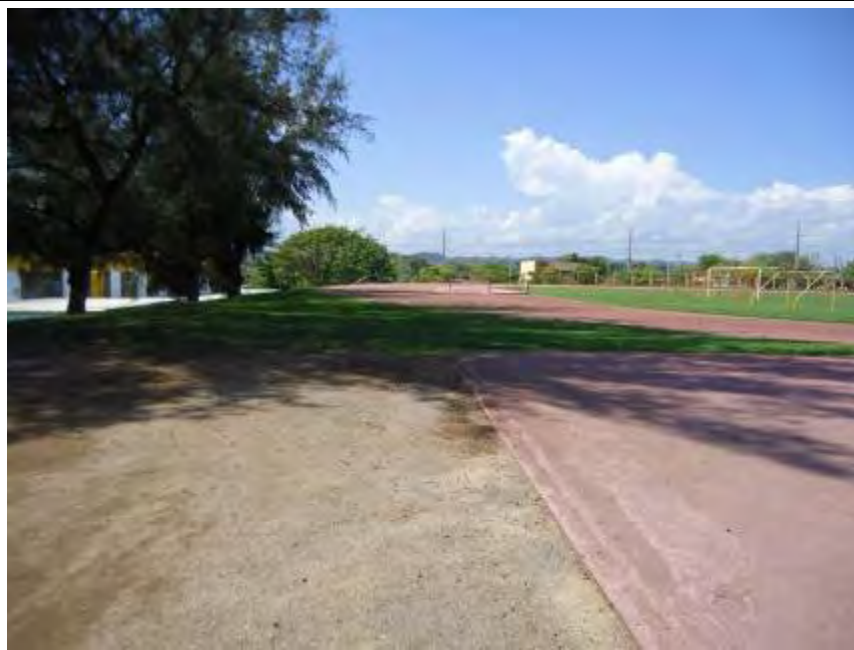
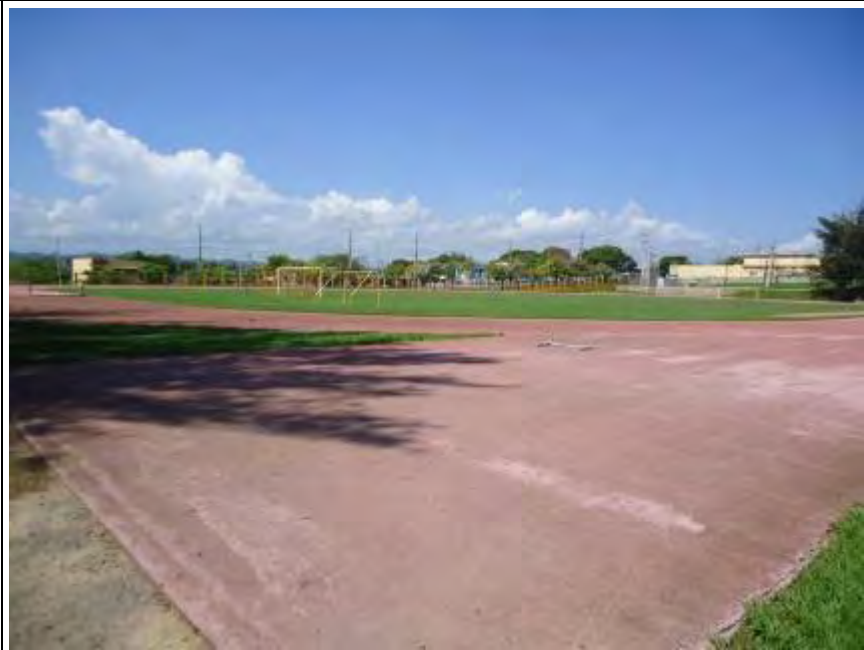
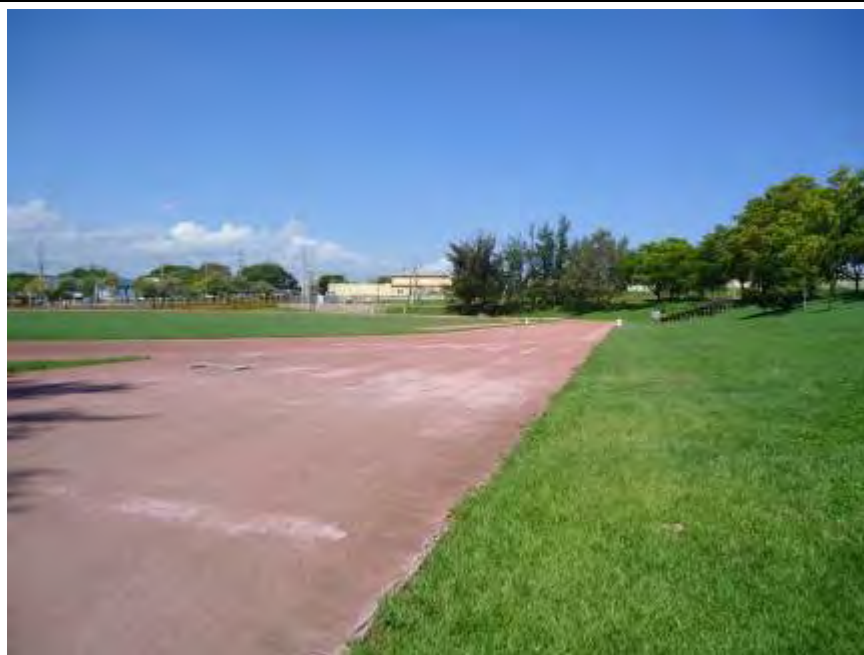
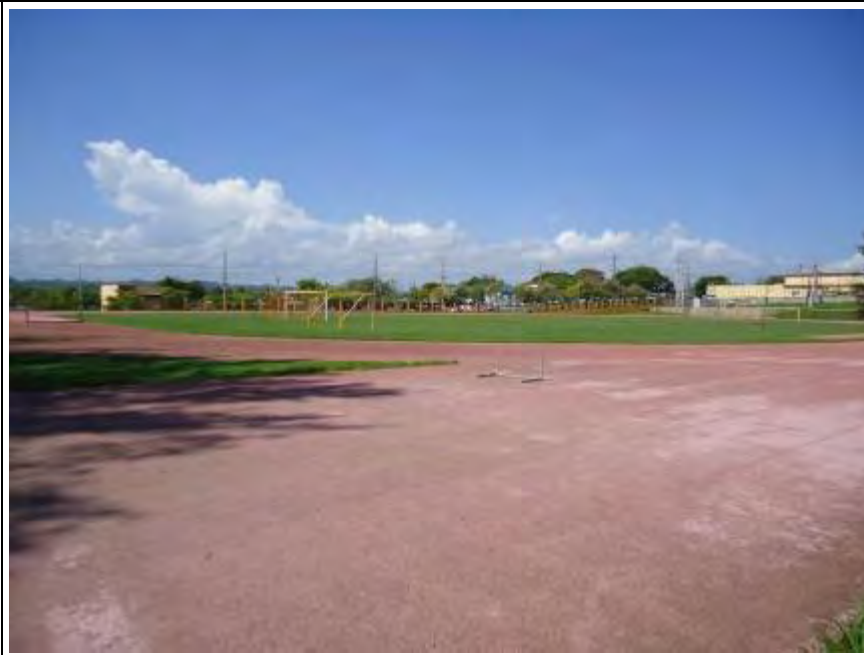
Well #17 area – Looking south. Lat: 18°28'00.9"N Long: 66°44'27.5"W. University athletic track.

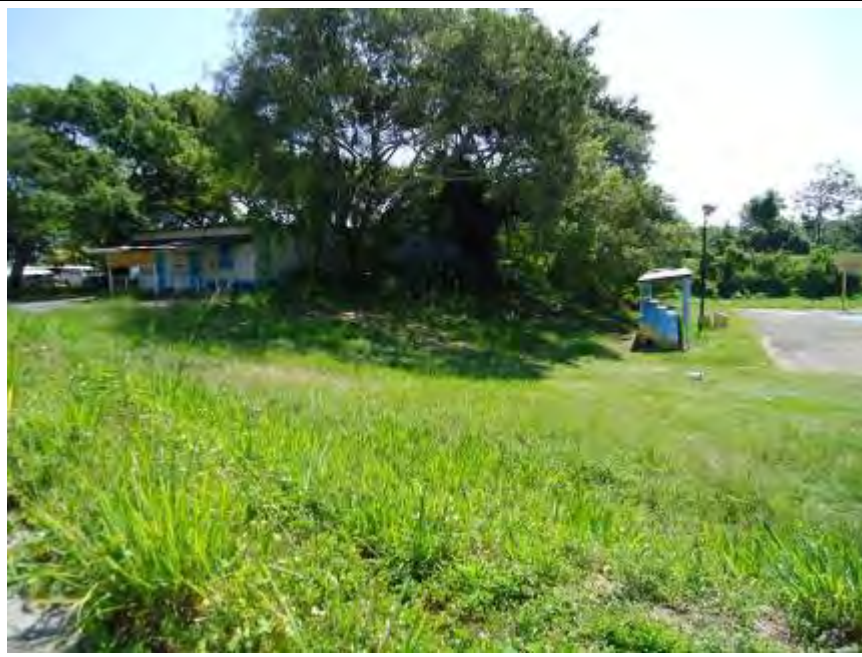
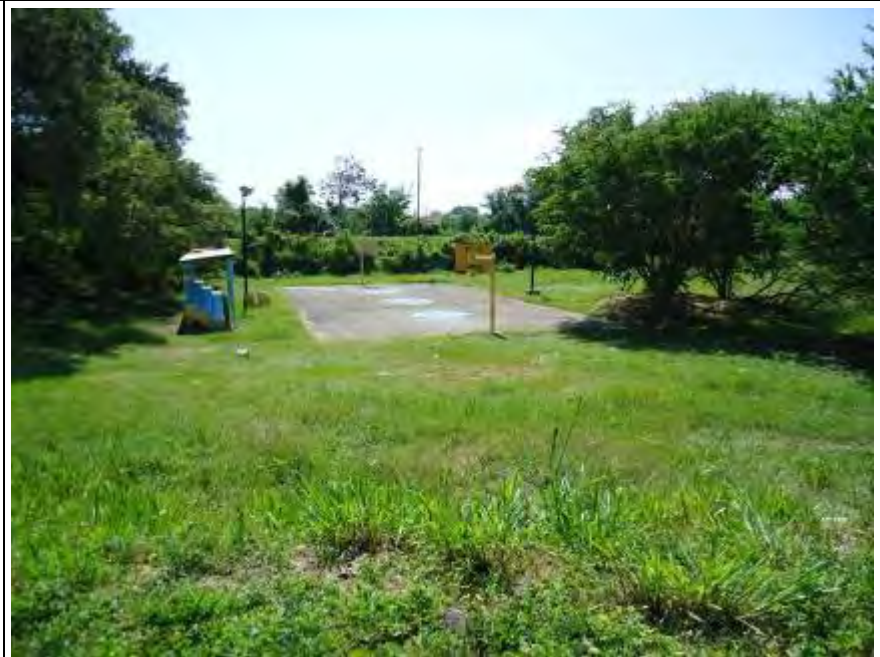
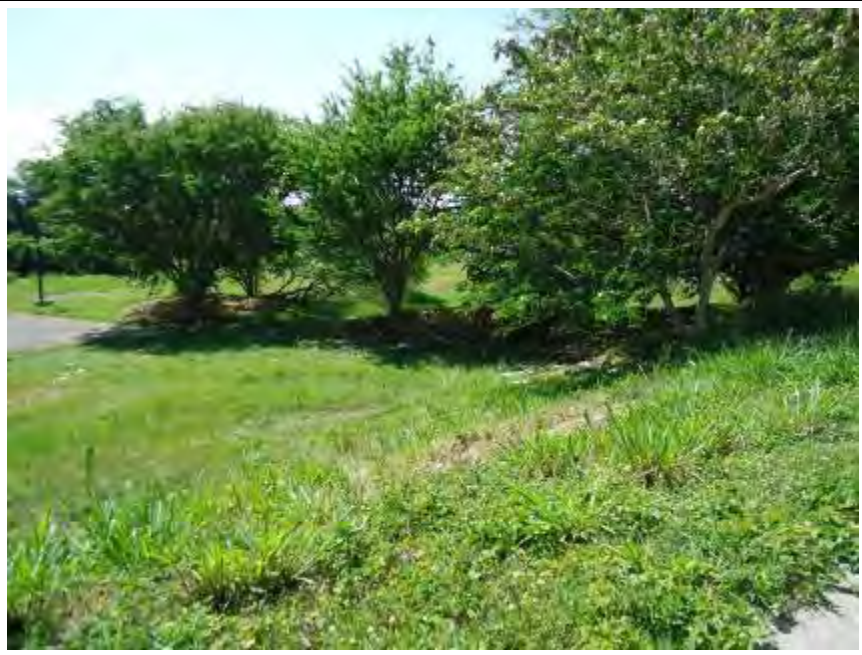
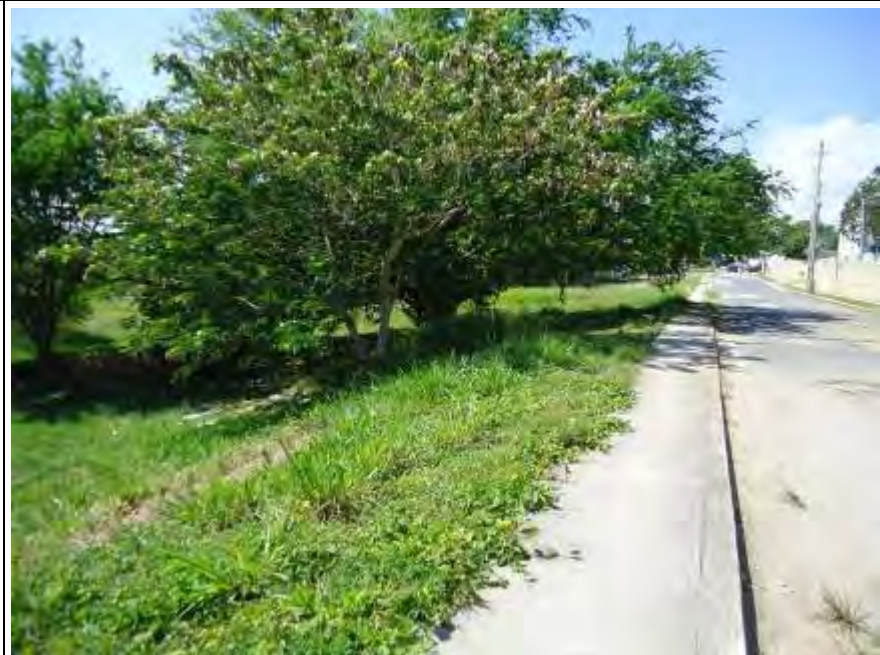
Wells #20-25 and 27 area – Looking north, Lat: 18°28'11.1"N Long: 66°43'57.3"W
Basketball court

Wells #20-25 and 27 area – Looking northeast, Lat: 18°28'11.1"N
Long: 66°43'57.3"W. Basketball court

Wells #20-25 and 27 area – Looking east, Lat: 18°28'11.1"N Long: 66°43'57.3"W
Former baseball field beyond trees.

Wells #20-25 and 27 area – Looking south, Lat: 18°28'11.1"N Long: 66°43'57.3"W
Former baseball field beyond trees.

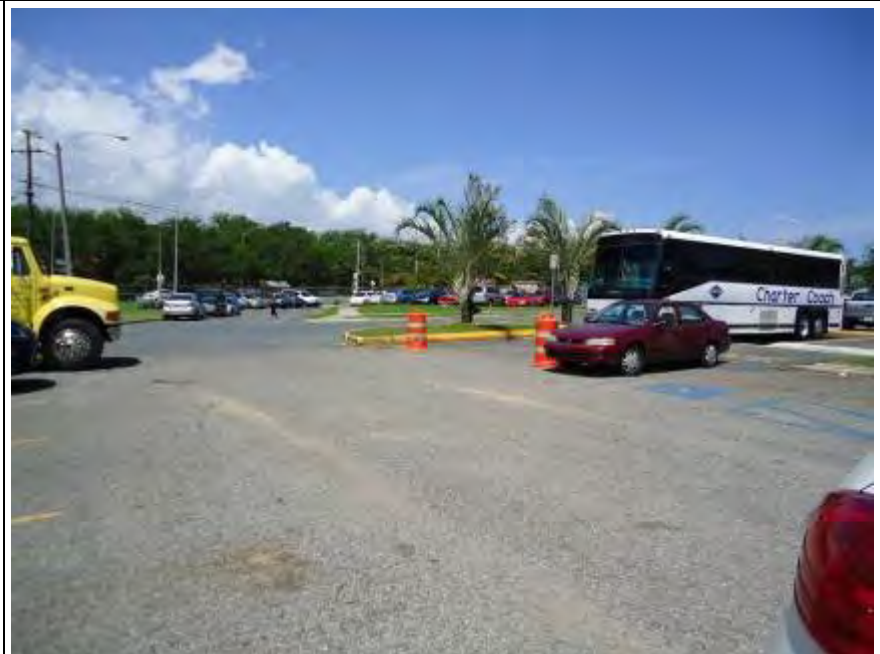
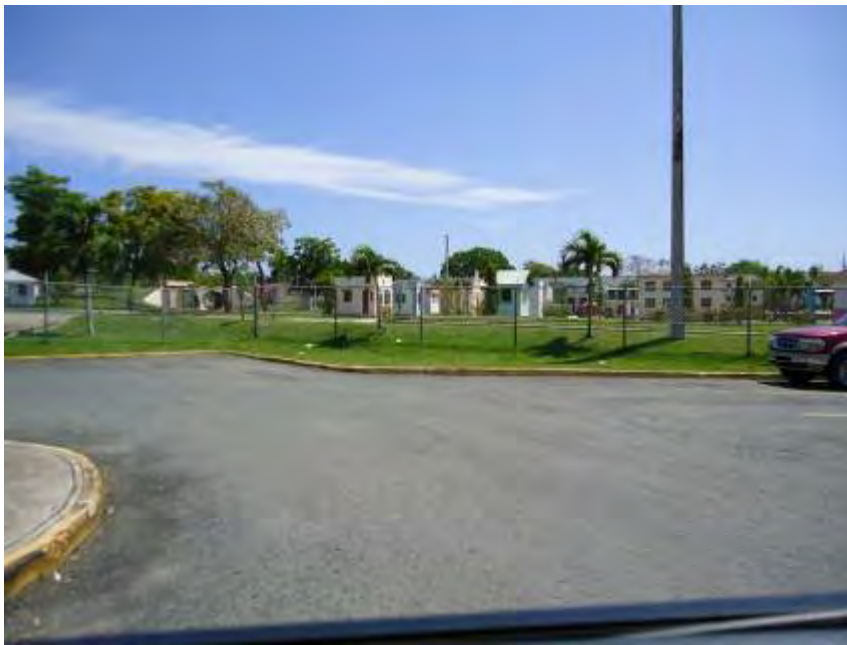
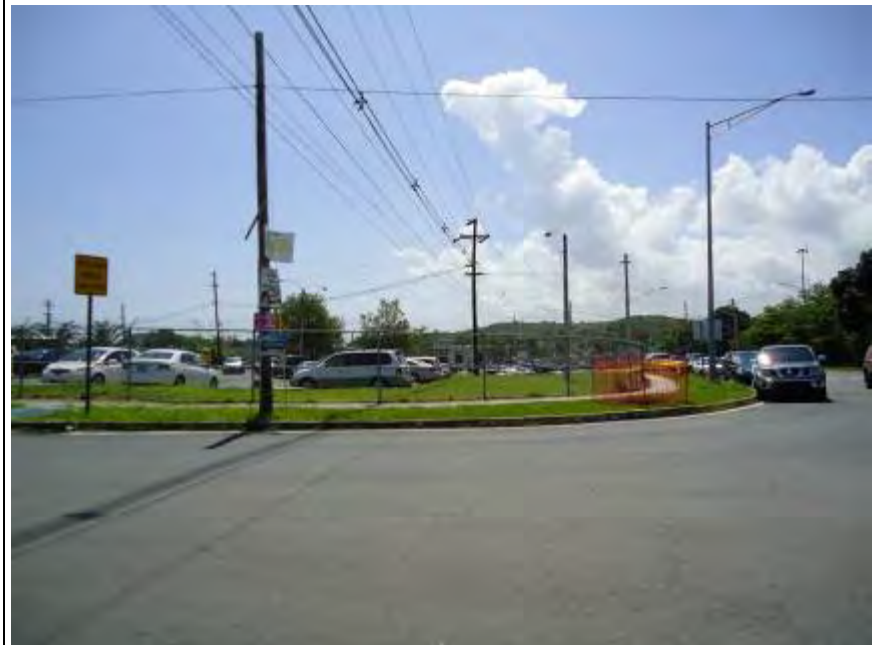
Well #8 area – Looking south, Lat: 18°27'25.5"N Long: 66°44'36.5"W

Well #8 area – Looking north, Lat: 18°27'25.5"N Long: 66°44'36.5"W

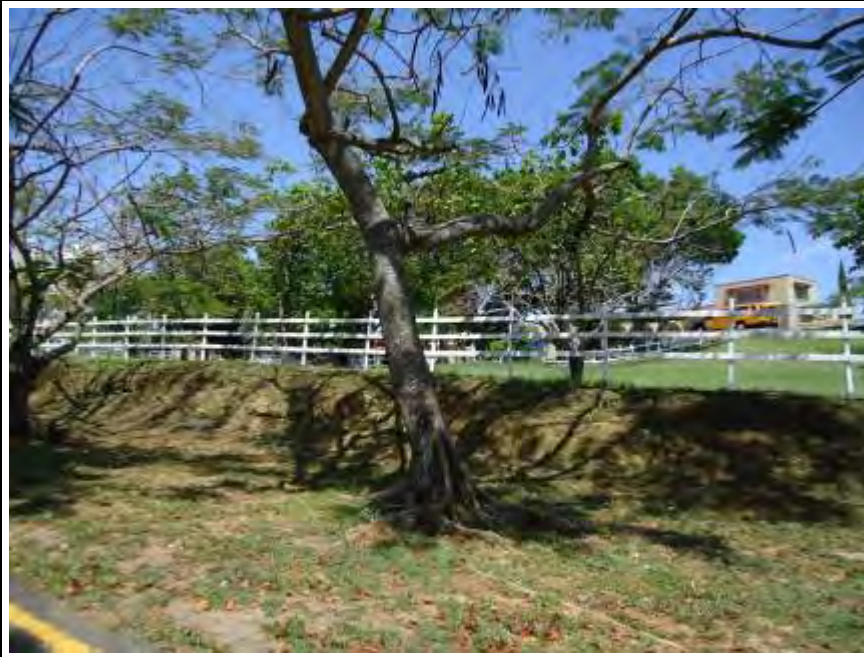
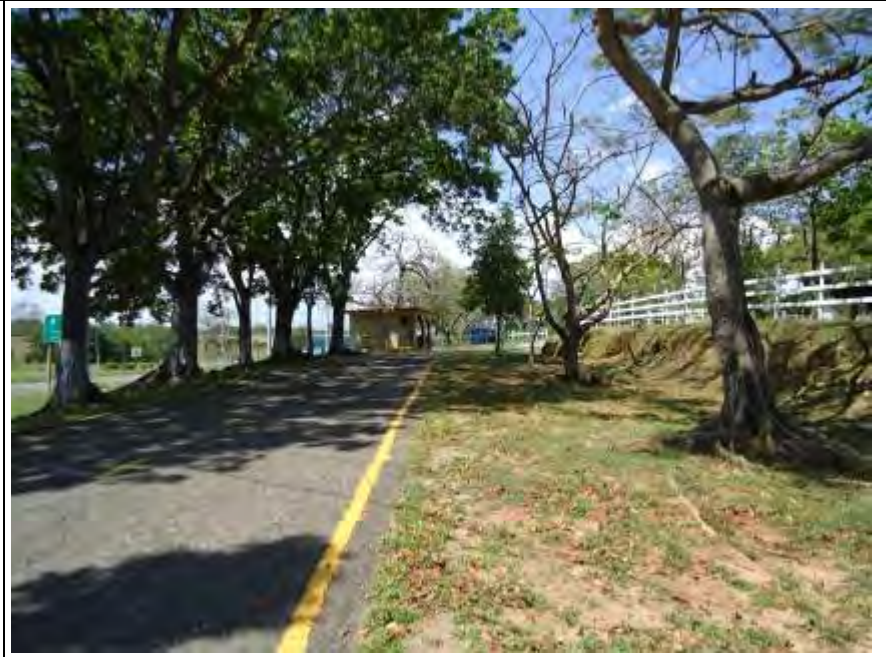
Well #6 area – Looking west, Lat: 18°27'19.1"N Long: 66°44'40.3"W

Well #6 area – Looking south, Lat: 18°27'19.1"N Long: 66°44'40.3"W
