NONPOINT SOURCE SUCCESS STORY

Treatment of Mine Drainage Restores Longs Run

EPA 841-F-17-0010
September 2017

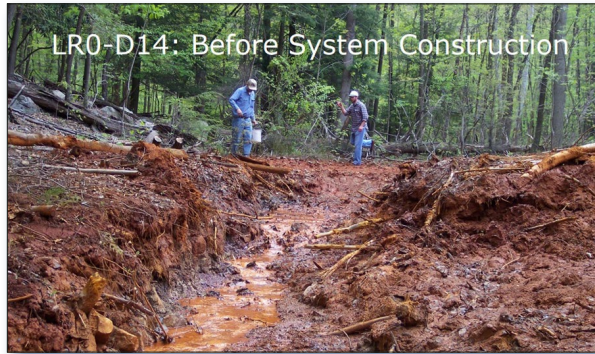
Figure 2. Before project implementation, AMD flows emerging from a seep in the hillside caused erosion and carried pollutants. (Photos by Skelly and Loy, Inc.)

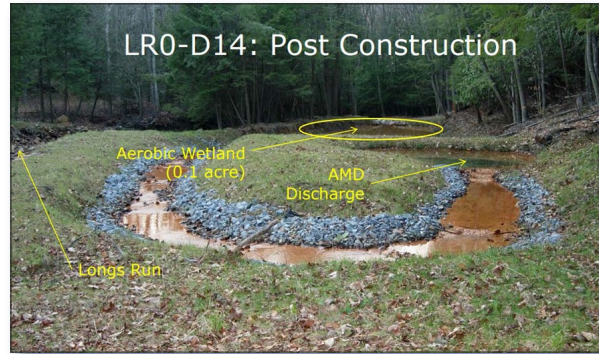
Figure 3. At site LR0-D14, AMD flows through an open limestone channel passive treatment system and into a small aerobic wetland before discharging to Longs Run.

Project partners analyzed the AMD discharges in the Longs Run watershed and developed a remediation plan and TMDL. To help achieve TMDL targets, partners designed and constructed passive treatment systems to reduce metals and neutralize acidity in the AMD discharges while improving the water quality and aquatic habitat of Longs Run (Figures 2 and 3). When the water comes into contact with limestone the pH levels are raised, which in turn helps neutralize the acidity and allows dissolved metals to precipitate out of solution in a controlled environment (outside of the stream ecosystem).
