Project ID #17-0284

Proctor Creek Watershed Monitoring FY17 Third Quarterly Report

Fulton County, GA

Project Dates: April 11-12, 2017

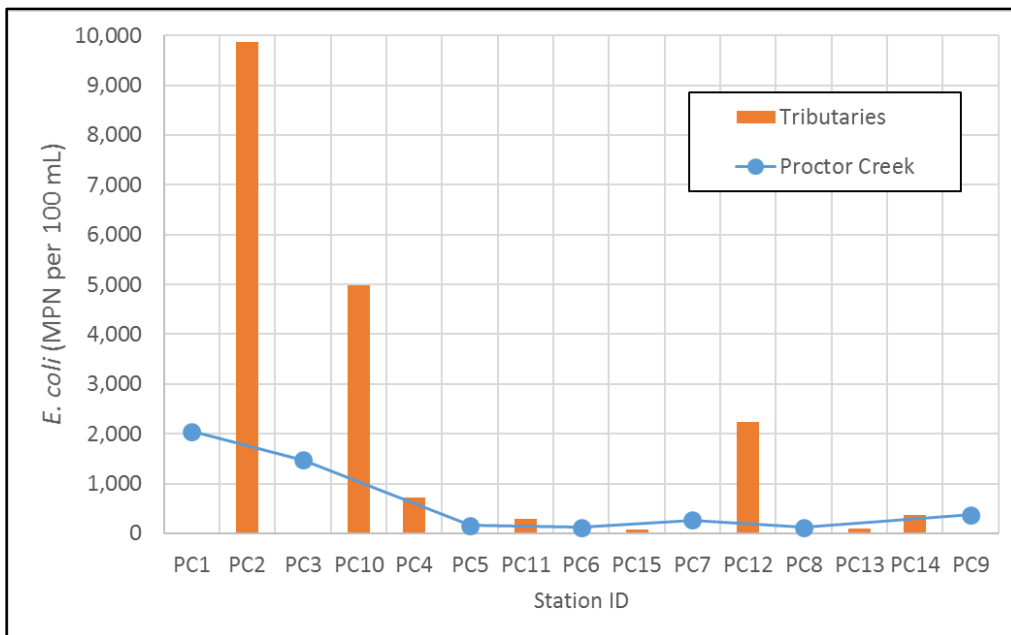
Figure 4: *E. coli* (MPN per 100 mL) in Proctor Creek and its tributaries. Locations are shown from upstream to downstream, in order from left to right.

Data for fecal coliform counts are provided in Table 2, reported as the most probable number (MPN) of *E. coli* per 100 mL. While the Georgia state water quality standard is written in terms of fecal coliform, not specifically *E. coli*, the *E. coli* data provide a conservative estimate of fecal coliform since they are a subset of this group. Therefore, exceedance of the standard by *E. coli* indicates a likely exceedance by fecal coliform bacteria as a whole. The applicable standard for this sampling period (between November and April) for a designated use of ‘fishing’ is a geometric mean of 1,000 per 100 mL, calculated using at least four samples during a 30-day period, with single measurements not to exceed 4,000 per 100 mL (Ga. Comp. R. & Regs. r. 391-3-6-.03(6)). Only one sample was collected at each station during this sampling event, which precludes calculation of a geometric mean. However, samples collected at 5 stations contained concentrations of *E. coli* higher than 1,000 MPN per 100 mL (Table 2). Counts were especially high, and above the 4,000 MPN limit, in the Greensferry tributary (PC2) and in the tributary at Lindsay Street (PC10) (Figure 4).
