Long-Term Stewardship Assessment Report

Sims Metal Management

EPA ID #: VAD980918221

Assessment Date: March 22, 2018

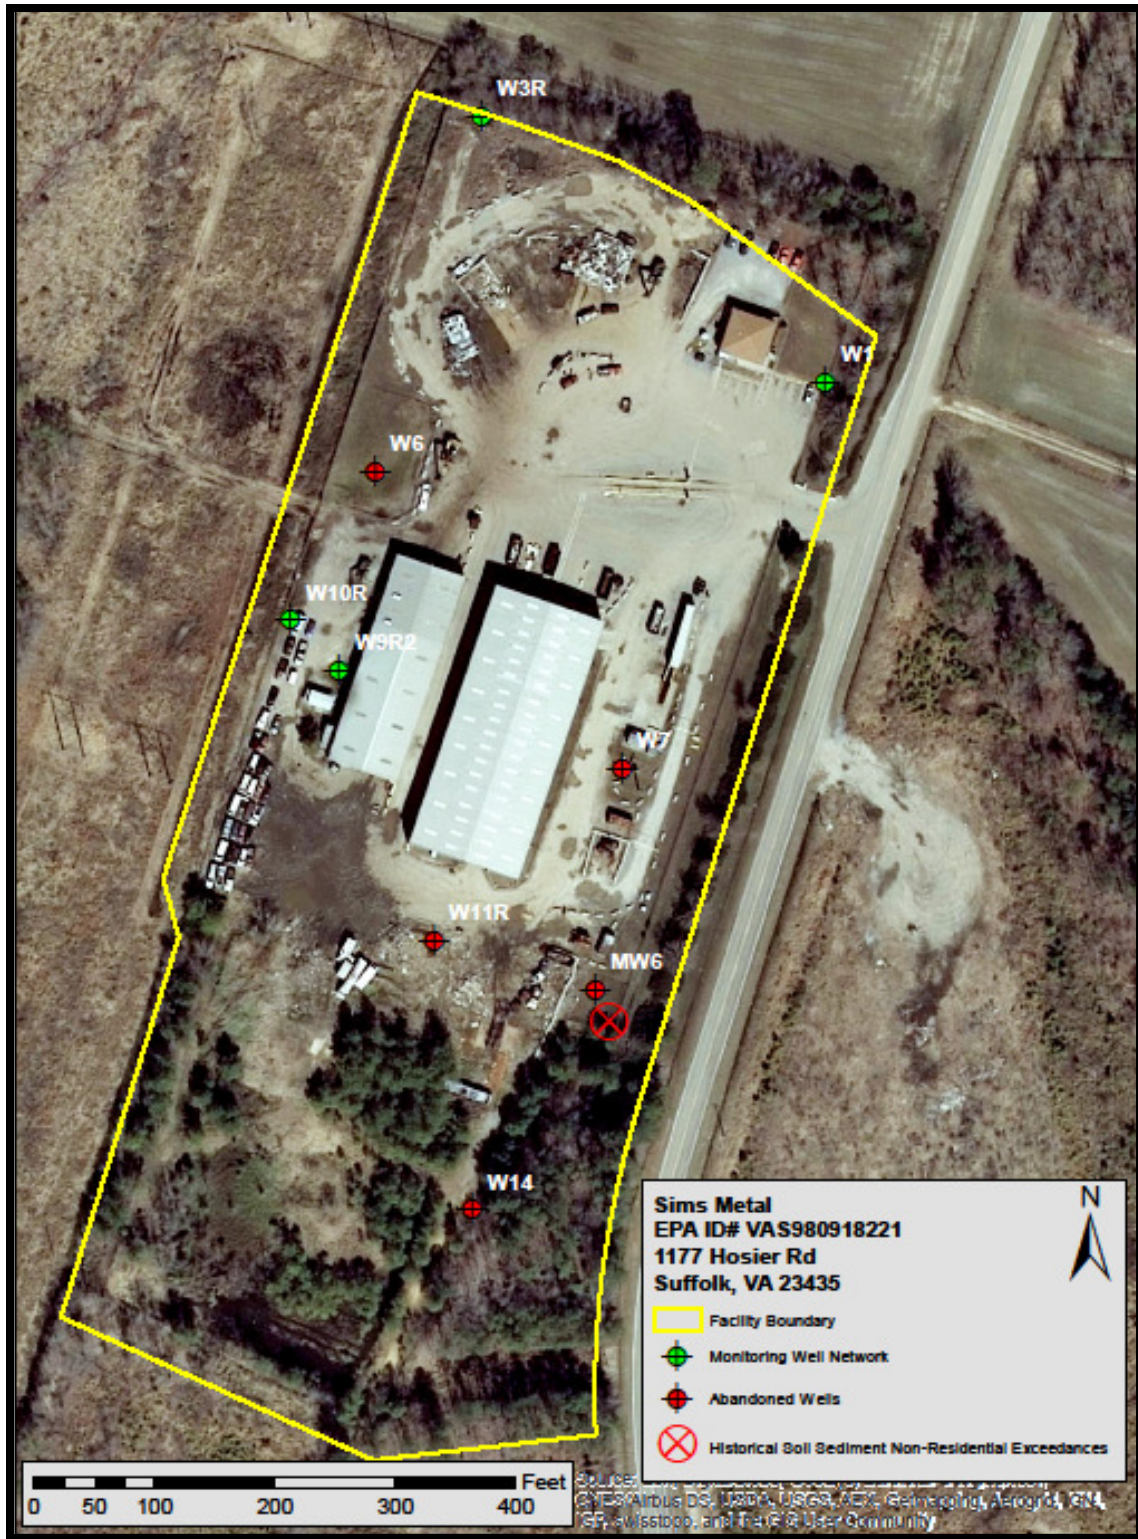
Figure 1: Aerial Map of Sims Metal Management

UECA Environmental Covenant: The Covenant is the method for implementing institutional controls required as a condition of the Statement of Basis and Final Decision. The following ICs apply to the former SMM facility, shown on Figure 1:

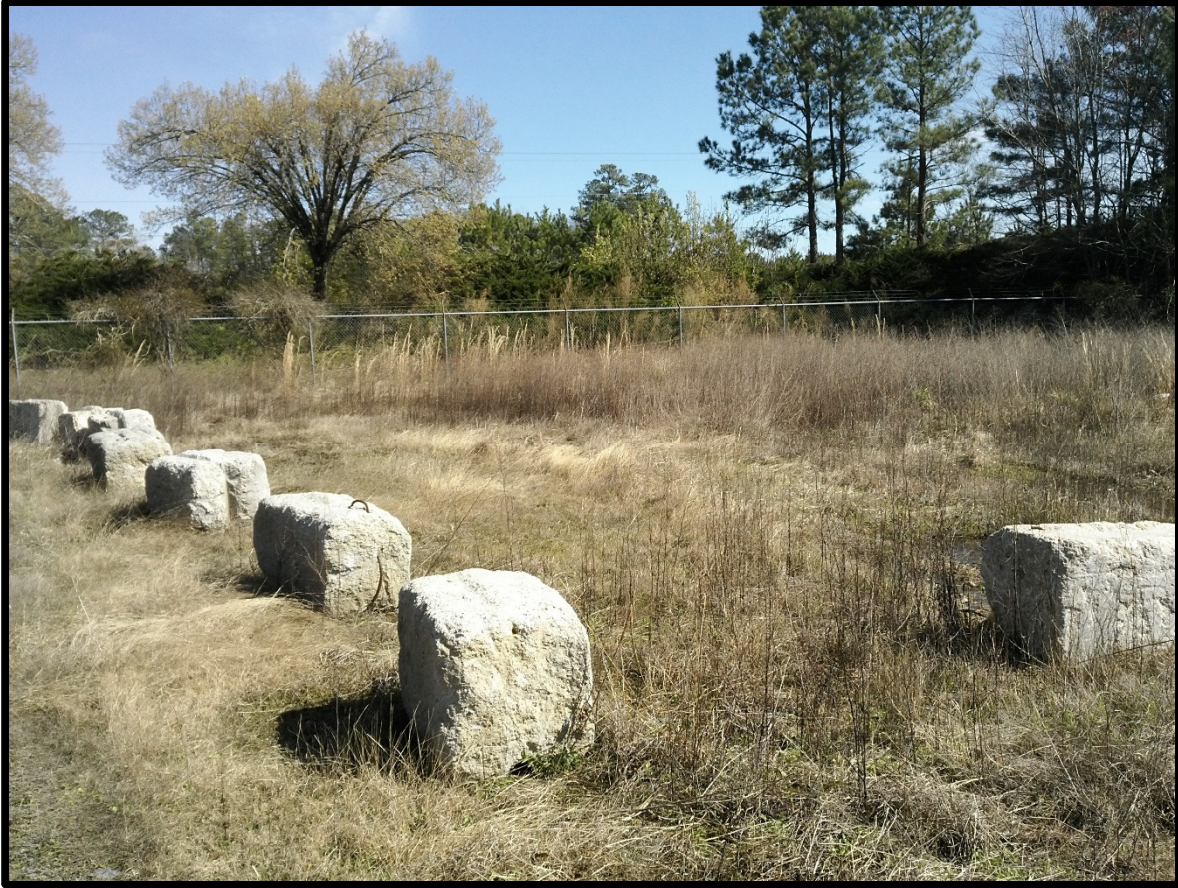
Picture 1: Vicinity of Soil Boring S-3

Materials Management Plan: The Materials Management Plan (MMP) details how all excavated soils will be handled and disposed in areas of known contamination, such as the vicinity of soil boring S-3. This area is delineated by large concrete boulders (Picture 2). Soils removed from MMP areas must be sampled, characterized and handled accordingly. The vicinity of soil boring S-3 was observed intact with no signs of earth-moving activities.

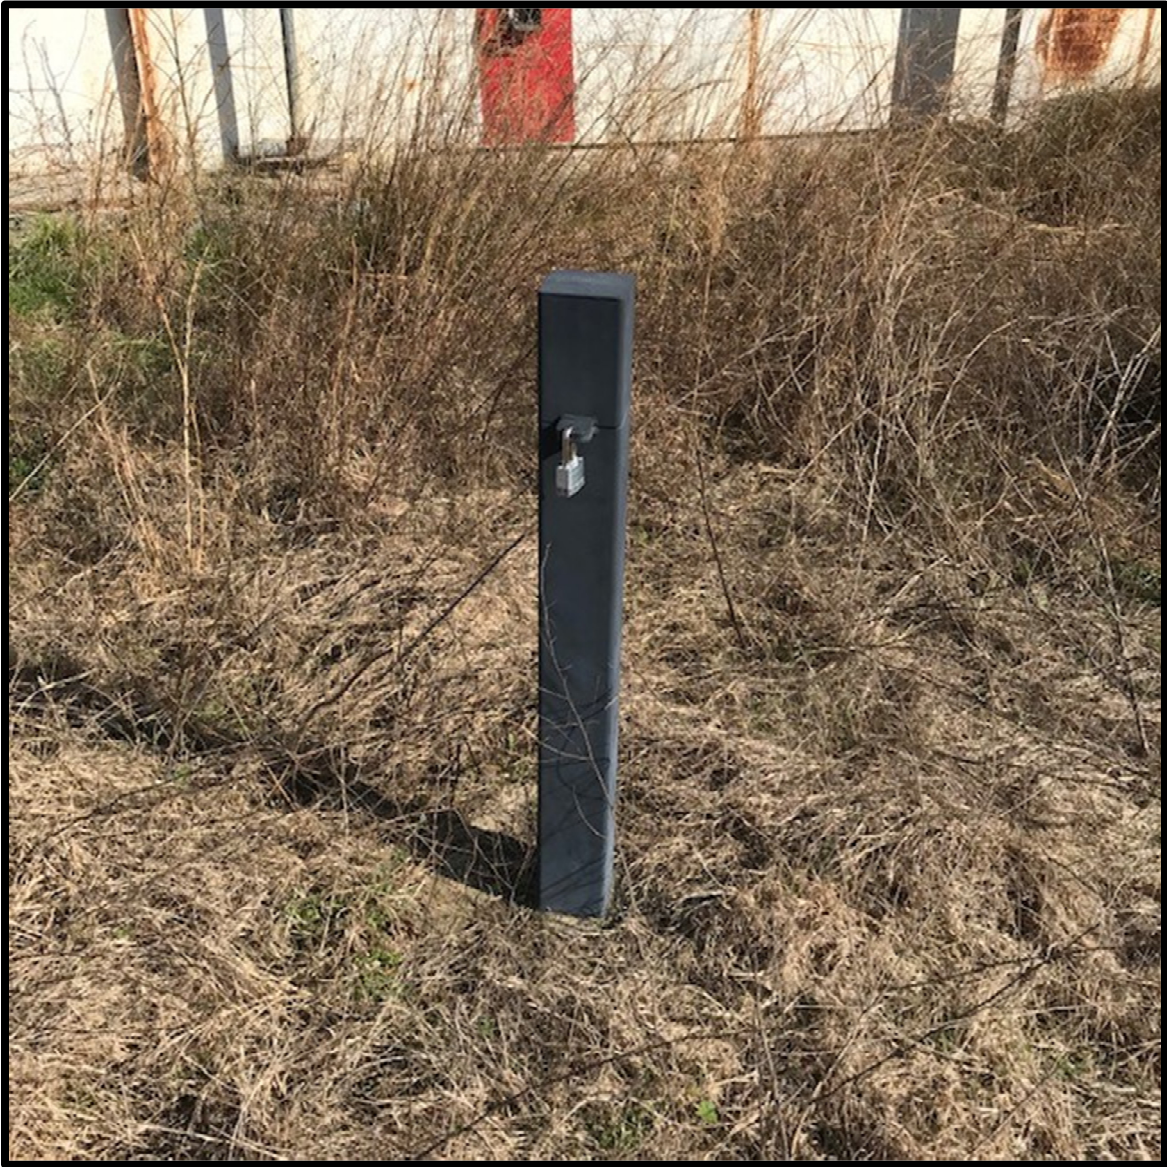
Picture 2: New Padlock on Monitoring Well W9R2

Monitoring Well	Location	Condition	Notes
W1	Downgradient/Sentinel	Good Condition	✓
W3R	Downgradient/Sentinel	Abandoned	See Abandonment Report
W10	Downgradient/Sentinel	Abandoned	See Abandonment Report
W9R2	Interior/Source Area	Good Condition	Add Lock

Conclusions and Recommendations: No EC/IC deficiencies were identified. EPA has determined that the remedy ECs/ICs have been implemented. EPA recommended that SMM place a padlock on monitoring well W-9R2. SMM confirmed with a picture of the new padlock (Picture 2).

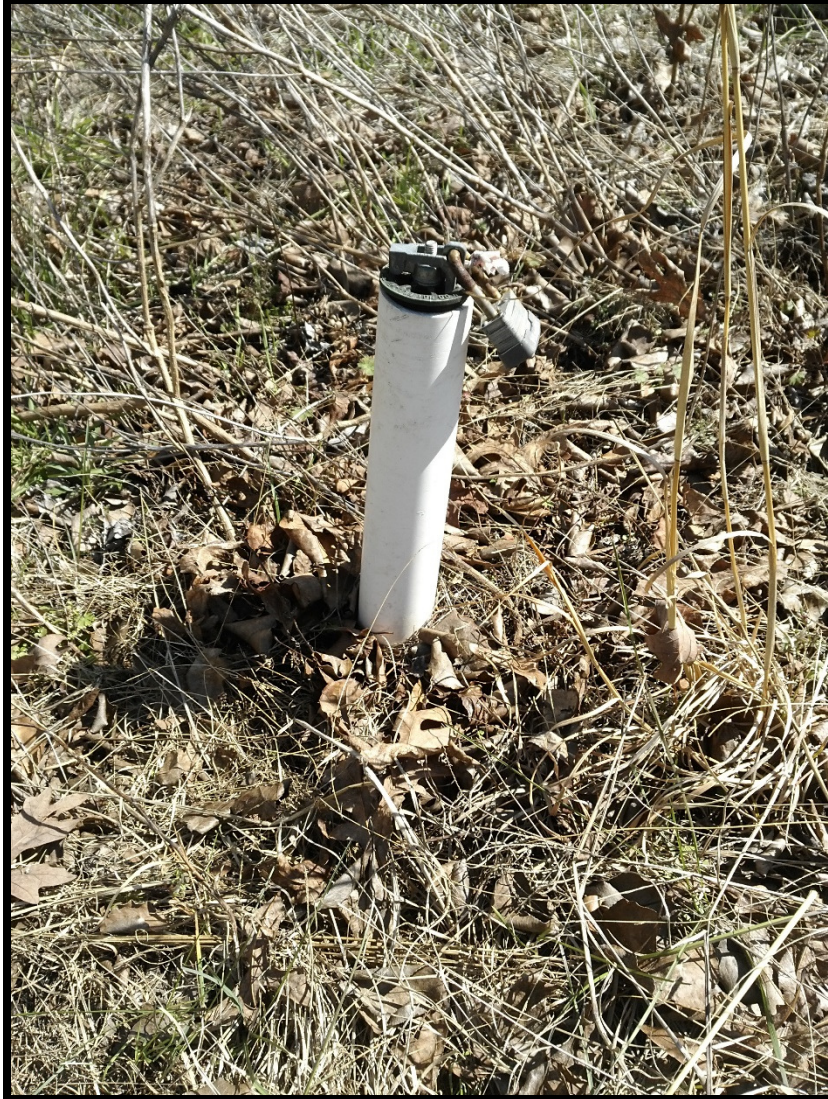
Picture 3: Monitoring Well W1

Groundwater Monitoring: SMM conducts annual groundwater monitoring at two wells. One downgradient or sentinel well (W-1) and one source area well (W-9R2) are sampled for benzene, ethylbenzene, methyl tert-butyl ether (MTBE) and arsenic. The latest 2017 groundwater sampling results showed neither benzene or ethylbenzene were detected in either of the two wells. MTBE was detected below the EPA Region III Tapwater Screening Level of 14 ug/L at W-9R2. Arsenic groundwater concentrations of 22 ug/L and 200 ug/L at monitoring wells W-1 and W-9R2 exceeded the Maximum Contaminant Level (MCL) of 10 ug/L, respectively.
