2018 Straits of Mackinac Pipeline Inspection Report

Enbridge Energy
Superior, WI

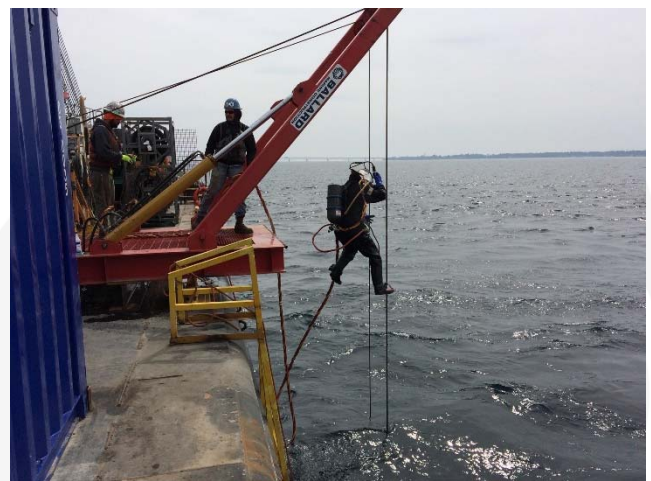
AUV inspection services mobilized to Mackinaw City on June 26, 2018, while ROV inspection services mobilized on July 16, 2018. Inspection services were conducted with a combination of AUV and ROV method that included Multi-beam and Side-Scan survey systems, acoustical tracking system and video recording devices. After an initial review of the data, no span was identified as having exceeded 75 ft. in length. The attached spreadsheet contains updated results completed after BMC's initial review. It is BMC's understanding that Enbridge Energy would submit request in 2018 for permits allowing for installation of additional anchors as needed. BMC is prepared to install additional anchors as directed once all required permitting and approvals have been received.
