Long-Term Stewardship Assessment Report

Browning Ferris Incorporated Solley Road Landfill

Assessment Date: February 28, 2019

Report Date: March 19, 2019

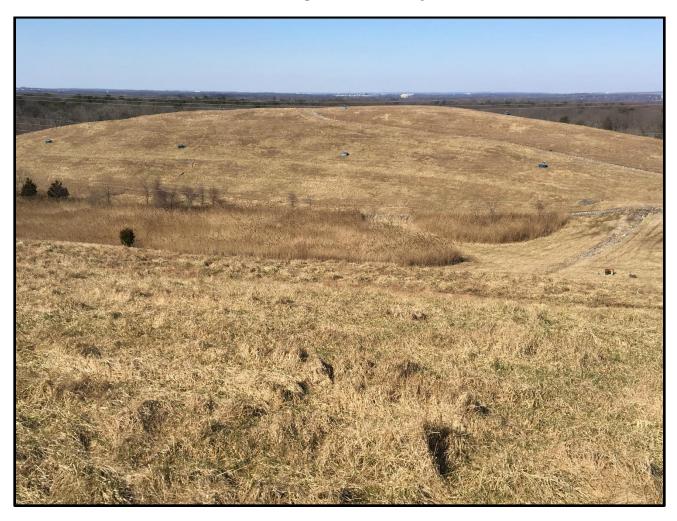
Picture 1: From top of East Fill facing west

BFI has maintained the integrity and effectiveness of the landfill caps by mowing twice per year, typically once during May or June and once during September or October. BFI performs bi-weekly perimeter and monthly site inspections. No plants with deeply penetrating root systems or erosion of

the cover were observed during the site visit. Surface water berms and swales were in good condition with no signs of ponding.

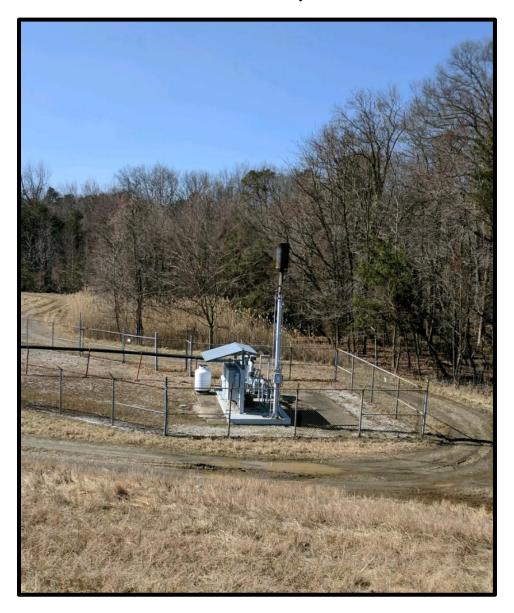
Active landfill gas extraction system: In 1995, BFI installed and began operating a landfill gas extraction system on the East and West Fills. The landfill gas extraction system is currently operated pursuant to permit number 02-9-0495-M. Pursuant to the Post-Closure permit, BFI is required to maintain and operate the system as follows: automated operation of the blower and flare system; weekly collection of operating data; balance extraction well network to maintain proper vacuum at well heads and to maintain sufficient methan concentrations for combustion; monitor perimeter gas probes on a quarterly basis to evaluate off-site gas migration; and collect condensate and dispose at a licensed disposal facility. Gas extraction wells were observed to be in good condition at the time of the site visit. BFI continues to operate the landfill gas extraction system as intended.

Picture 5: Methane Gas Extraction System candlestick flare

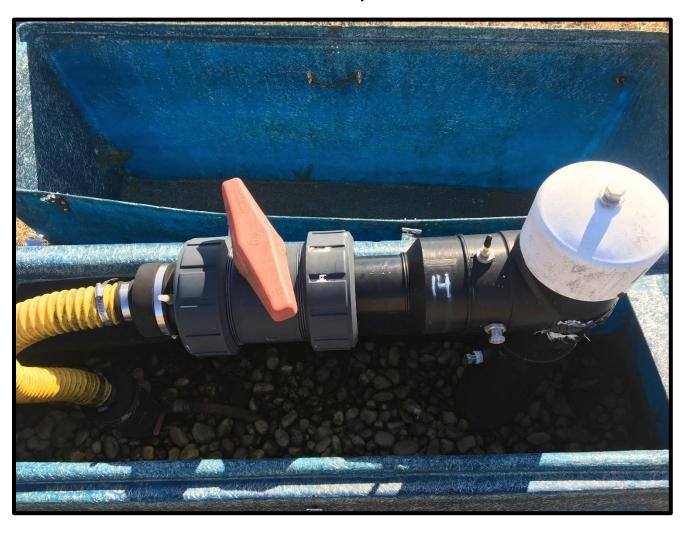
Picture 6: Gas Extraction System well #14

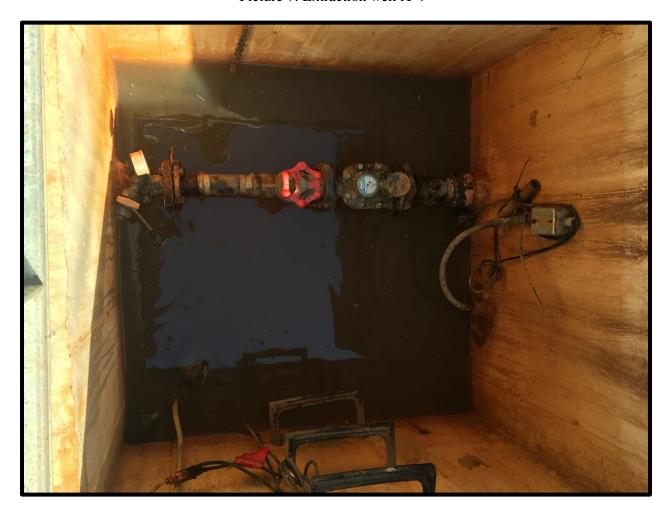
Monitoring Reports pursuant to Maryland NPDES Permit 16-DP-2755. Recovery wells were observed to be in good condition at the time of the site visit. BFI continues to operate the GWRTS as intended.

GWRTS Monitoring: BFI conducts semi-annual groundwater monitoring for VOCs compounds at ten locations, nine monitoring wells and recovery well E-6, to evaluate the performance of the treatment system. Also, four additional monitoring wells are sampled annually for VOCs. In general, groundwater flow direction is towards the west/northwest. Results of the latest November 2018 sampling event suggest that total VOC concentrations in groundwater are consistent with historical trends and that the GWRTS is effectively containing the VOC groundwater plume on-site. Five of thirteen monitoring wells were non-detect for total VOCs. Detected concentrations ranged from 3.9 ug/L at well R-15-2 located near the westerly extent of the plume to 7,100 ug/L at TW-10 located near the toe of the West Fill slope. Monitoring well R-9-3 showed a significant increase in total VOCs to 183 ug/L during the May 2018 sampling event. As a result, the pumping rate at extraction well X-4 was increased. The reported result for November 2018 at R-9-3 was 65 ug/L for total VOCs. X-4 will continue to be pumped at the increase rate to evaluate if it has a positive effect on R-9-3.

Picture 7: Extraction well X-4

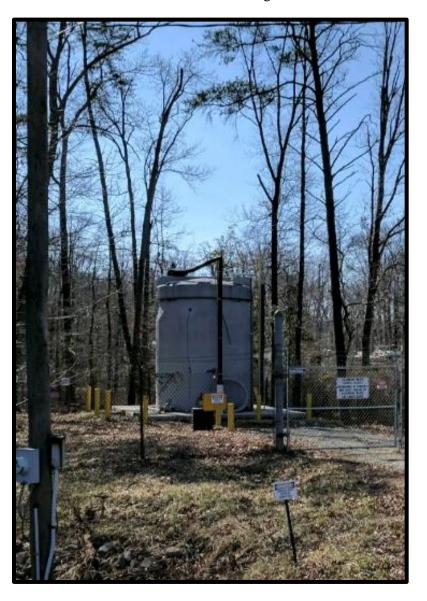
Sump levels are monitored about 3 times per week. Each month, approximately 10,000 - 12,000 gallons of leachate is collected from the East Fill while approximately 3,000 gallons is collected from the West Fill. The leachate collected is transferred and disposed off-site approximately once or twice each month. BFI performs monthly visual inspection of the condition of sumps and reports quantities of leachate collected and disposed semi-annually as part of the Post-Closure Monitoring Report required by Permit A-033. BFI continues to operate the leachate collection as intended.

Picture 8: Leachate storage tank
