## Smart Water Management

# Taking a Bird's Eye View

## La Rinconada Country Club Changes Course and Uses a Drone to Deliver Savings

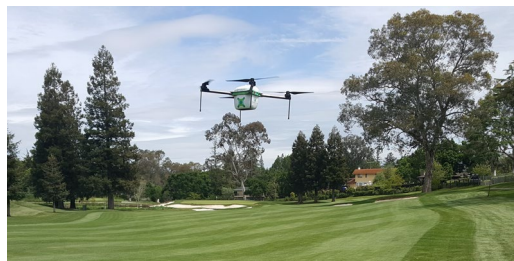
**In this infrared image provided by Kevin Breen, the colors show plant health and degree of moisture (bright colors are unhealthy, green colors are healthy).**

Here's how the drone worked: A camera attached to the device took hundreds of images of the golf course, then those images were processed and stitched together so the maintenance staff could identify areas of the landscape that needed immediate attention. Using a contractor to operate the drone for a year cost La Rinconada approximately \$6,000, which covered the technology, maintenance, insurance, and compliance with federal aviation requirements.

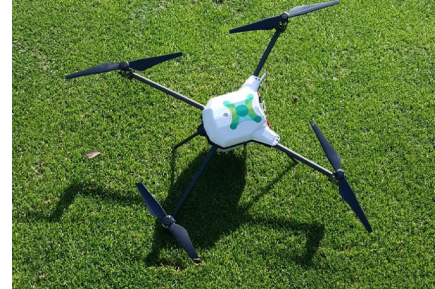
Drone used to take daily images of the La Rinconada course.

To get a complete view of the landscape with the drone, first a flight plan was developed based on the cargo load, battery life, area to be covered, and the number of photos needed by determining the area visible to the camera on each pass. La Rinconada's drone flew over the 110-acre property each day at noon for about 19
