Watershed	Canyon	Permitted Feature	Site Monitoring Area	Site ID	Receiving Water
Los Alamos/ Pueblo	Rendija Canyon	R002	R-SMA-1	C-00-041	Rendija Canyon
		R003	R-SMA-1.95	00-015	Rendija Canyon
		R004	R-SMA-2.3	00-011(e)	Rendija Canyon
		R006	R-SMA-2.5	00-011(a)	Rendija Canyon
	Bayo Canyon	B001	B-SMA-0.5	10-001(a)	Bayo Canyon
				10-001(b)	
				10-001(c)	
				10-001(d)	
				10-004(a)	
				10-004(b)	
				10-008	
				10-009	
		B002	B-SMA-1	00-011(d)	Bayo Canyon
	Pueblo Canyon	P001	ACID-SMA-1.05	00-030(g)	Acid Canyon-tributary to Pueblo Canyon
		P002	ACID-SMA-2	01-002(b)-00	
				45-001	
				45-002	
		P002A	ACID-SMA-2.01	00-030(f)	
		P003	ACID-SMA-2.1	01-002(b)-00	
		P004	P-SMA-0.3	00-018(b)	Pueblo Canyon
		P005	P-SMA-1	73-001(a)	Pueblo Canyon
				73-004(d)	
		P006	P-SMA-2	73-002	Pueblo Canyon
				73-006	
	P007	P-SMA-2.15	31-001	Pueblo Canyon	
	P008	P-SMA-2.2	00-019	Pueblo Canyon	
	P009	P-SMA-3.05	00-018(a)	Pueblo Canyon

Volume 1

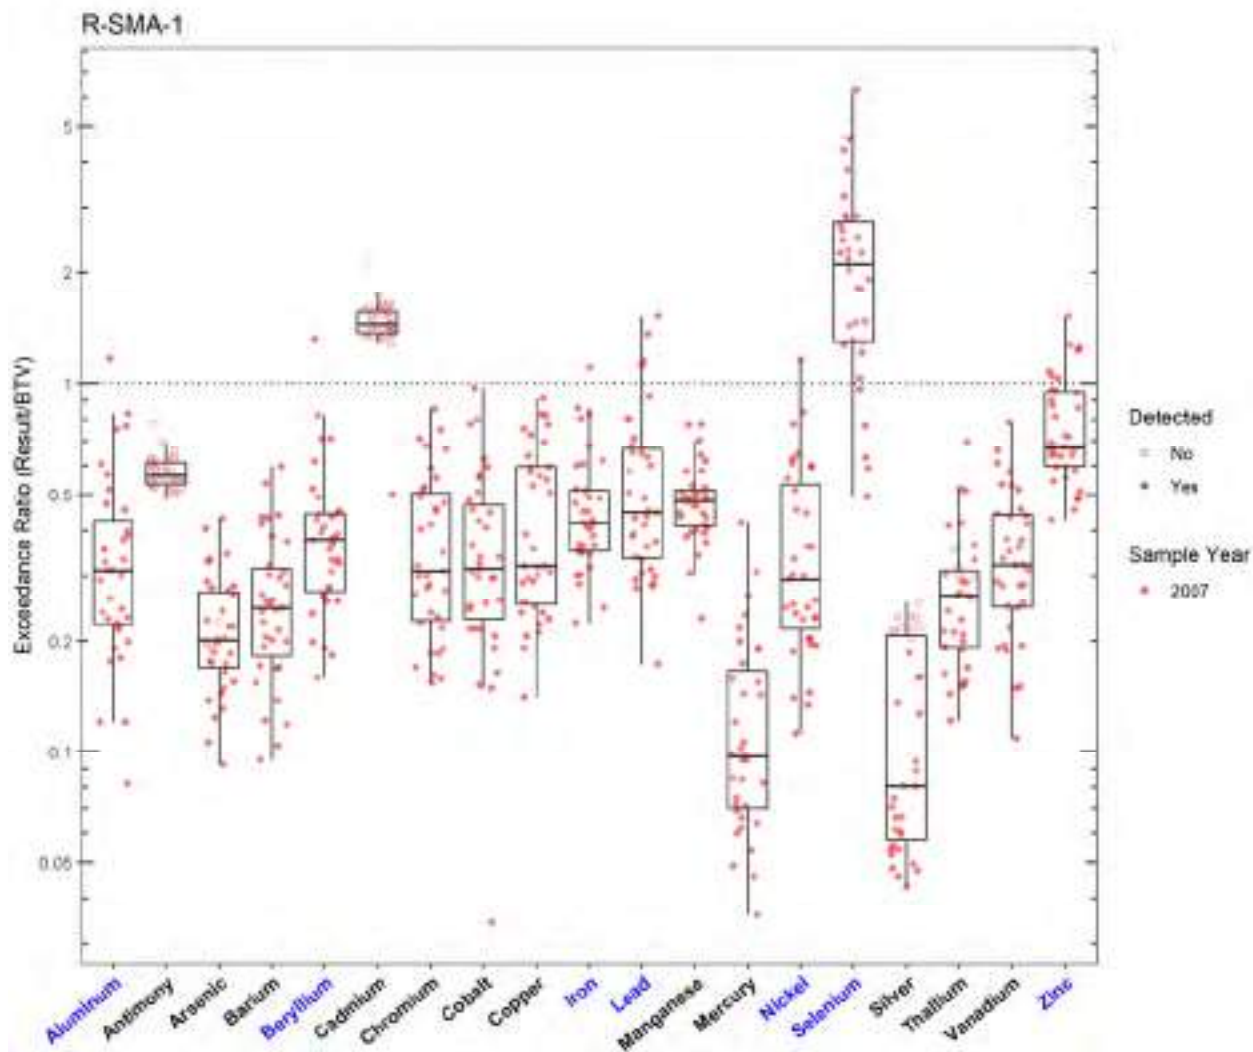
Figure 1.3-1 Inorganics Analytical Results from Soil Samples Associated with R-SMA-1

Decision-level data for AOC C-00-041 consist of results from samples collected in 2007. Analytical results from those samples are presented in Figures 1.3-1 through 1.3-4. The 2007 IR, Revision 1, concluded that the nature and extent of contamination are defined.
