HISTORICAL DOCUMENT REVIEW AND INFORMATION SUMMARY REPORT

Manistique River
Area of Concern
Manistique, Michigan

Task Order No. 0003, WP0, R0/Contract No. EP-S5-06-01

September 2012

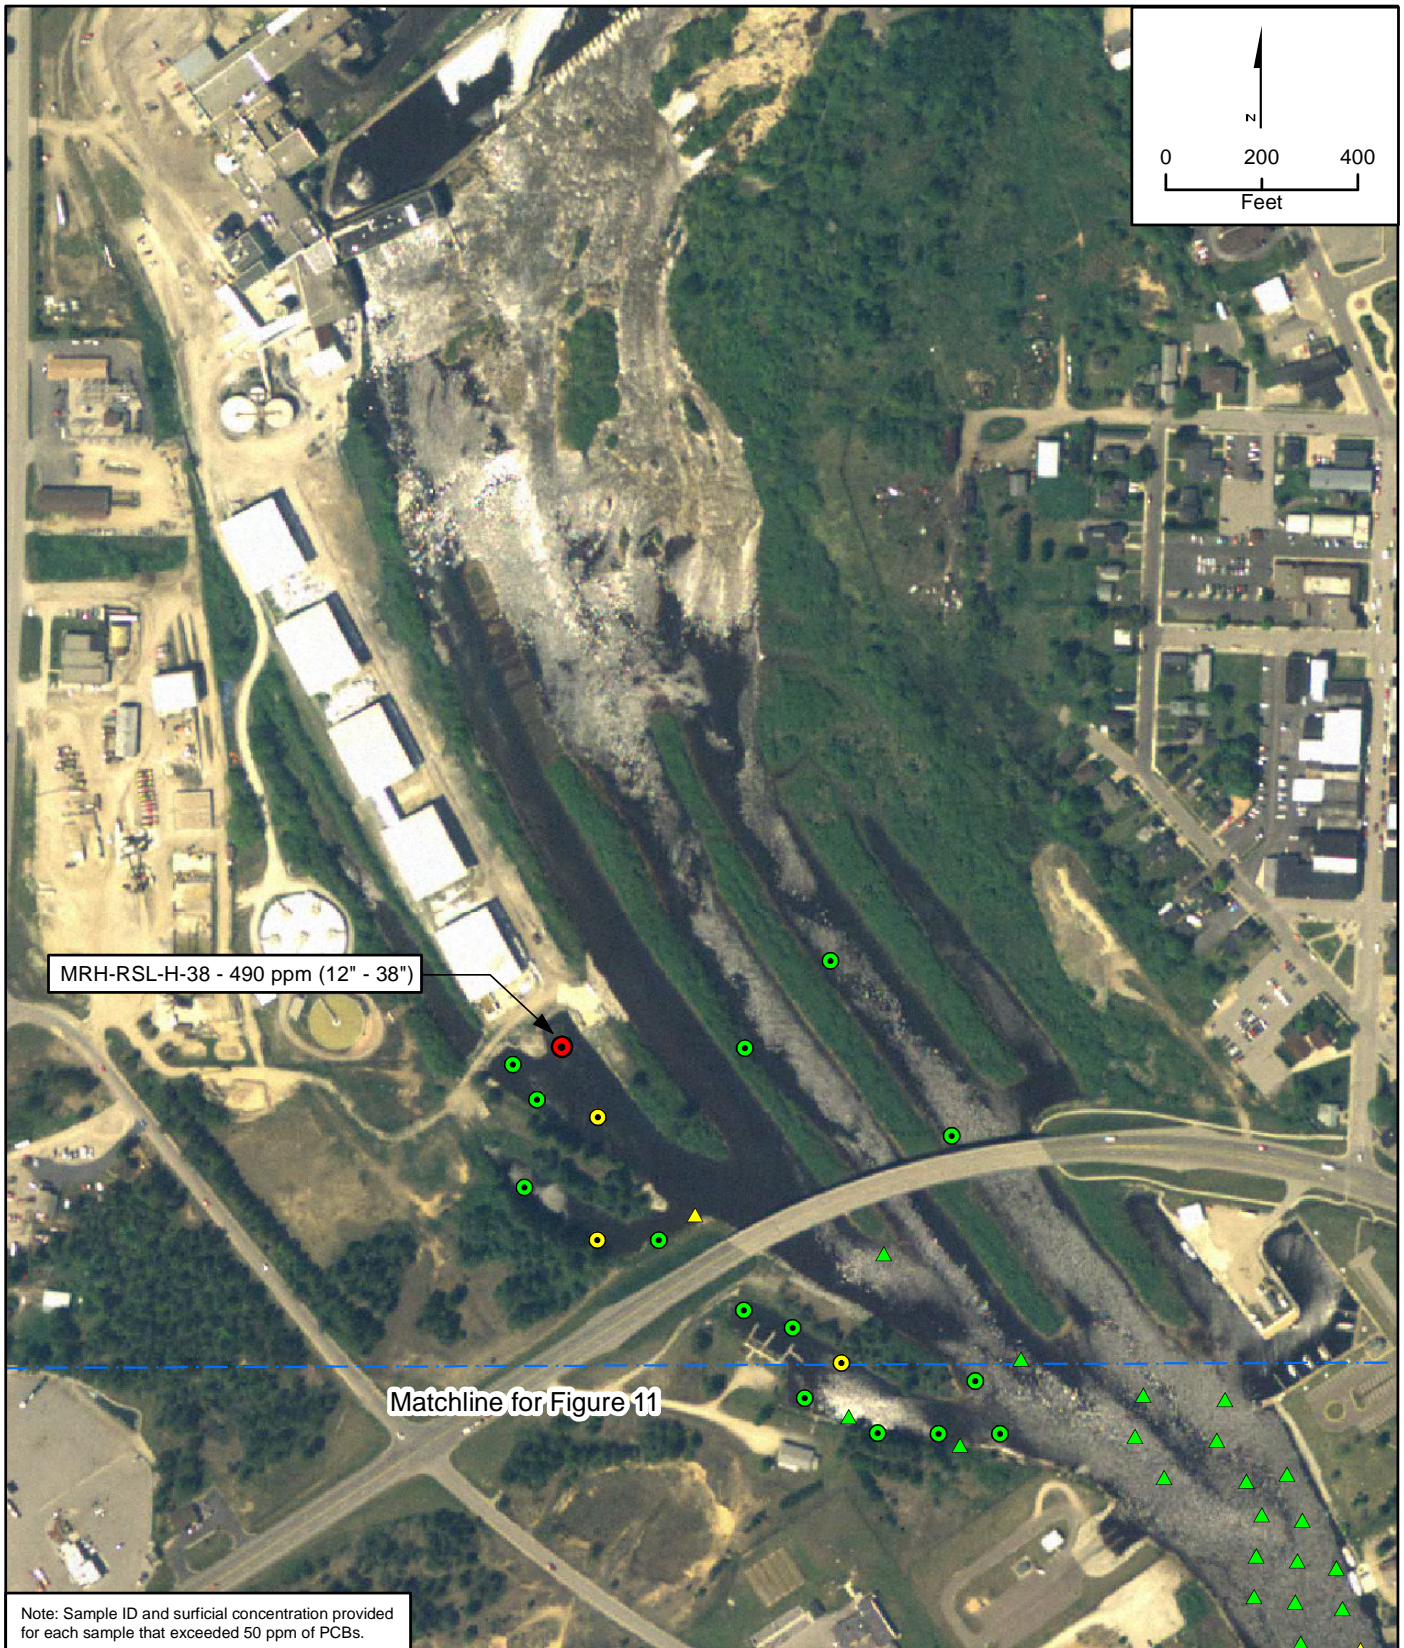
FIGURE 10
 Post-Dredge Maximum Subsurface
 Sample Concentrations
 Historical Document Review and
 Information Summary Report
 Manistique River AOC
 Manistique, Michigan

Note: Sample ID and surficial concentration provided for each sample that exceeded 50 ppm of PCBs.
